The Analysis of 220kV Transformer Abnormal DC Resistance

Fushun Power Supply Company, Liaoning Electric Power Company Limited, State Grid, China,
fushunpowersupply@163.com

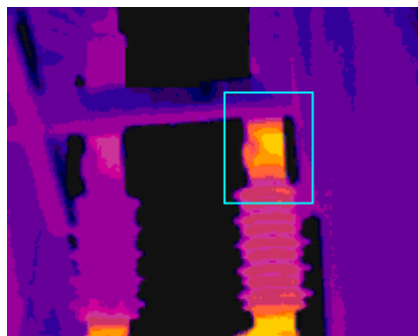
Helping substation 1st Main transformer on the 1st January 8, 2000 and put into operation, operation life for 13 years. Production of transformers Type: SFPSZ11-120000 / 220. Before 2013 blackout overhaul, all joints of the external transformer infrared thermal imaging tests. Found in the test phase 66kV side A higher temperature of both ends of the sleeve 26.2 C (see Figure 1), the current 1000A; temperature while it is on the left side end portion of the sleeve relative to B 15.9 C, current 990A; ambient temperature 12.6 C. After a review of the recent transformer insulating oil chromatographic analysis report, the comprehensive analysis in accordance with the current load, ambient temperature, etc., we will not affect the safe operation of the transformer, and then a treatment can wait until the maintenance outage[1-4].

Figure 1 66kV of the A-phase infrared test tube case

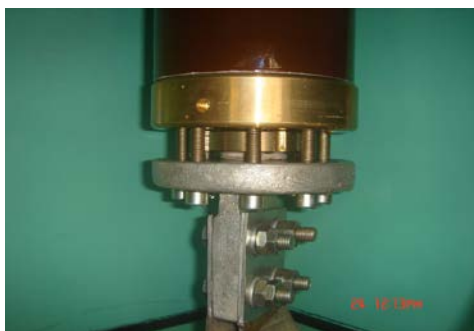
By maintenance personnel will be on the 1st transformer main transformer insulating oil put to 66kV side manhole below, open manholes, found the first phase winding A conductive terminal and connecting rod (wiring board) 4 bolts and some loose (see Figure 2) .

Figure 2 The 4 bolts loosening phenomenon

The cause of 66kV side of the A-phase transformer winding DC resistance is too large, is due to manufacturers in the production of the winding uneven solder when soldering the first end of the connector, and not using a dedicated thermostat tire tool intensify welded parts, warming to the tin when the melting point temperature of the extruder 232 C excess solder to form the solder layer is not formed and the cavity between. When the first connector and the conductive rod end windings (wiring board) connection is used under the nut flat washer, rather than high temperature Disk Spring (not opening a spring washer, shape UFO), tighten the connection in this case, can not completely overcome repeated deformation of metallic materials after thermal expansion, resulting in the gradual relaxation bolt preload, thereby causing the DC resistance of the windings increases, the range of values deviate qualified lead winding DC resistance unbalance the difference exceeds the "regulations" provisions.

From Table 1 that, load September 18, 2006 the largest transformer, the highest temperature. Since this would mean that the highest temperature linear expansion of the metal material will be larger, and the transformer load with decreasing temperature, the line will follow the expansion of the metal material is reduced, the bolt preload will loose contact with the contact surface of the resulting the resistance becomes large.

Through the above analysis, the calculation shows that this part of the pressing force generated by the difference in pressure only by deforming the solder layer, this part of the expansion to offset the "space", such deformation is reversible. At the same time due to the ferromagnetic transformer runtime generated shock will have some of these parts of the shaking force and friction, long time is also easy to make the solder layer deformation accelerated, so that the bolt preload relaxation.

After re-tighten, try again side DC resistance test data Am0: 10.56 mΩ, Bm0: 10.58 mΩ, Cm0: 10.52mΩ, three-phase average difference of 0.56%, and in accordance with the test data of qualified "rules" requirement. The following line of metal materials from the factory expansion and production processes, analysis of these issues, identify where the problem is put forward possible solutions to prevent the problem from happening again.

For a similar case when a transformer during overhaul, transformer maintenance personnel should be added under high temperature Disk Spring nut and difficult plus flat washer, which not only solved the vibration caused by ferromagnetic first end fitting bolt preload transformer winding runtime relaxation; also solved due to the volume change of the metal due to repeated thermal expansion and pressure changes in the two contact surfaces, the contact resistance of the winding to ensure that the first end of the connector and the wiring board between the large change does not occur.

Do not add the opening spring washer on the flat washers. Due to the opening of the spring washer outer diameter smaller than the effective outer diameter of the nut pressing, reducing the pressure receiving area of the two contacting surfaces, but also easy to be deformed flat washer. At higher temperatures, larger temperature difference between the repeated changes both metal fastening, use the opening spring washer effect is not very good, it is better to use only flat washer's effect. However, when used flat washers pay attention to the press (edge burrs) facing up, tighten the nut flat washer after extrusion surface smooth, uniform force receiving surface to prevent the bolt preload relaxation but also add a drop Mother.

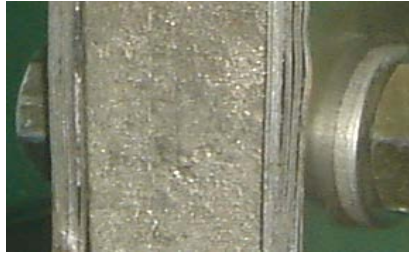
Figure 3 a multi-layer winding of the first end of the copper

Manufacturers recommend improvements in the process. According to design requirements 66kV transformer winding between the first end of the multi-layer copper immersion tin after treatment, the use of tires with the winding temperature first end fixed to intensify, heated to 232 C solder melts, then the appropriate intensify tire tool, extrusion winding first end of excess solder between the multi-layer copper is removed between the tip surface of the shaped cavity is formed (Figure 3),

Welding surface of the solder between the thin and uniform. Avoid sudden cooling, because the thermal expansion coefficient of the metal, the thermal conductivity of the different surface quality of the weld and will, cause the first end of the volume resistivity of the windings increases. To natural cooling, the temperature dropped to ambient temperature, and then releases the tire tool; winding first end fitting after such treatment, in operation issues mentioned in the text will not appear.
