Summary on Seismic Damage Characteristics of Bottom Frame Structures in Wenchuan Earthquake

Abstract—The application of masonry buildings with frame and seismic-wall in the lower stories in the “5.12” Wenchuan earthquake disaster area was very extensive. The main damage characteristic of this kind of structure was summarized through field investigation where a large number of examples appeared. Overall, the seismic damage of the bottom frame structures can be summarized as the following: firstly, if the stiffness of frame shear wall stories is larger, the failure of underlayer is light but the upper masonry stories get seriously damaged; if the stiffness of upper masonry stories are larger, the underlayer gets seriously damaged but the failure of upper masonry stories are light. Secondly, the damage of wall is heavier than the column, the damage of column is heavier than the beam; the damage of column cap is heavier than column base, and the damage of corner column is heavier than inside column and side column. Thirdly, the force of transition layer is complex, and the wall is destroyed seriously. Fourthly, the destruction of the upper part of the bottom frame structure is similar

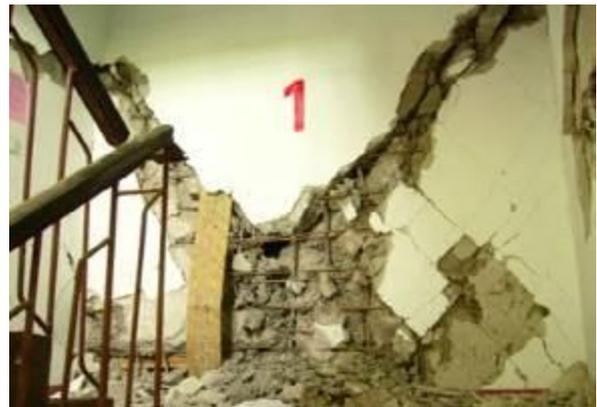
(a). Shear failure of reinforced concrete anti-seismic wall.

current seismic code. During the seismic design stage, the anti-seismic walls are designed to bear all the earthquake shear force. Seismic damage of reinforced concrete shear wall in the actual damage scene is relatively rare, the main reason is the strength and stiffness of shear walls are great, and it is not easy to result in obvious damage. However, when the seismic peak acceleration is large or the aspect ratio is too small, the shear failure will occur because of the earthquake shear, which the reinforced concrete shear wall is subjected over its limit bearing capacity (Fig. 1). The destruction of the shear wall consumes the energy of the earthquake and protects the main structure, which is regarded as the first defending line of the bottom frame structure^[2].

Secondly, much more attention should be paid to multi-seismic resistance during the seismic design. The reinforced concrete anti-seismic wall in bottom layer of bottom frame structure should be considered as the first defending line of structure. In the initial stage of the earthquake, the anti-seismic wall bear most of the seismic shear, and when it is damage inactivation the frame column still can ensure to undertake according to the rigidity distribution corresponding to the ratio of the shear. This is the second defending line of the bottom frame structure. In the upper masonry layers, the brick wall is considered as the first defending line in the initial stage of the earthquake which is the main load-bearing component. When the thorough crevice appears to the walls, constructional column and the ring beam are considered as a second line of defense which is similar to the frame structure system, in order to ensure the integrity of the upper masonry layers.

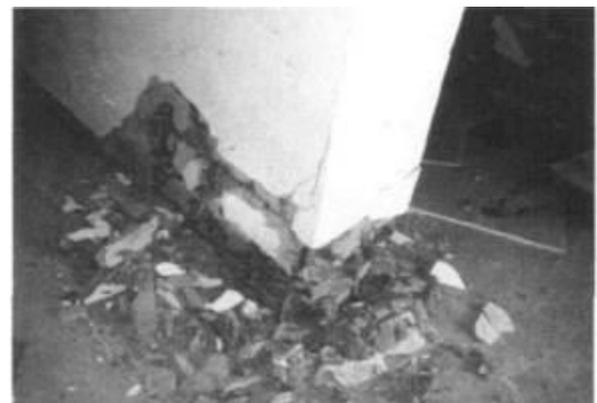
(b). Damage of wall corner.

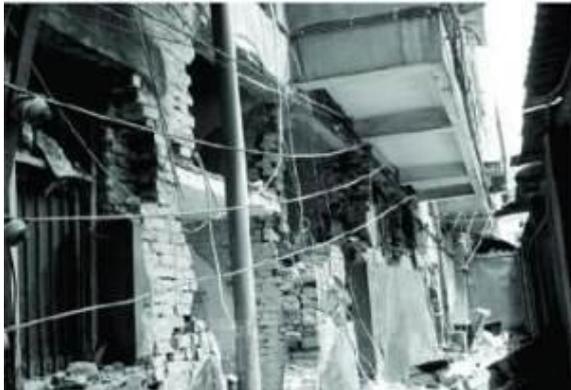
The common brick masonry anti-seismic wall was used in previous bottom frame structure. However, due to the low shear strength, poor ductility and brittle failure of the masonry (Fig. 2), the current seismic code^[3] provisions that only the total floor number of bottom frame structure does not exceed four can use common brick masonry anti-seismic wall in 6 intensity section. And the mixed use of reinforced concrete anti-seismic wall and brick aseismic wall in the same direction is not allowed. The reason is that the material properties of these two anti-seismic walls are very different, and preventing the defeat in detail under the earthquake action causes adverse effects on the main structure.

(a) Damage of masonry anti-seismic wall in longitudinal direction

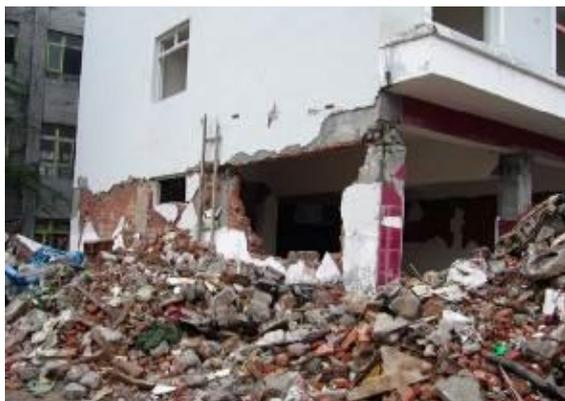
(b) Damage of masonry anti-seismic wall in horizontal direction.

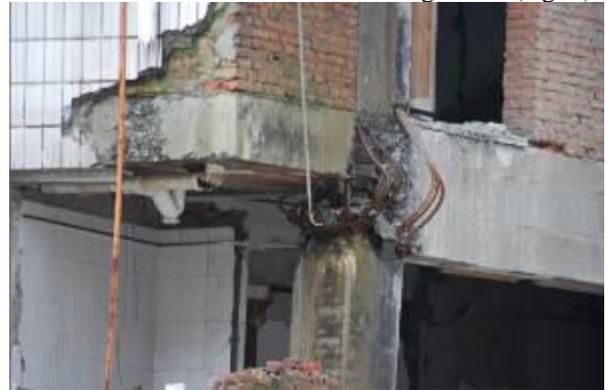
When the failure occurs on the bottom frame columns, almost all the plastic failures appear to be column cap and column base, rarely appears to ductile failure of beams. At the highest bending stresses of concrete column, the concrete of column cap is crushed and shedding, steel bar occur severe deformation of the bending and twisting. The more serious damage to the columns of bottom frame structures lead to tilt, fracture and collapse of the bottom layer directly. Sometimes, due to the setting of infilled walls in the bottom layer, it will produce additional shear and additional bending moment to the frame columns which causes the shear failure or bending failure (Fig. 3).

(a) Compressional buckling of steel bar of column.

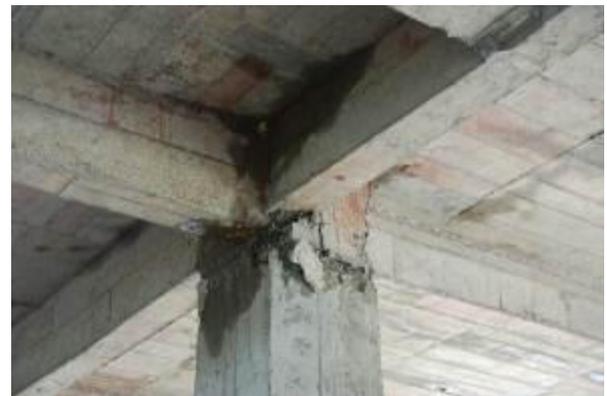
(b) Plastic hinge appears in beam-column joint.

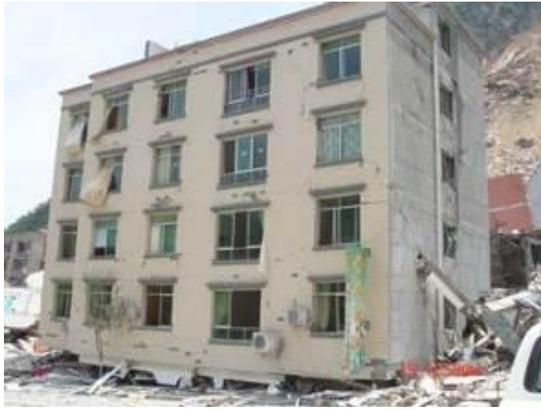
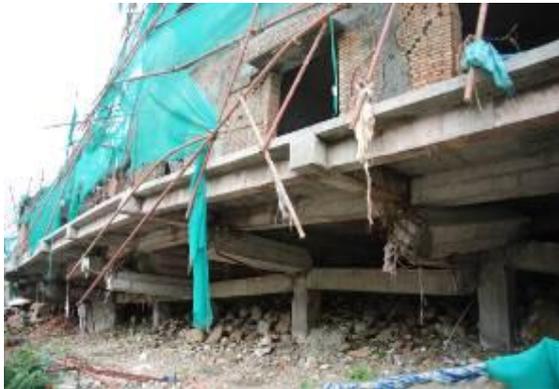
Figure 4. Collapse of the bottom layer.

For structure buildings, the earthquake shear of the bottom layer is the largest. When the earthquake acceleration peak is higher, and there is no aseismic wall in the bottom layer or the quantity of aseismic walls are few, the bottom frame-shear wall stories appears obvious interlayer displacement after entering the elastic-plastic deformation. When the deformation exceeds a certain threshold, the stiffness of bottom anti-seismic wall degenerates greatly and frame bears larger earthquake force. The failure of beam-column joint and eventually leads to the serious damage of bottom layer or even collapse (Fig. 4).

(a) Collapse of the bottom layer.

(b) Collapse of the bottom layer.

Firstly, the lateral stiffness ratio of the structure should be strictly controlled, and the uniform damage should be guided for the whole structure. The emergence of obvious weak floors should be avoided. The ductility and energy dissipation capacity of the bottom shear layer are better, and the bottom frame shear layer should be used as the main energy dissipation floor.

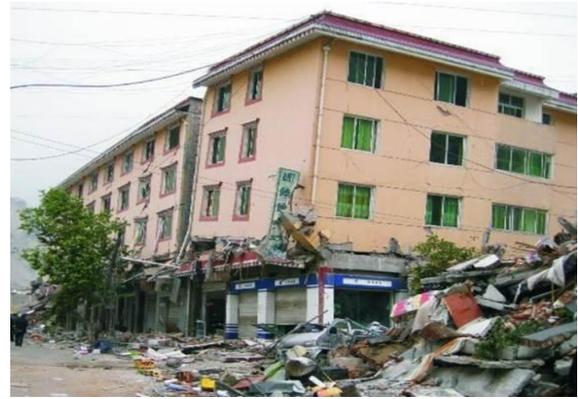
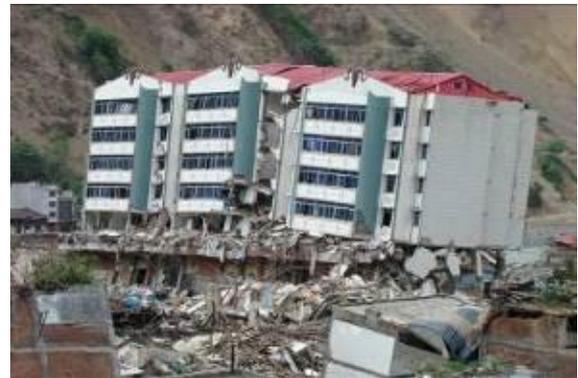
Figure 5. Damage of the transition layer.

The lateral stiffness of the transition layer is changed dramatically, which is easy to produce stress concentration. In addition to bearing the earthquake shear force, the transition layer also needs to bear the overturning moment of the upper layers. The force is more complex, so it usually gets most serious damage during the earthquake. When the horizontal earthquake shear force exceeds the bearing capacity of the transition layer, the "sitting layer" phenomenon of the whole transition layer under the weight force of the upper structure is more common (Fig. 5).

Comparing with the collapse of the bottom layer, the reason of the "sitting layer" phenomenon of the whole transition layer is that much more anti-seismic walls or infill walls are set in the bottom layer. So that the stiffness and shear strength of bottom layer is large, that causes the weak floor of the structure transfers from the bottom layer which has better ductility and energy dissipation capacity to transition layer. That results in serious damage to the walls of the transition layer. So the difference of material properties is considered by seismic code^[4], and the rigidity of the bottom layer is required to be lower than the transition layer. However in the actual seismic damage, the damage to the walls of the transition layers are very serious regardless of whether it is strictly according to the standard design. That means the stress of transition layer is complex, the seismic mechanism of the transition layer needs further analysis and more reasonable design index needs to be researched.

(a) Damage of the transition layer.

(b) Damage of the transition layer.

Thirdly, the walls of transition layer should be strengthened. The actual earthquake damage shows that the damage to the walls of the transition layers are very serious regardless of whether it is strictly according to the standard design. The walls of transition layers locate in the region which has complex stress and vertical stiffness changes violently. Therefore, it is suggested that the level of masonry mortar should be increased, the number of constructional column should be increased, and the connection measures between the wall and the construction column and ring beam should be strengthened.

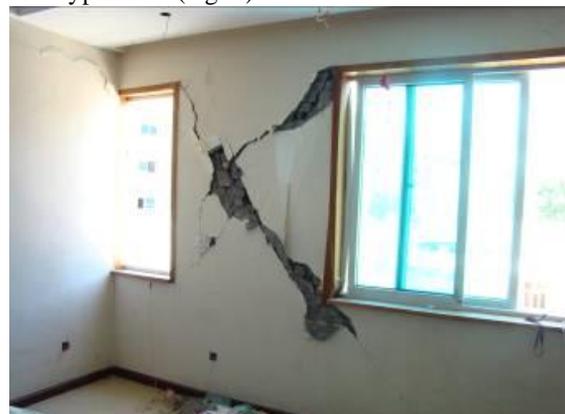
The failure characteristics of the upper masonry layers of bottom frame structures are similar to the multistory masonry structures^[5]. The main failure characteristics including wall cracking, shear inclined cracks, cracks in X crossover type, horizontal and vertical cracks. One of the common damage is the destruction of the wall between windows. wall between windows Because of poor integrity, low bearing capacity and window and door openings produce stress concentration, these reasons lead to wall between windows often appear shear inclined cracks or cross X type crack (Fig. 6).

(a) Inclined cracks in wall between windows(internal).

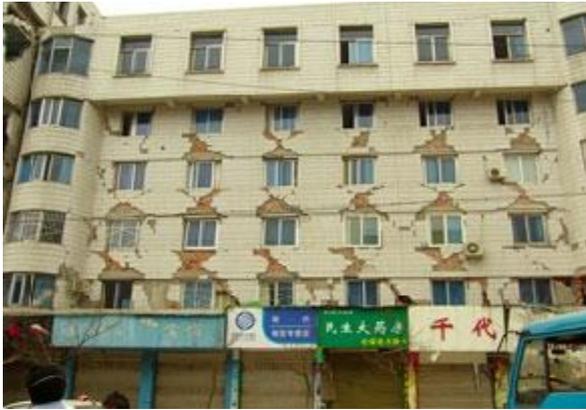
(b) Damage of the wall under windows in upper masonry layers.

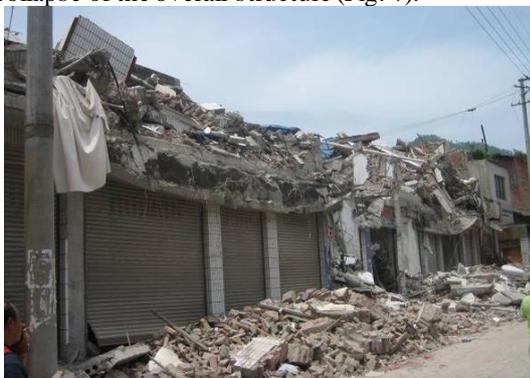
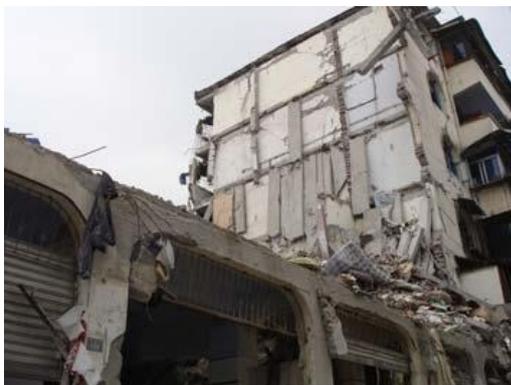
Figure 7. Collapse of upper masonry layers.

The bottom frame shear layer is damaged lightly, but the upper masonry layers are severely damaged or collapsed. The reason is that much more anti-seismic walls or infill walls are set in the bottom layer, so the stiffness and shear strength of bottom layer is large, that causes the weak floor of the structure transfers from the bottom layer to the upper masonry layers. The tensile strength and shear strength of masonry structures are very low, and the ductility is poor, it is easy to be brittle failure under the horizontal earthquake action. When the walls of upper masonry layers are less and the earthquake peak acceleration is very large, it will cause wall cracks because of the deficiency of anti-collapse ability, and even cause the collapse of the overall structure (Fig. 7).

(a). Collapse of upper masonry layers.

(b). Collapse of upper masonry layers.
