Improvement on accuracy of coiling temperature at tail of strip during U-type cooling process

Zhimin Zhang^{a*}, Changli Zhang^b, Fengqin Wang^c, Yanhui Hu^d,
Jinsheng Yang^e

Shougang Research Institute of Technology, Shougang Group, Shijingshan District,
Beijing, 100043, China

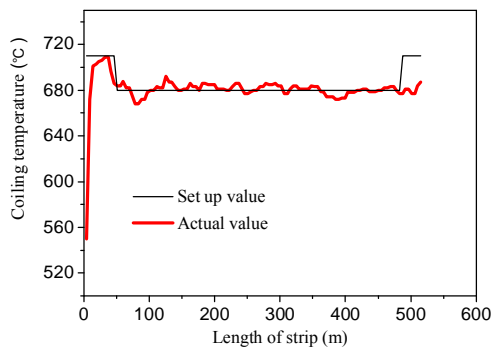
Fig.2 Coiling temperature

Coiling temperature at tail of strip is lower than target temperature sometimes when hot rolling strip is cooled during U-type cooling process. Poor coiling temperature of strip during U-type cooling process is shown in Fig. 2. The technological parameters of strip in Fig. 2 are shown in Table 1.

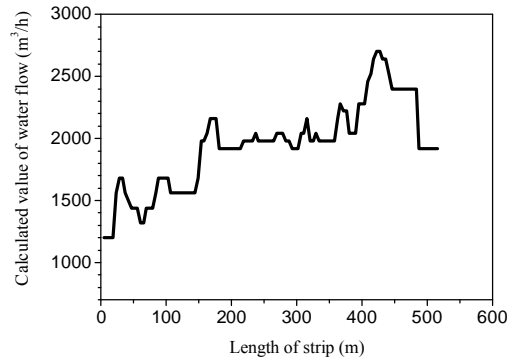
Fig.3 Calculated value of water flow

Water flow, running speed of strip and number of valves turned on in micro zone were obtained from cooling log. Calculated value of water flow along strip length direction is shown in Fig. 3. Actual value of water flow along strip length direction is shown in Fig. 4. From Fig.3 and Fig.4, it can be seen that water flow is increasing along strip length direction. Running speed of strip is shown in Fig. 5. It can be seen from Fig. 5 that speed of strip during cooling is increasing. Water flow increases when speed of strip becomes faster. It is necessary to obtain a constant target coiling temperature.

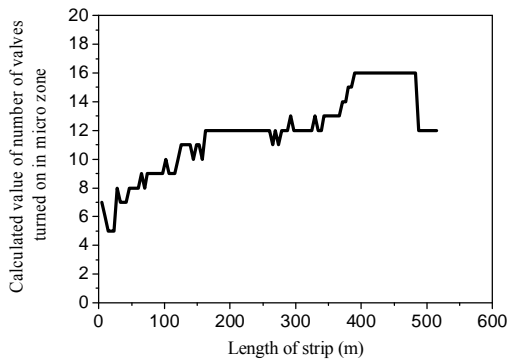
Fig.6 Calculated value of number of valves turned on in micro zone

The increasing water flow is closely related to number of valves turned on. Calculated value of number of valves turned on in micro zone is shown in Fig. 6. Actual value of number of valves turned on in micro zone is shown in Fig. 7. From Fig.6 and Fig.7, it can be seen that number of valves turned on for strip during cooling is increasing. It also attributes to the increasing speed of strip.

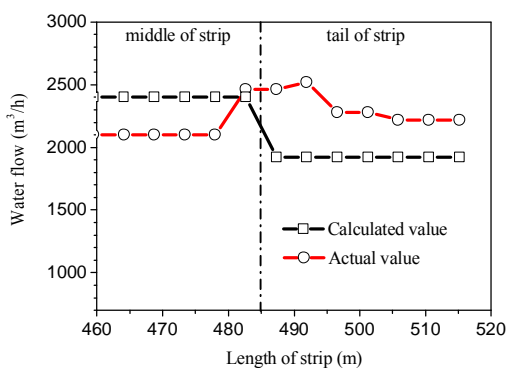
Fig.8 Comparison between calculated value and actual value of water flow for strip tail

Fig.8 can be obtained by comparing calculated value of water flow for strip tail in Fig.3 with actual value of water flow for strip tail in Fig.4. Fig.9 also can be obtained by comparing calculated value of number of valves turned on in micro zone in Fig.6 with actual value of number of valves turned on in micro zone in Fig.7. Target coiling temperature at tail of strip is higher than middle part of strip during U-type cooling process. So water flow for strip tail should be less than water flow for middle part of strip. From Fig.8 it can be seen that calculated value of water flow for strip tail is less than calculated value of water flow for middle part of strip. It is correct. But actual value

of water flow at tail of strip is not consistent with the corresponding calculated value of water flow. Actual value of water flow for strip tail is greater than actual value of water flow for middle part of strip. That is the reason of low coiling temperature at tail of strip during U-type cooling process.

From Fig.8 and Fig.9 it can be seen that calculated value of water flow shows the same tendency of changes with calculated value of number of valves turned on in micro zone and actual value of water flow shows the same tendency of changes with actual value of number of valves turned on in micro zone. In fact calculated value of water flow depends on calculated value of number of valves turned on in micro zone and actual value of water flow depends on actual value of number of valves turned on in micro zone. In U-type cooling process, water flow for strip tail is less than water flow for middle part of strip. So number of valves turned on in micro zone for strip tail should be less than for middle part. According to Fig.9 calculated value of number of valves turned on in micro zone for strip tail is less than for middle part. It is correct. But actual value of number of valves turned on in micro zone at tail of strip is not consistent with the corresponding calculated value. Actual value of number of valves turned on in micro zone for strip tail is greater than for middle part of strip. That is the reason of greater actual water flow at tail of strip.

Water flow for strip tail should be less than for middle part in order to obtain higher coiling temperature at tail of strip than middle part. That is to say, number of valves turned on in micro zone for strip tail should be less than for middle part. Calculated value of number of valves turned on in micro zone for strip tail is not wrong. But actual value of number of valves turned on in micro zone at tail of strip is not consistent with the corresponding calculated value. It means the corresponding valves do not turn off in time when strip tail enters into cooling zone.

Required water flow is calculated according to target coiling temperature by level two control system of laminar cooling device and required number of valves turned on/off is calculated according to water flow. Then the message of turning on/off valves is sent from level two system to level one system. This procedure needs a short period of time. This time is response time of valve. As time of valves turned/off lags behind actual need, the improvement measure is compensation adjustment for response time of valves. Then actual value of number of valves turned on in micro zone at tail of strip is consistent with the corresponding calculated value and actual value of water flow at tail of strip is consistent with the corresponding calculated value.

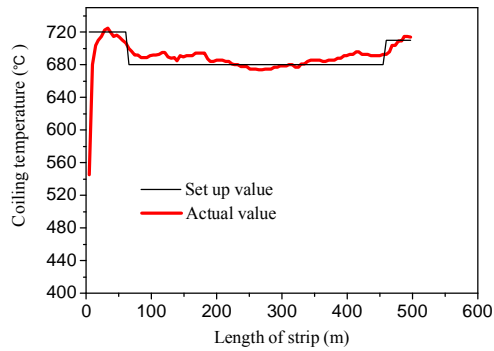
Fig.10 Coiling temperature

Perfect coiling temperature of strip tail is obtained after adjusting compensation time of valves. Accuracy of coiling temperature at tail of strip during U-type cooling process is improved. Coiling temperature of strip after improving is shown in Fig.10. The technological parameters of strip in Fig.10 are shown in Table 2.
