Failure Analysis of Welding Insulation Cylinder

Abstract: In order to analyze the failure cause of welding insulation cylinder, to which explosion had happened, in a filling station, a series of experiments and analysis were taken, including macroscopic analysis, chemical composition analysis, fracture Analysis, metallographic examination and so on. The results showed that irrational structure led to fatigue cracking of fillet weld, connecting the inner-shell and neck pipe, and then pure oxygen continuously leaked into the vacuum interlayer. Friction heat or static electricity generating with the leaking finally caused combustion and explosion of flammable insulation materials in the interlayer. At the end, proposals were put forward.

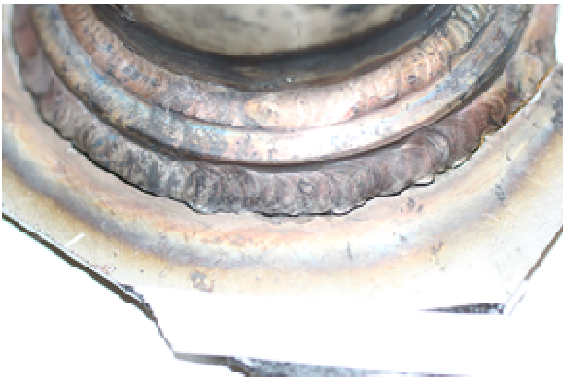
The fillet weld between the inner-shell's upper head and reinforcing ring fractured along the whole circle weld toe. As shown in Fig.1. Fig.2 showed fracture was flush and there were two obvious tearing rips belonging to the final fracture zone of the weld.

Fig.1 Fillet weld fracture

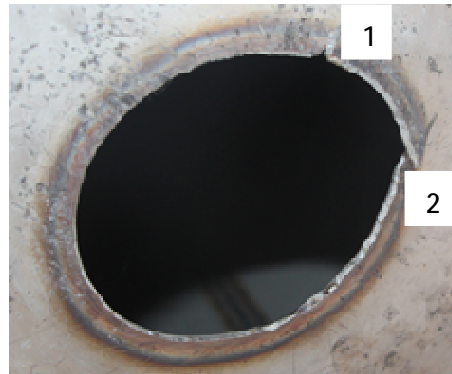
Fig.2 Tearing rips(1-Tearing rip, 2-Tearing rip)

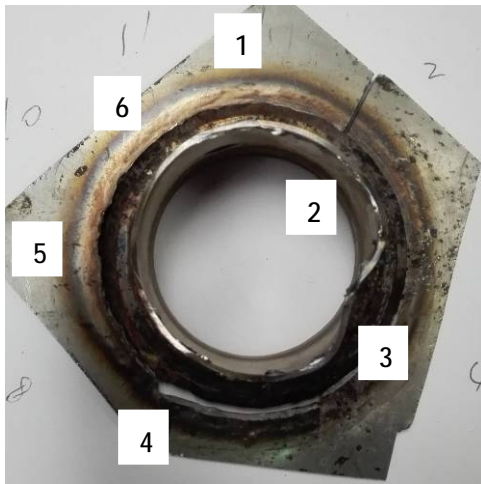
As it is shown in Fig.3, samples from the weld of fracture between the inner-shell's upper head and the reinforcing ring were used for morphology analysis. The result showed fatigue fracture characteristics with multiple fatigue sources. As shown in Fig.4, there were fatigue striations existing on the whole circle fracture and fatigue steps existing on the local area. In addition, the fatigue striations on the fracture between the position "M" and the position "N" covered almost the entire cross-section, which meant crack and leak originated in this region ^[3].

Fig.3 Diagram of fracture morphology (1- Inner-shell's Upper head, 2-Neck pipe, 3-Reinforcing ring, 4-Fracture, 5-Position "M", 6-Position "N")

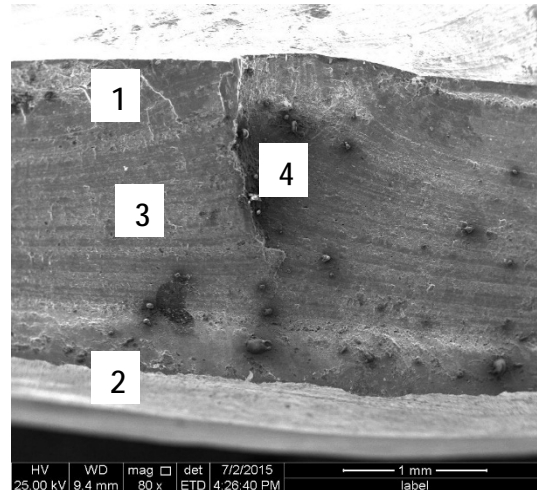
Fig.4 Fracture morphology (Reinforcing ring side, 11th)
(1-Outer wall, 2-Inner wall, 3- Fatigue striations, 4 -Fatigue steps)

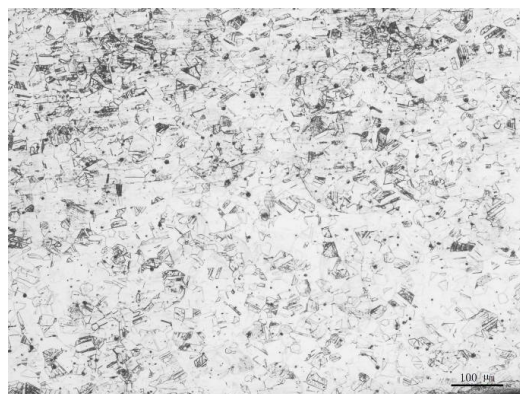
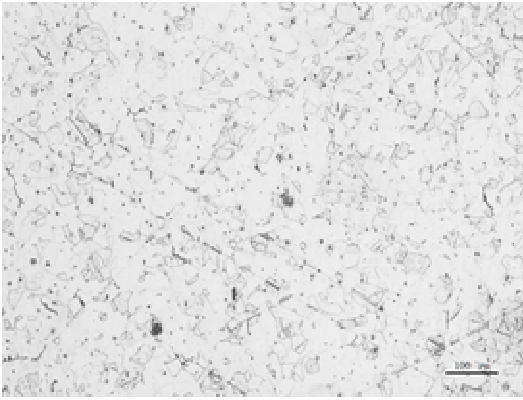
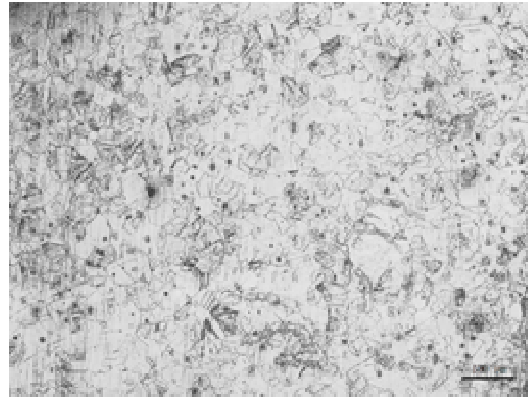
(1)The microstructure of base metal in the inner-shell's upper head, reinforcing ring, and neck pipe, was twinning austenite (in Fig.6~Fig.8), without exceptions. While in weld, was austenite of columnar crystals, and there was apparent carbide precipitation in base metal of heat affected zone (in Fig.9~Fig.10).

Fig.6 Base metal of upper header (100×, Position "B")

Fig.7 Base metal of reinforcing ring (100×, Position “A”)

Fig.8 Base metal of neck pipe (100×, Position “A”)

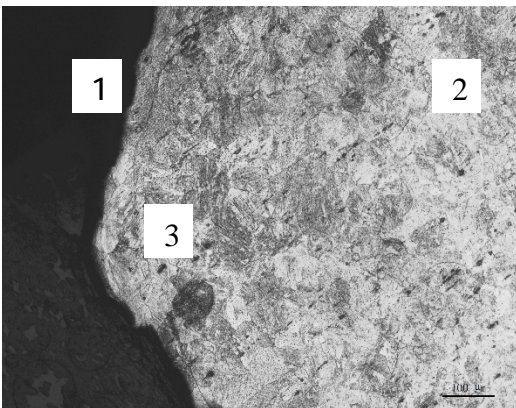
(2)Fracture was located on the heat affected zone of fillet weld, connecting the inner-shell's upper head and reinforcing ring, near the side of head (in Fig.9~Fig.11), and incomplete fusion existed in the fillet weld (in Fig.12).

Fig.9 Fracture of inner-shell's upper head (100×, Position “B”) (1- Fracture, 2- Base metal, 3- Heat affected zone of inner-shell's upper head)

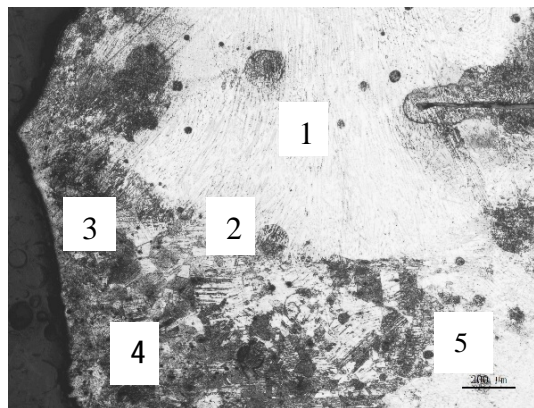
Fig.10 Fracture of reinforcing ring (50×, Position “A”) (1- The outside of weld, 2-Fusion line, 3- Fracture,4- Heat affected zone of inner-shell's upper head, 5- The inside of weld)

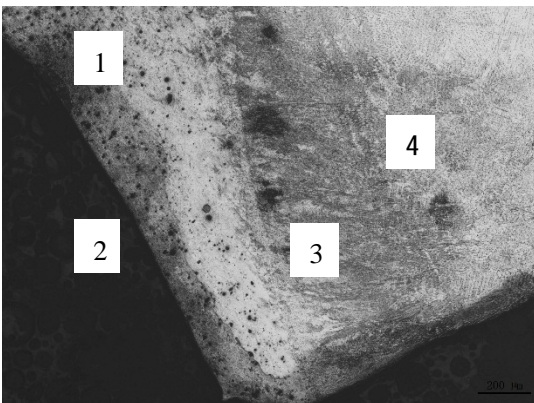
Fig.11 Fracture of reinforcing ring (50×, Position “A”) (1- Heat affected zone of inner-shell's upper heat, 2- Fracture, 3- Fusion line, 4-Weld)

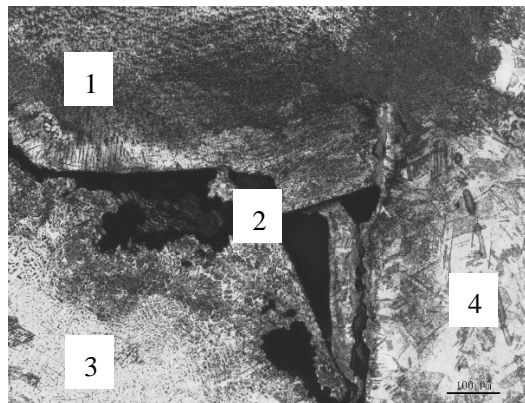
Fig.12 Fillet weld (100×, Position “A”) (1- The outside of weld, 2- Incomplete fusion area,3- The inside of weld, 4- Reinforcing ring)

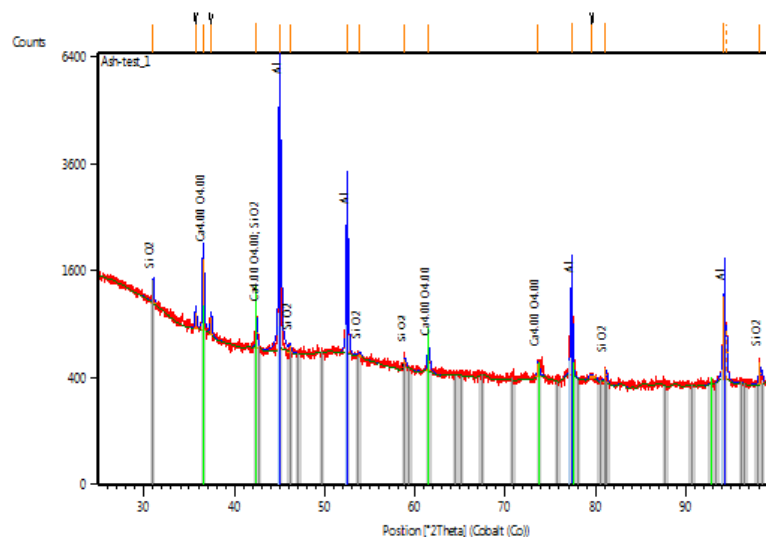
Dark attachments, which were taken from the inner wall of outer-shell, were used for X-ray diffraction analysis of chemical composition. Results showed that the main components of attachments were Al, CaO and SiO₂ (in Fig.13), which should be the combustion products of insulation materials (aluminum foil, mineral fibers, etc.)

Fig.13 Spectrum of chemical composition
