Analysis and Detection of Seepage Path of Nanmenxia Reservoir Using Ground Penetrating Radar

Keywords: Ground Penetrating Radar, Nanmenxia Reservoir, seepage path, detection and analysis

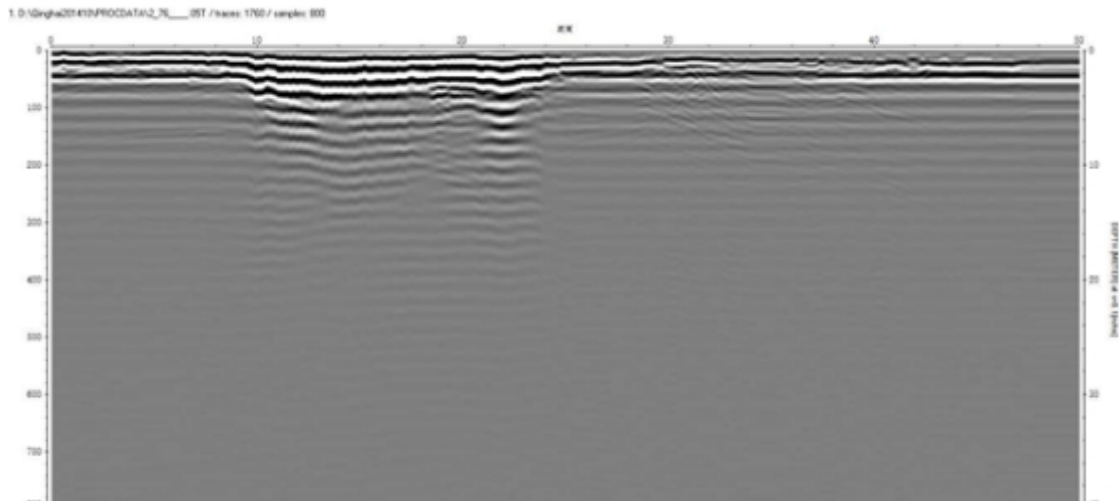
Figure 3 GV2 GPR gray scale of grouting adit on the right bank

Fractured zones at grouting tunnel on the right bank. Through GV2 GPR test and analysis in the right bank of the dam grouting tunnel, the test results showed that the 0 + 450 to 0 + 470 m section of right bank of the grouting tunnel exists obvious fractured zones, as shown in Figure 3. it need to be paid full attention in reinforcing.

Through test and analysis by GV2 radar, there has obvious fissure zone in local of the right grouting tunnel to be found, which should be paid full attention in reinforcement.

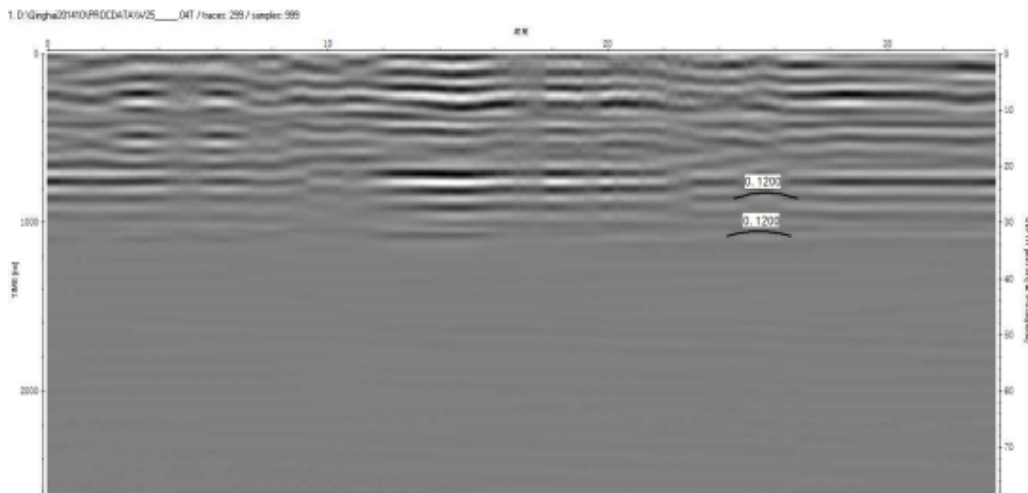
Figure 4 GV6 GPR gray scale in front slope of dam vertical to dam axis

Conditions of the seepage cutoff wall of dam foundation. It is between base surface and the bedrock surface, used to prevent gravel overburden on the bedrock surface seep. Due to the lack of accurate drawings of the original design, during the previous dam foundation grouting, it was generally believed that the cut-off wall was on the edge of the existing grouting platform and paralleled with the strike of the dam. By GV6 GPR test in dam fore slope in the direction of survey line is perpendicular to the dam axis, we found the seepage cut-off wall is vertical to dam axis in the horizontal direction, 2 ~ 3m away from the existing grouting platform, as shown in Figure 4. This may be an important reason of previous poor grouting effect.

Through GV6 radar test and analysis, the position of dam foundation anti-seepage wall and the status of the extension were determined. According to the comprehensive analysis of multi-way measuring line of the front slope of dam, combined with the result of drilling core, the position of the seepage cut-off wall was 5.4m away from the center line of upstream parkways curtain grouting to downstream bank. The thickness of the anti-seepage wall is about 0.50m, and it has the horizontal distance of about 3m away from the current grouting platform, which may be one important cause that the previous grouting effect was bad.

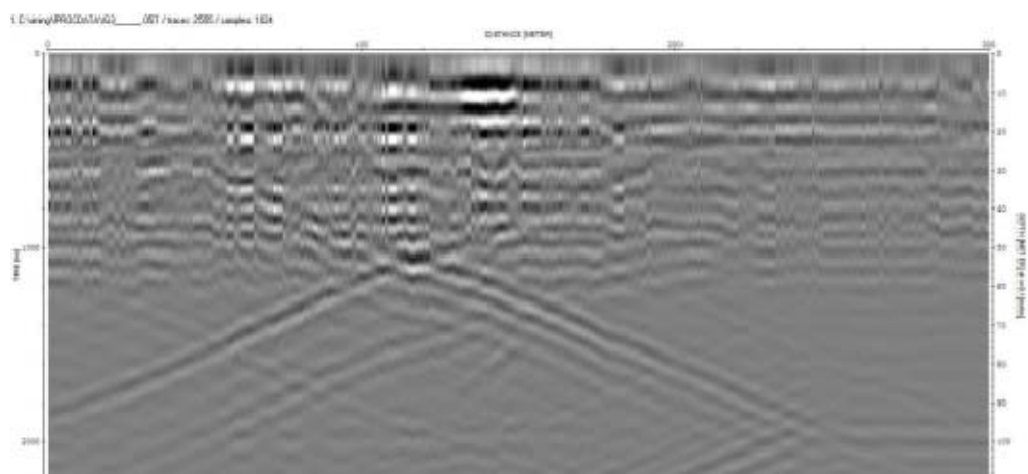
Figure 5 GV6 GPR gray scale at bottom slope of dam parallel to the dam axis

Found strong penetration band in dam bedrock. Through GV6 GPR test at bottom slope of dam that was parallel to the dam axis, found the bedrock under overburden exist significant strong penetration band in the range of 0 + 155 to 0 + 205, as shown in Figure 5.

Drilling holes at 0 + 160, 0 + 180 and 0 + 200, fault fracture zone and partial unfilled fissure zone were seen. Self-water drilling emerged at the platform behind dam also proved that the monolith has strong permeability and a certain pressure resistance, as shown in Figure 6.

Found and determined that obvious strong permeability zone existed in the dam foundation rock by GV6 test and analysis, fracture zone could be seen in drilling verification holes at 0+160, 0+180 and 0+200. Local part has no-fill fissure zone, which was the main leakage passage of deep dam foundation.
