## Research on Capacitor Bank Failure Processing Methods

<sup>1</sup> Fushun Power Supply Company, Liaoning Electric Power Company Limited, State Grid, China

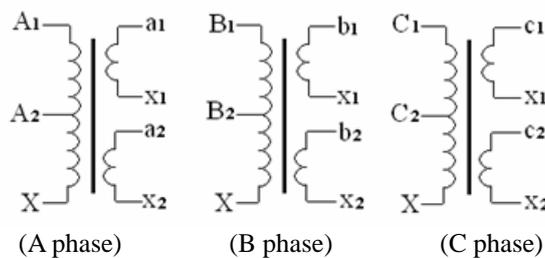
As can be seen by the data in Table 4, there is a large imbalance voltage between the secondary winding of each group of the discharge coil. Discharge coil secondary winding first phase connected with each other (a<sub>1</sub>x<sub>1</sub>-b<sub>1</sub>x<sub>1</sub>-c<sub>1</sub>x<sub>1</sub> and a<sub>2</sub>x<sub>2</sub>-b<sub>2</sub>x<sub>2</sub>-c<sub>2</sub>x<sub>2</sub>) to form an opening triangular, the voltage difference constitutes the unbalanced voltage. Since each set of the secondary coil voltage has a big difference, leads to a relatively large opening triangular occurs unbalance voltage, which is formed of the vector diagram shown in Figure 1 and Figure 2.

Figure 1 Triangular openings unbalanced voltage ΔU

Figure 2 Opening triangular voltage imbalance  $\Delta U_2$

By calculation, we can draw two open delta voltage Figure 3 and Figure 4, respectively  $\Delta U_1 = 6.594V$  and  $\Delta U_2 = 6.676V$  under (assuming ideal conditions, the three-phase primary winding voltage are 11 / kV, respectively, the phase angle difference  $120^\circ$ ), and this unbalanced voltage capacitor bank protection action setting is 5.86V. As the actual grid voltage applied across the coil discharge is generally less than 11 / kV and the presence of the measuring error, and the above analysis result data is idealized, so during normal operation, the actual open delta voltage may be in protected from critical point balance voltage operation around the set value, when the system voltage fluctuations, voltage unbalance will break through the setting value, causing tripping protection.

After identify the reason, replace the discharge coil. Put into operation before the handover of the discharge coil test, simultaneous measurement of the primary winding and a secondary winding of the overall center-tapped secondary winding coil voltage ratio, the experimental data are shown in Table 4.
