## A Transformer Screens Discharge Analysis and Processing Method

Fushun Power Supply Company, Liaoning Electric Power Company Limited, State Grid, China

**Abstract.** Combined with the actual set of concrete measures are for preventing the transformer screens dendritic discharge fault. Aiming at the 220kV main transformer screens dendritic discharge fault, introduce the basic process of screens dendritic discharge failure occurs, proof insulation damp and gas is the main external cause screens dendritic discharge fault.

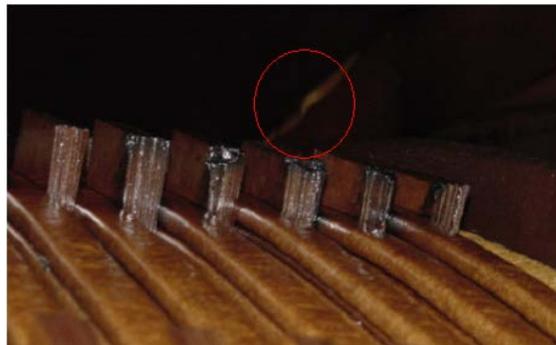
arc discharge). From the gas analysis data, all kinds of fault gas concentration is far more than the concentration of oil gas, the fault gas in oil not dissolved, into gas, indicating that the transformer fault exists serious. From the contents of CO and CO<sub>2</sub>, the fault has been related to insulation board part.

In the scene of the hanging core examination, lead no exception. Found traces of discharge on the A, B and white B-phase screens outermost layer of cardboard, from the longitudinal position of view, the high pressure outlet of the winding head end (central of high voltage winding) of the third downward, i.e. location winding Minister pad in contact with the screens, third winding has five burns, fourth paragraph windings have burn marks, which are shown in Figure 1 and Figure 2. Open the B-phase high-pressure screens, the innermost layer of cardboard found a large number of branches discharge burns. If not found, a short circuit accident will be lead to between the windings of the transformer.

Figure 1 The discharge site from coil spacer to screen

In the middle of the first surface of the winding of the oil gap and add a layer of screens, the first original is divided into the oil clearance from 30mm to 15mm, the middle phase insulating screens increase, thereby increasing the middle phase insulating level.

Pour into the R8 fillet reason: in the field of any member will with be potential, shape determines its field size. Because at the time of the design the long block is a rectangular, two sharp corners of the front end the first support to the screen board, in case of screens tight long cushion block linear of the front end part that is connected with the cardboard . This makes the screen board by high field effect in M and N points, but also to withstand screens tight mechanical action, discharge phenomenon first occurs in the M, N points of long block front end, and connected with the screen board was burned and thus two outward expansion (in our actual observation also confirmed the two first appeared in discharge pattern), make the discharge burn marks develop along the board to the ground. Pour into R8 fillet can be limited to reduce electric field intensity.

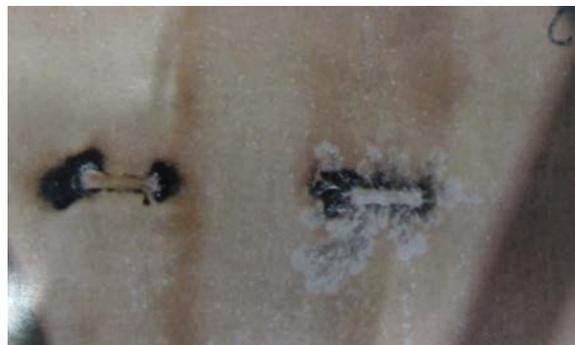
Figure 2 The discharge site on screen pad
