Analysis of the Causes of Electrical Accidents Caused by Operating Over-voltage of High Voltage Switchgear

Abstract. In this paper, the lightning arrester explosion accident and transformer short-circuit accident in power supply system were analyzed in detail. It was found that the operating over-voltage caused by the frequent operation of the 35kV high voltage switchgear was the main cause of the accident. It was found that the frequent operation of high voltage switchgear had caused cumulative damage to the insulation property of high voltage power equipment. When the operating over-voltage exceeded the threshold value of insulation performance of power equipment, the insulation breakdown caused accidents. According to the characteristics of the power supply system, the reasonable suggestions were put forward, which was helpful to improve the safety performance of the power supply system.

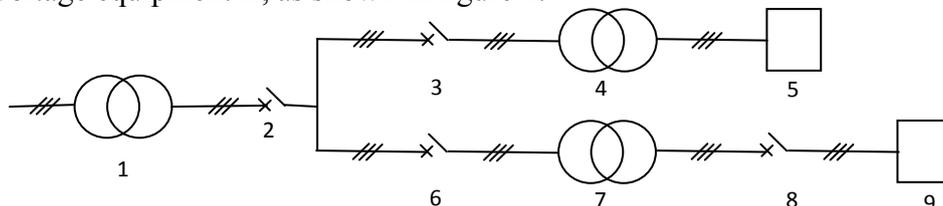
Fig. 1 Schematic diagram of power supply system

1. 110kV/35kV transformer, 2. 35kV high voltage switchgear I, 3. 35kV high voltage switchgear II, 4. 35kV/400V transformer I, 5. low voltage equipment I, 6. 35kV high voltage switchgear III, 7. 35kV/400V transformer II, 8. low voltage switchgear, 9. low voltage equipment II

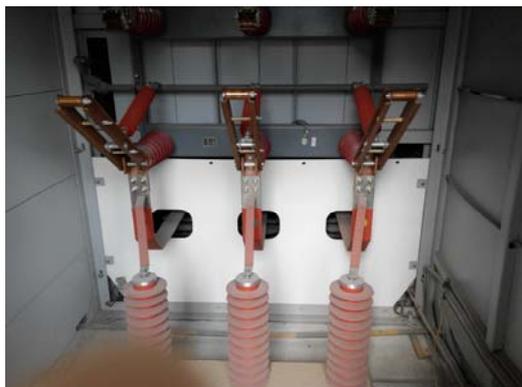
Fig. 2 Normal installation of lightning arrester

The normal installation of high voltage switchgear lightning arrester was in figure 2, and lightning arrester installed in the 35kV high voltage switchgear circuit breaker between the into line wire and the ground wire.

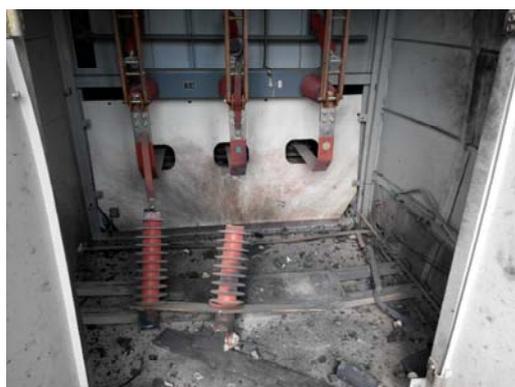
Fig. 3 Accident explosion scene of lightning arrester

The lightning arrester explosion accident scene was in figure 3, compared to figure 2 could be found in the A phase of the lightning arrester was the most serious damage, followed by the B phase, C phase damage was relatively light.

1. According to the provisions 6.2.6.2 of GB3906-2006, high voltage switchgear needs to bear standard lightning impulse test voltage 35kV, 1.2 μ s/50 μ s, positive and negative polarity were applied to its rated withstand voltage for 15 consecutive times for each test condition. But there is no requirement for the operation of high voltage switchgear, that is, the performance of the high voltage switchgear has not been considered in the design. The work environment of the accident: high voltage switchgear needs to frequent close and disconnect operation in normal weather, in a

thunderstorm and other severe weather stopped working. Therefore, the high voltage switchgear in the use of over-voltage is the operating over-voltage, not the lightning over-voltage.

2. The amplitude of over-voltage damage not only depends on the waveform, is also associated with the wave-front steepness. The characteristics are different between operating over-voltage and lightning over-voltage. The arrester can't effectively limit the operating over-voltage, but damage the performance of the lightning arrester. The insulation performance of the arrester is decreased under the action of the cumulative effect of the operating over-voltage on the arrester.

Combined with figure 3 and figure 4, the lightning arrester which connected with the high voltage side A was found to be short-circuit. The lightning arrester was difficult to withstand the heat and electrical power caused by short-circuit fault, which caused the explosion of A phase arrester, and damaged the adjacent B phase and C phase arrester.

1. Lightning arrester type selects zinc oxide lightning arrester, and effectively monitor whether the lightning arrester is in a reasonable range of use.

2. The resistance capacitance absorbing device is added in circuit breaker inlet port of the 35kV high voltage switchgear so limits the peak value of operating over-voltage and absorbs the energy of over-voltage. The connection mode of resistance capacitance absorbing device is Δ to avoid the occurrence of high voltage side grounding short circuit.

3. The circuit breaker in high voltage switchgear uses parallel resistance circuit breaker, to reduce the operation over-voltage between closure and disconnection operation for high voltage switchgear.
