Analysis of Brake Material Issues in the Elevator Hoisting Accident

Xiao Liang^{1,a}, Bo Li^{1,b}

¹Shanghai Institute of Special Equipment Inspection and Technical Research, 399 North Nujiang Road, Shanghai 200333, PR China

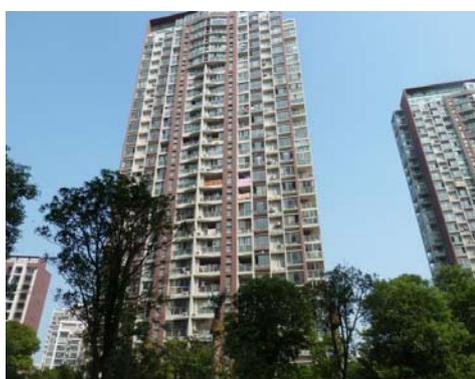
Fig. 1. Accident scene

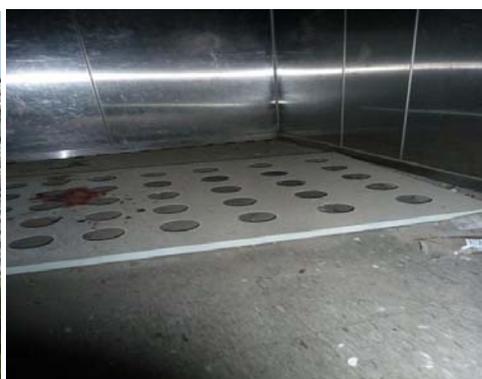
Fig. 2. Drop the car ceiling

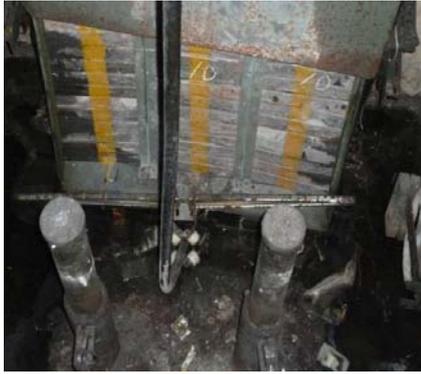
Fig.3. Scattered counterweight

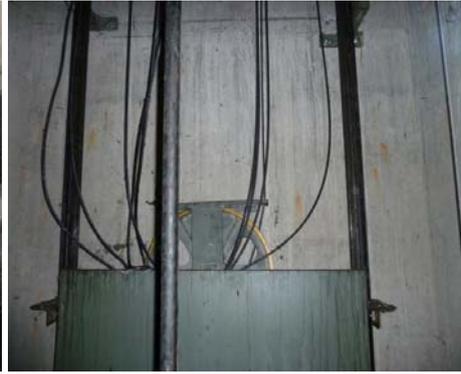
Fig.4. The steel wire rope

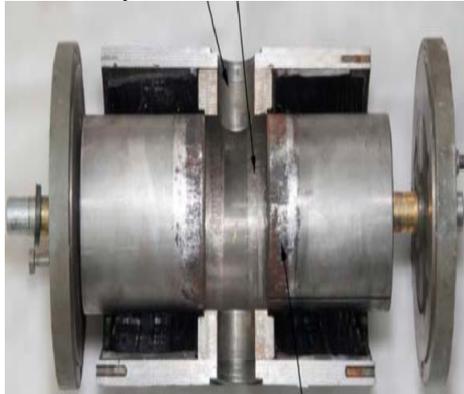
Fig.5. Elevator brake electromagnet assembly cut graph

After the Elevator brake demolition, the machine base, a guide magnetic ring (sets) along a central longitudinal incision morphologies, such as Figure 5 shows, the guide ring and the plunger (sets) with surface area have obvious longitudinal wear striations, and small granulated powders and flakes adhesion complexes in the gap region, these particles and adhesion complexes in the magnetic field were formed along the magnetic field distribution, suggesting that both ferromagnetic materials.

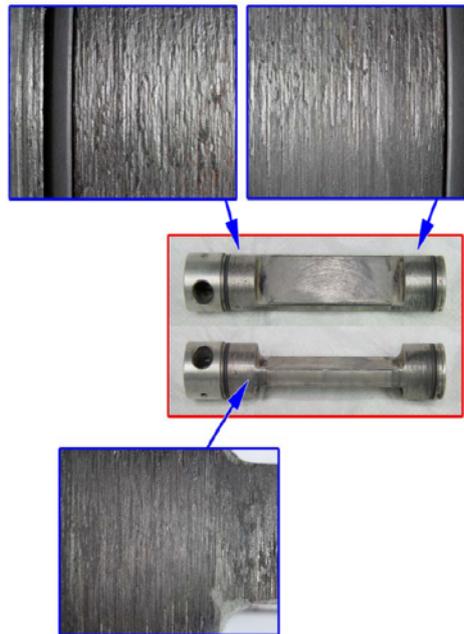
c. By macro and electron microscope and energy spectrum micro analysis can be seen, release the brake rod appearance by galvanized, and the magnetic conducting ring of bearing hole matching surface more serious wear (unilateral wear up to 0.07 mm, and by signs of wear that loose brake rod in operation is abnormal rotation. At the same time, carrying the wear debris scattered in the magnetic coating of the inner cavity, and into the plunger and the magnetic gap.

Fig.6. Brake rod and wear morphology

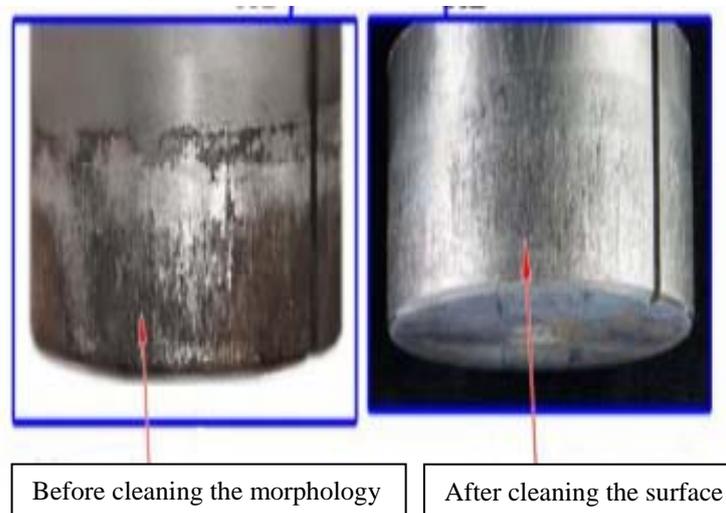
d. The macro and the micro analysis can see also , between the plunger and the guide magnetic ring occurred abnormal rheological adhesive wear, and according to abnormal wear distribution and wear area containing zinc particles are embedded in a predictable, abnormal wear and loose brake lever scattered debris on.

Fig.7. The plunger and sleeve (ring) between the wear phenomenon

A comprehensive analysis of the results can be inferred that brake electromagnet assembly in use occurred Nika blocking plunger die fault and the plunger and the magnetic conducting ring between abnormal adhesion wear and tear. The adhesive wear occurred mainly due to loose brake lever to the abnormal rotation and the formation of wear debris embedded piston and a guide magnetic ring gap caused by. At the same time, due to the loose brake lever hardness was significantly higher than that of the guide ring and piston, and the guide ring and piston are non normal ferromagnetic material (DT4), will increase the adsorption of iron magnetic scraps will exacerbate loosen rod wear stripping of relatively high hardness particles embedded between the conductive ring and the plunger, increased the abnormal adhesion wear the probability of occurrence .

The accident appeared in the process of using brake ability is insufficient, reflecting the elevator maintenance unit capacity is insufficient, did not discover the potential risks and the brake problems, leading to the elevator car rushed to the top of the accident. Therefore, daily maintenance personnel should give brake and related components enough attention, regularly on the brake maintenance, ensure the elevator stops at the station when brake can output enough braking torque. At the same time, maintenance personnel should timely cleaning, adjustment, in order to avoid rust, resistance fault card brake piston for, and thus lead to injury accidents occur.
