A Study on the Accident Reasonidentification and Reinforcement of the Floated Basement

Yu Zhang

Guizhou Hongxin Chuangda Engineering Detection & Consultation Co. Ltd.

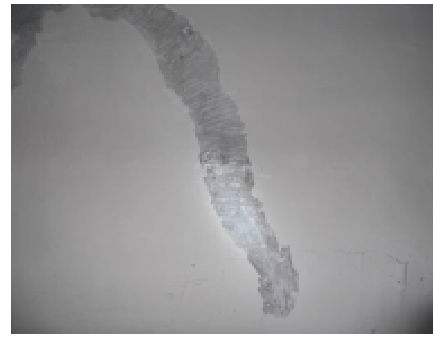
3) The typical oblique shear cracks appear in the partially filled wall, as shown in Fig. 5.

Fig. 5 Diagonal shear crack of the filler wall

4) Aiming at the cracks in the basement wall, combined with the planting and pasting carbon fiber cloth, repair treatment (Fig. 10):First by using polyurethane foam plugging cracks in the wall, then clean out concrete chisel except line; then implanted steel and new reinforced mutual welding; followed by the use of cement based grouting material for pouring; Finally in the surface layer is pasted a layer of carbon fiber cloth.

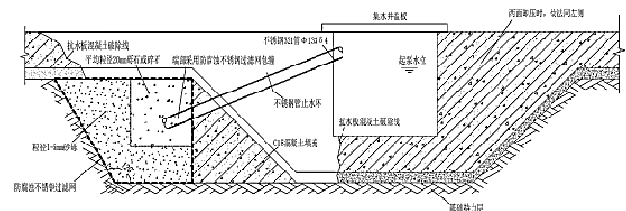
Fig.7 Schematic of sump transformed into relief well

increased diversion pipeline way to divert due to atmospheric precipitation, surface water, groundwater, and use the discharge pressure of underground water head pressure reduction, to ensure that the anti floating stability of basement structure and specific practices see Fig. 7.

The relief well construction method: first of all to get rid of the concrete next to the water collection well, followed by the different size of gravel and gravel composed of anti filter layer; once again to install diversion pipe; Finally closed processing. After the field test, the diversion pipeline can be successfully imported into the water collecting well, and finally, through concentrated and continuous drainage, in order to achieve the purpose of precipitation.

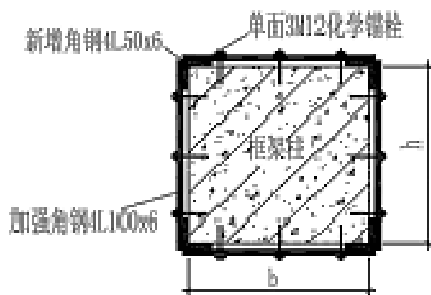
Fig.8 Reinforcement schematic of concrete column

1) In view of the damage of reinforced concrete columns, combined with the outsourcing of steel and the method of node partial replacement, and other methods to repair. First, cut in addition to the original cracking and crushing of concrete, revealing a solid grass-roots, the surface pores and uneven place that should be adopted in the epoxy mortar moping; secondly, the steel plate bonding surface and surface polishing of roughening treatment. Finally, the plate is placed predetermined position with adhesive in plastic injection pressure, as shown in Fig. 8.

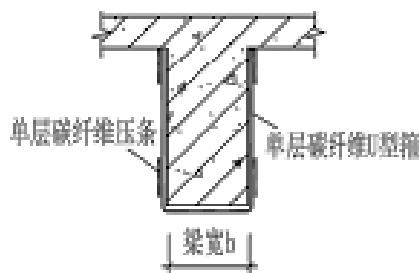
Fig.9 Reinforcement schematic of the main beam of basement

2) In order to produce cracks in the main beam, the use of carbon fiber method to repair the paste (Fig. 9):First, the beam surface polished smooth and depression by leveling glue to repair, and the acetone wipe coated with a primer layer, corner paste of chamfer and polished into a circular arc shape. Secondly, the adhesive evenly wipe the paste position of the concrete surface, laying carbon fiber cloth; subsequently, the roller along the fiber direction repeatedly rolling, so that it is flat and without bubble; then, according to the carbon fiber sheet strengthening technical specification for concrete structures[11] pasting carbon fiber cloth, cement mortar. Finally, the effect of carbon fiber reinforcement is tested.

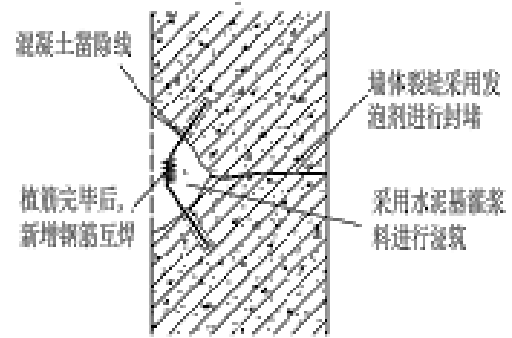
Fig. 10 Reinforcement schematic of basement walls
