Research on black-dot defects on galvanized thick sheet surface after galvanizing line

Abstract: The black-dot defects on galvanized thick sheet surface after galvanizing line, which is the traditional construction materials with 1.5mm thickness, was studied. Characterizations of the research samples were carried out using a SEM in order to understand the causes of the defects. The results showed that the local oxidation mainly led to the surface defects. What's more, the bad conditions of touched rollers also results in the black-dot. The paper also discussed the terms of settlement.

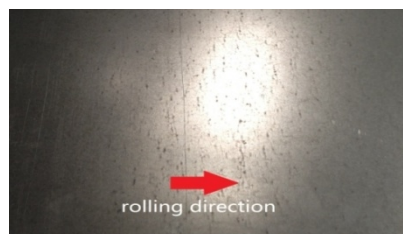
In the process of production of thick hot galvanized sheet, roughly speaking, 1.5 mm above, the steel surface defects often appear with the appearance of black horizontal stripes, always called black-dot. Specifically, embodied on the strip surface along the width direction, and the distribution in the length was about 1 cm. When the defects were serious, the touch is obvious with hands. As shown in Figure 1^[1-2].

Figure1 Black-dot defects on galvanized thick sheet surface

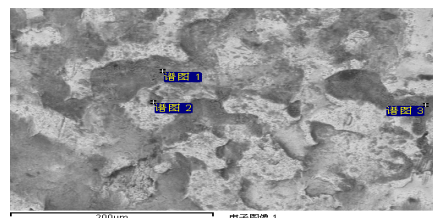
Under the SEM, the zinc layer composition of different locations on the surface was analyzed, as shown in Figure 3 and Table 2. Location 2 oxygen content was as high as 26%, significantly higher than normal galvanized flat position after finishing passivation. This indicated that black horizontal stripes existed oxidation phenomenon in the zinc layer surface.

Figure 3Composition of SEM analysis

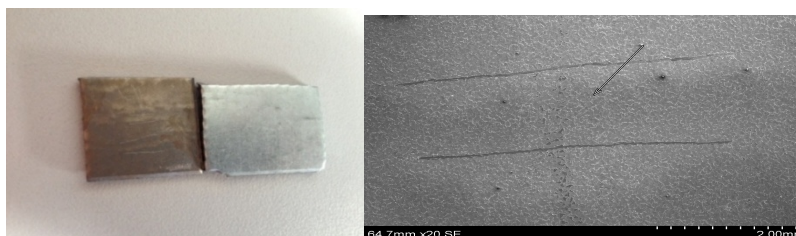
Surface with defects were cleaned up with dilute hydrochloric acid corrosion inhibitor in order to get rid of the zinc layer surface. After removing zinc coating, appearances of plate on the surface were as shown in Figure 4 and Figure 5. It was obviously visible from the figure that by removing the zinc layer, on the substrate surface there were slight traces under the SEM, the defect position corresponding to the substrate surface presented some slight sags. The reasons were that defect location in zinc and crest of position, the zinc layer around the zinc layer had large thickness, when the steel were finishing, the pressure of the zinc layer was larger, resulting in slight dents on and in the substrate

Figure 4 Macro-surface of substrate surface after cleaning Figure 5 Micro-surface of substrate surface after cleaning under SEM

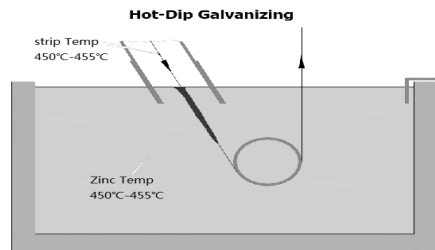
The temperature of strip into the zinc pot was so high (460°C-465°C) that it was difficult to cooling as discussed above. Therefore reducing temperature from 460-465°C to 450-460°C, could reduce the core hot of strip, making surface liquid zinc temperature low after the airway, decrease the

1) Decrease the temperature of strip steel in zinc pot and liquid zinc

Figure 6 Decrease the temperature of strip steel in zinc pot and liquid zinc

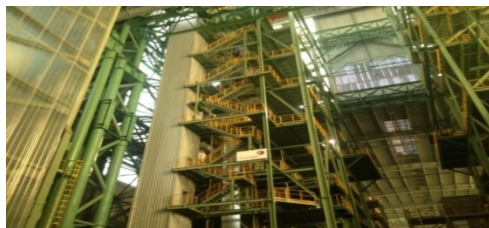
Before the reformation, the internal temperature of the cooling tower was so high, and the internal heat dissipating was hard, leading to the temperature of top roller reached more than 280. As shown in figure 6, a window was put for top roller.

3) Opening a window for cooling tower

Figure 7 Opening a window for cooling tower

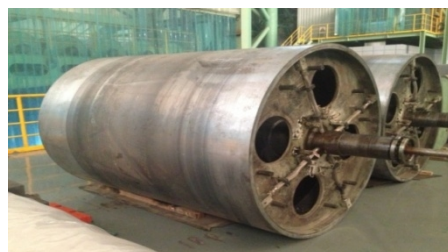
Due to long time under high temperature and the strip surface friction, the top roller' surface condition was bad, therefore, to deal with the top roller for regular replacement two times per yea. as shown in Figure 7.

4) Replacement of the top roller

Figure 8 Replacement of the top roller
