Failure analysis of No.2 main transformer in Fushun SiShui substation

The accident case

SiShui substation is the Ministry of infrastructure projects, it put into operation in 2014 October after the acceptance, it is the use of YouGao 2# line with a main transformer running before fault, and it is running with all the load, 10kV bus-bar switch is closed. The YouGao 1# line has not been formed, so 1# main transformer isn't in an operation state. Its load is 2.2MW before fault. August 1, 2016 at 14:49, heavy gas action occurred in Fushun SiShui substation, the primary and the secondary side switch the secondary side were trip and the substation was blackout, the action process is shown in Table 1.

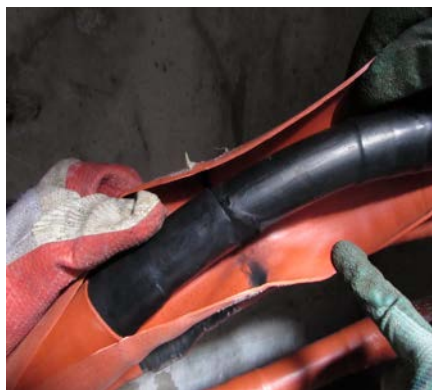
Fig.1

August 1, 2016 14:49:53 , The cable fault causes the 10kV side 10622 intervals of 2# main transformer in SiShui substation to send out the accident signal and act, the cable cable causes the 2# main transformer to produce the turn (layer) the short circuit discharge. August 1, 2016 14:49:55, light and heavy gas action occurred in 2# main transformer in SiShui substation. After the accident of 2# main transformer,1# main transformer was supplied electricity In August 5, 2016, cable defect immediately exposed after 3 hours tuning, the switch of 10kV Gaokan line tripped again. the 3 joints of the cable had been breakdown and burning loss when finding cable fault in August 6 to 8. As shown in Figure 1 and 2,two holes have been burned in A and B phase, This also shows that the cable fault is very serious, such a serious fault is not only caused by an accident, but most of the cumulative results of several accidents.

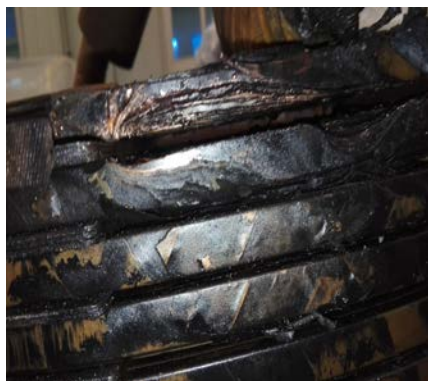
Fig. 3

In August 24th, the staff checked the transformer by hanging core, and they found that A phase of the high-tension coil had burning traces in the head position, A phase of platen had Insulation damage in the head position, and no obvious abnormality was found in other location. the morning of August 25th, The staff broke down and checked the main transformer coil in coil department to find out the specific reasons. Through the inspection found that the conductor wire between the second and the third section of the high-pressure coil A phase is burning loss seriously, the insulation of wire is carbonization. As shown in Figure 3 and Figure, which shows that the conclusion of high energy discharge fault in transformer internal by the chromatographic analysis is correct.
