The treatment technique of dynamic analysis of highway slope diseases under complicated geological conditions of high temperature and rainy area

This paper, exemplified by the treatment of right slope on section K66+250~K66+534 in Gangu Expressway, made a detailed analysis of destructive mechanism caused by deformation of slopes formed by broken rocks Under a complicated geological condition in rainy and hot area, and proposed in particular a reasonable suggestion for treating slope hazards, which provided experience that can be learnt to employ in the prevention and treatment of the similar type of slope hazard in similar areas.

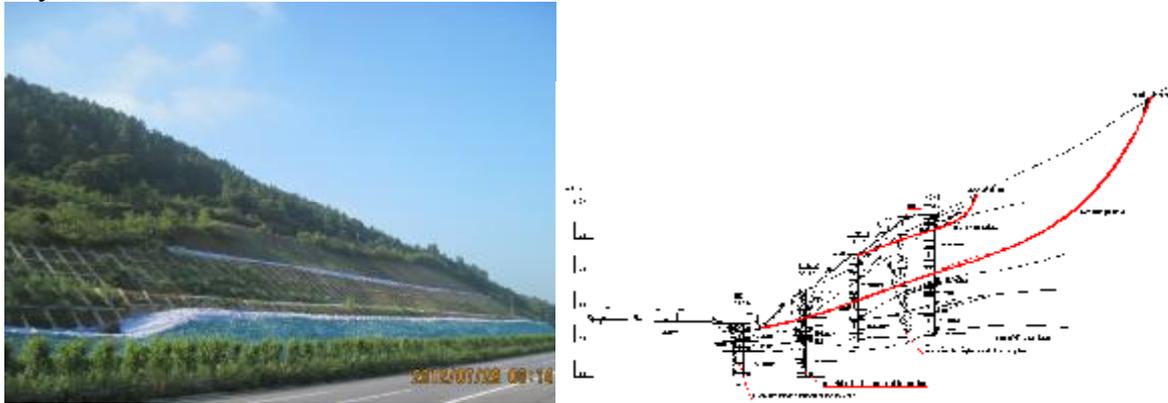
Fig. 1 emergency treatment and deformation of slope Fig. 2 typical geological section of slope
The geological conditions of slope project

The first hazard appeared during the construction in June, 2010. Afterwards anchor frame beam is used to reinforce the Grade-I and Grade III of slope, and anchor cable frame beam is taken to consolidate Grade II of slope. But from June and July in 2011, deformation of some sections is worsening in the period of implementing reinforcement. Crosshead anchor gridiron beam is added to reinforce Grade I. In June, 2012, with the top of the slope cracking and the surface of slope and pavement bulging, rock and soil mass as a whole structure showed a sign of integral slide and loss of stability.

Slope was under construction in 2009, and the evacuation was almost finished by May, in 2010. The ratio of Grade I slope was 1:1, and Grade II and III is 1:1.25, with a graded height of 10m and platform width of 2.0m. In the rain season of June, 2010, penetrating crack can be seen in a mini-mile end of Grade II and III slope an top with a width of 10cm. Top and platform of Grade II showed a sign of sliding downward. The ditch of Grade I platform is deformed and surface is bulged outward. The preventive and protective plan is adjusted to that, anchor grillage beam is employed in Grade I slope, anchor cable frame beam in Grade II, and anchor grillage beam in the seriously suffered section in Grade III. In this phase, the main characteristics of deformation in slope is that the cracks in the rear are located with the area influenced by evacuation of slope, and the bulged section in the front is seated in the middle-lower section of Grade I slope with a deformation in shallow-middle part and potential sliding surface in the depth influenced by the evacuation, whose destructive features carry a characteristics in an obvious similar soil slope hazard.

By June, 2011, the construction of slope reinforcement developed into Grade I slope, but owing to a constant stormy rain, the original hazard of this slope was worsened. With a lot of penetrating rain exuding from the surface of Grade I and II slope, Grade I collapsed with a serious effusion and a severely deformed bulge in ditch; the original cracks in Grade II and III were deformed further with a width of 5-9cm from the outer area of top to the top itself. On the basis of strengthening supervision, we made a strengthened preventive and protective plan. 3 lines of prestressed anchor cable frame beam is set in the collapsed section in Grade I (crosshead beam was applied previously), and inclined upward drainage holes were paved to reinforce the work of blocking and drain aging in depth. The deformation in this phase is an intensification and development based on the last phase, and the depth of deformation went into the deeper part and the rear. Meanwhile, influenced by the scour an immersion of intensive rainfall, some parts of loose soil on the surface of slope were sliding and collapsing.

At the beginning of 2012, a second-time treatment of reinforcement was complicated. In June of a strong rainy season, 2012, a lot of centralized rainfall penetrated into the slope, which led to a hazard of sliding in the slope with a total sliding volume of $40 \times 10^4 \text{m}^3$. There was a crack caused by tensioning the outer side of the slope top with a dislocation height of 1m. The old deformed cracks was widened with a bulged and collapsing surface in Grade I, and the whole structure of lattice beam dislocated and cracked with many cracks on the surface of slope and platform of Grade I and II falling. the side ditch was overthrown, and the sub-grade of driving ways was bulged upwards, but obvious deformation was not seen in the slope of Grade III. Some parts of slope in Grade II were bulged, but the whole structure was integral. In a word, partial parts were damaged, but most of the integrity was not bad. The whole slope had a fast deformation. The explicit features of this deformation are as follows: the depth and thickness of deformation were greatly increased, and the rear of the deformation extended to the back. At the same time, due to the impact of deformation, in the some sections of Grade I slope, soil was loose and structure was destroyed, which performed a sign of sliding and collapsing wider the condition of rainy scour and immersion.

In July of 2012, the management department organized the constructors to conduct a reverse press on Grade I slope, and crack pouring on the slope, which controlled the speed of deformation in the slope for a while.

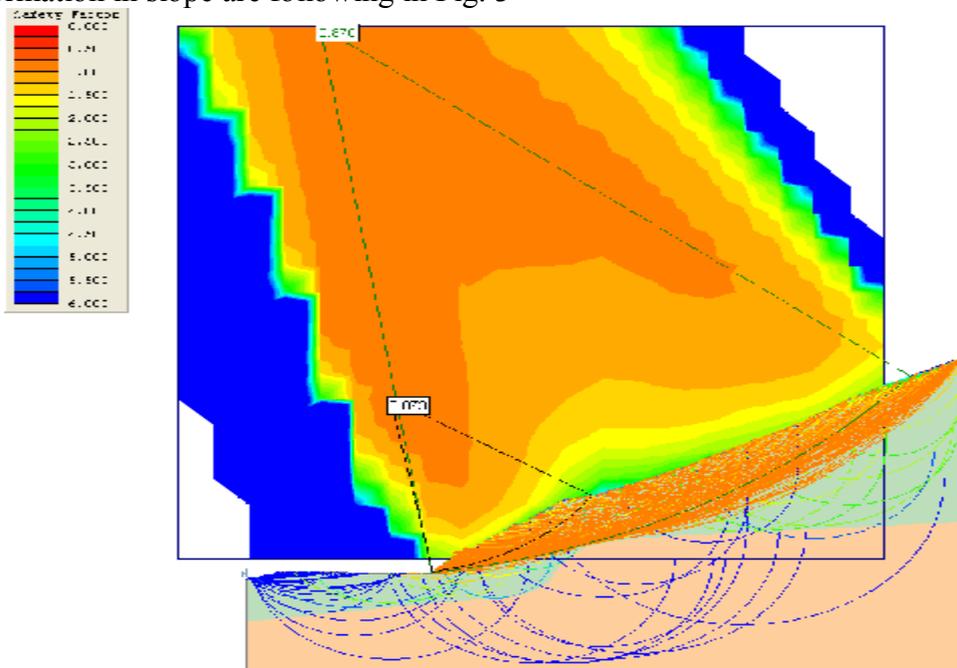
Fig. 3 the trend of slope deformation before consolidation (K66+380)

According to the above analysis, before conducting a treatment of reinforcing the slope, the stability of the slope was influenced by the geographic forms , composition and rainfalls. Based on the condition that the broken rocks composed the slope, from a macroscopic view, the features of deformation carry a destructive characteristics of similar soil slope deformation_the potential sliding face of slope damage is in a shape of arc, and at the same time, controlled by the Joint fissures of structure and layers, from a microscopic view, sliding surface will follow the Joint fissures and layers——the microscopic sliding surface performs the features of serrated and step shape. All in all, the damaged area caused by deformation of slope was located in where the evacuation was influenced, which is characterized by that the tensioned cracks caused by deformation are mainly located in the surface of the slope and the area nearby the signalized line of the slope, and shear exit was located on the foot of the slope and Grade I.

on the basis of the theory of limiting equilibrium, the results of analyzing the tendency of deformation in slope are following in Fig. 3

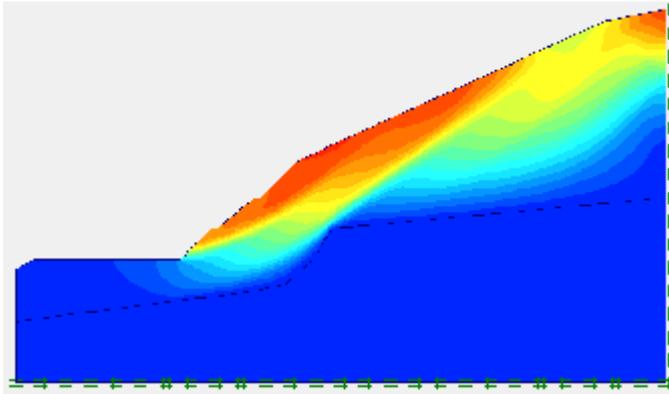
Fig. 4 deformation cloud image of the section excavation without support (K66+380)

We made a numerical simulation of the evacuated unsupported slope, from the grid and nephogram, we can see that evacuated slope deformed in a shape of retrogression. Because of an unstable slope, a run-through sliding surface came into being in the shallow part of slope. In the upper part, there appeared tensile stress area, and the secondary deep sliding surface was in the formation.

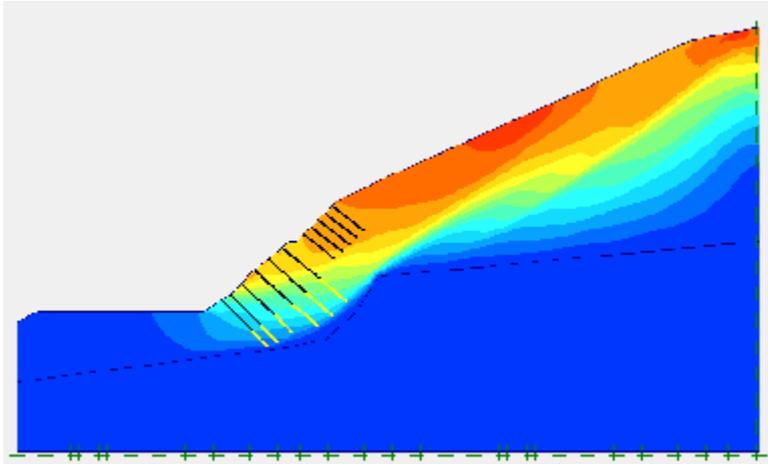
Fig.6 deformation cloud image of the section excavation after second support

We made a numerical simulation of the evacuated unsupported slope, from the grid and nephogram, after we support the slope, the deformation developed upwards, which can be seen from that the sliding surface limited by the supportive structure extended to the depth and a new deep sliding surface was formed. From a plastic distribution, we see that after the old sliding surface, a deep run-through sliding one was formed, which is outside the supported area and led to an ineffectiveness, and continuous deformation. Those are all evidence, like bulge of sub-grade, of partial slope and tension cracks in the upper part.
