Failure Analysis of Cr_7C_3 Coating for Helicopter Transmission System

Abstract. The Cr_7C_3 coatings used in a helicopter transmission system was peel off in service life. In this paper, the causes of the crack are analyzed by experiments. The results show that peeling mode is contact fatigue flaking. The reason for the peeling is that there are many crack sources in the coatings. In addition, the contact between the surface asperities makes the coating surface and the near surface subjected to shear force. At the same time, under the action of high-pressure oil wave and alternating stress, the cracks extend in the direction of 45 degrees through the surface. Finally, under the effect of the surface shearing force, the coatings begin to peel off.

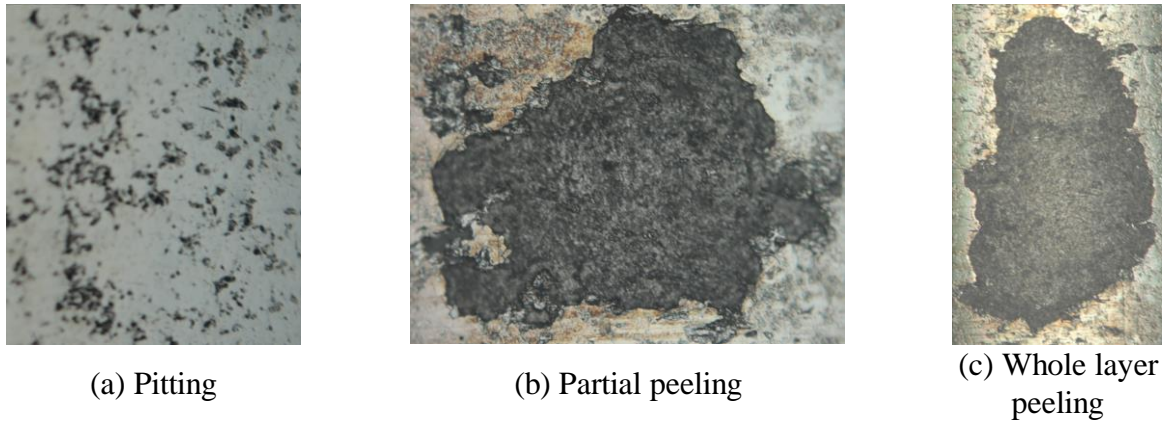
The dismantling analysis of the failed clutch shows that nearly half of the wedges lose efficacy for peeling in different degrees. There are three types of failure: pitting, partial peeling and whole layer peeling, as shown in Fig.1.

Figure 1. Macrographs of three failure modes of wedges (Magnification: 20 times).

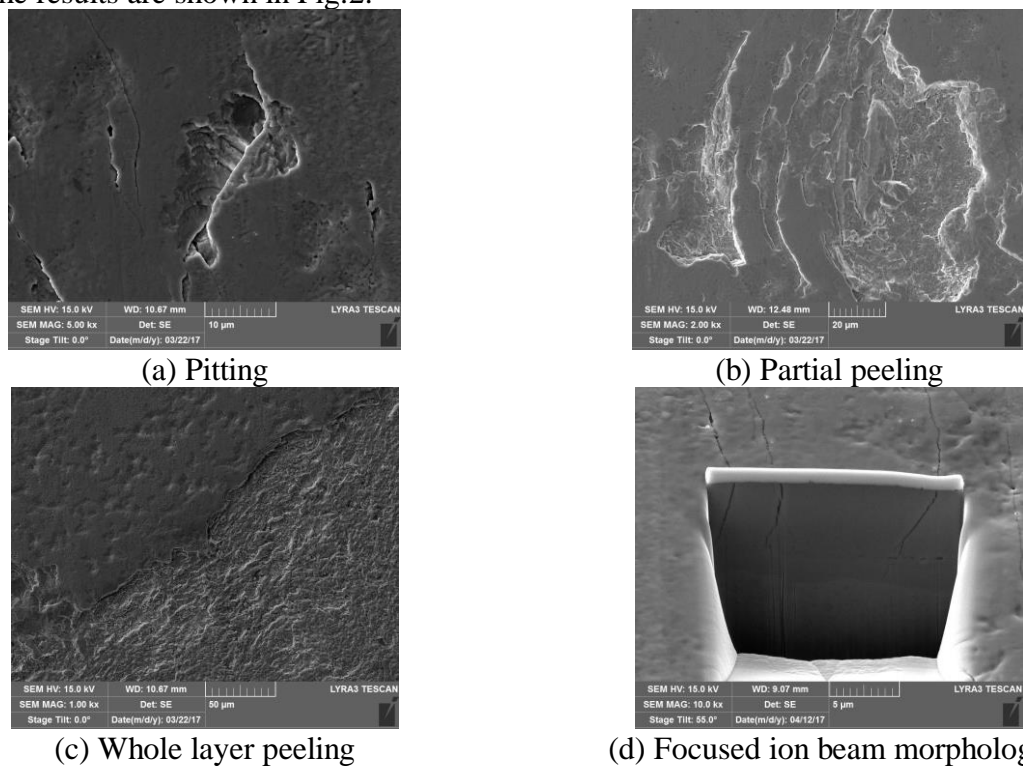
Figure 2. SEM morphology of Cr₇C₃ coatings.

Figure 2 shows that there are many cracks near the pitting, and obvious cracks inside the pitting. The edge of partial peeling pit is characterized by typical arc fatigue cracks. There are cracks in the edge and interior of the peeling pit. The edge of the whole layer peeling pit are the arc fatigue peeling characteristics, too. Microscopic morphology reveals that the coatings peeling mode is contact fatigue flaking.

The result of Stripping off the coating on the surface by focused ion beam (FIB) is shown in Fig.2 (d). According to the analysis of Fig.2 (d), it can be found that the angle between the crack and the surface is about 45 degrees, which indicates that the crack is propagate under the leading of the shear stress. Moreover, some cracks do not reach the substrate, which indicates that the cracks extend from the surface of the coating.

Under the action of alternating stress and shear force, the crack begins to germinate. Lubricating oil in the contact stress generated by the high-pressure oil wave will enter the fatigue cracks. High-pressure lubricants will produce pressure on the fatigue crack wall, allowing the cracks to expand in depth. At the same time, the cracks under the action of shear stress will expand along the surface into the direction of 45 degrees to the substrate. When the cracks spread to the limit or two cracks intersect, the coating begins to peeling due to the coating subjected to shear force at the surface or near the surface. This is the pitting stripping process^[7]. From the pitting SEM topography, it can be confirmed the crack initiation and expansion process. After pitting, the cracks will expand further to form partial spalling. Partial spalling SEM micrographs can be seen in the apparent arc fatigue spalling characteristics. After the coating is furthered peeled off to the substrate, the whole layer is peeled off. From the whole layer spalling SEM morphology, we can also see the obvious arc fatigue characteristics and fatigue crack.

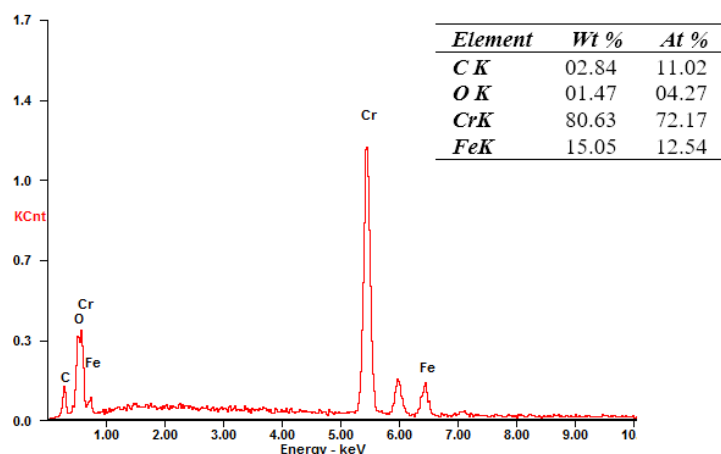
Qualitative and semi-quantitative energy spectrum analysis were performed on the surface of unused wedges by focused ion beam SEM. The result is shown in Fig.3. The surface of the coatings contain a large amount of iron, while the designed coatings contain only Cr and C elements.

Figure 3. ED's spectrum of the surface of Cr₇C₃ coating.

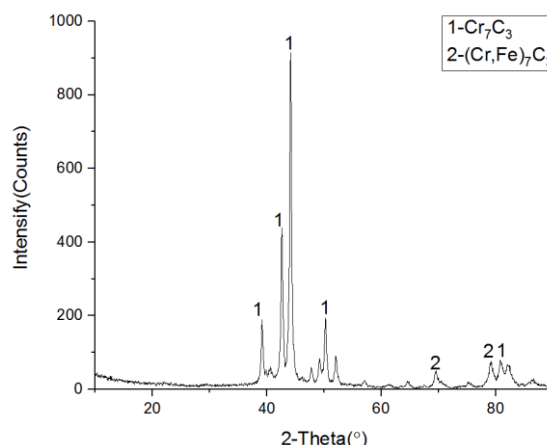
In order to further analyze the peeling reasons, the qualitative analysis of the phase for unused wedges surface is made by high power X-ray diffractometer (XRD). The result is shown in Fig.4. There is (Cr,Fe)₇C₃ in the coating. This is due to the formation of a complex six-dimensional lattice structure of Cr₇C₃, which can dissolve Fe atoms, in the process of chemical vapor deposition (CVD).

Figure 4. XRD diffraction pattern of the surface of Cr₇C₃ coating.

As shown in Table 1, comparing the mechanical properties of Cr₇C₃ and (Cr,Fe)₇C₃, brings out that the hardness of (Cr,Fe)₇C₃ is lower than that of Cr₇C₃. This leads (Cr,Fe)₇C₃ to be the weak phase in the coating. Because of the existence of the weak phase, the stress distribution in the coating is uneven, and the positions of high stress will become crack sources.

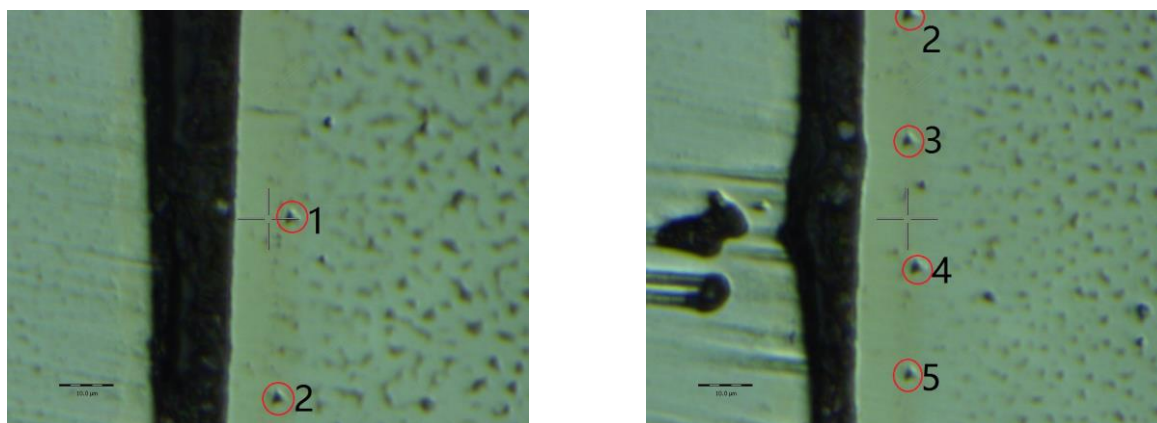
Figure 5. The location of Nano hardness test points.

The results show that the hardness of the coating is about 1877HV, which meets the design value of 1800 ± 200 HV. However, the hardness values of these 5 points are different, and the standard deviation is 169HV, which shows that the uniformity of the coating is poor. Consider the result of X-ray diffraction, it can be inferred that the hardness of the region is lower when the (Cr,Fe)₇C₃ content is high in some regions.

The processing and assembly accuracy of the wedges have a great influence on the force loaded on the wedges. Therefore, it should be improved. The unevenness of the coating and holes are potential cracks source. The coating process should be improved to reduce the holes in the coating and improve the uniformity of the coating.

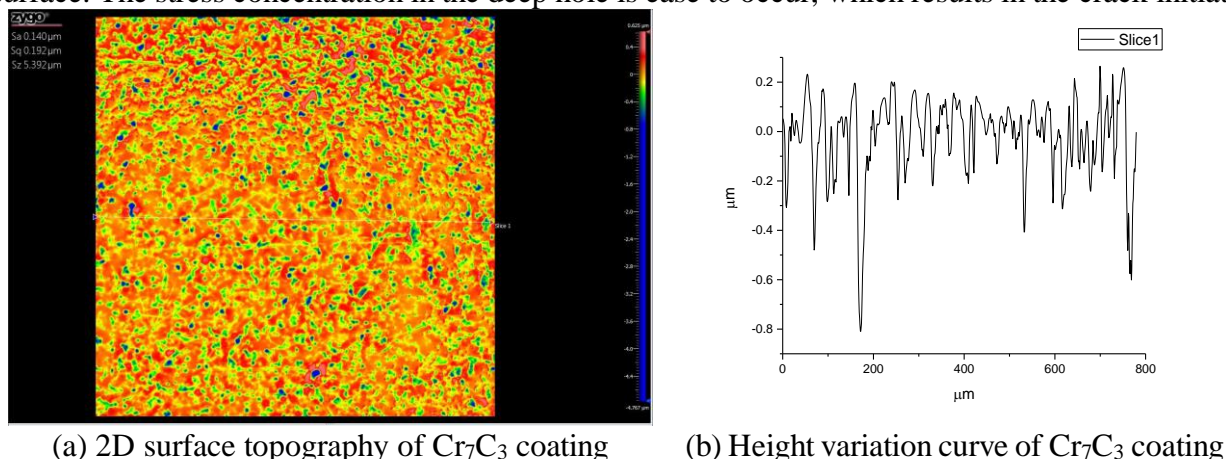
The surface of an unused wedge was measured by a three-dimensional white light interferometer. The result is shown in Fig.6. The surface roughness of the coating is $S_a = 0.14 \mu\text{m}$, which meets the requirement of surface roughness of $0.3 \mu\text{m}$. However, $S_z = 5.392 \mu\text{m}$ cannot be ignored for the coating thickness of $6\text{--}10 \mu\text{m}$, the data show that there are deep holes on the surface of the coating. It can be concluded from the two-dimensional topography that there are many deep holes on the coating surface. The stress concentration in the deep hole is easy to occur, which results in the crack initiation.

Figure 6. Coating surface morphology.
