Reason Analysis of Wheel Bag Crack in the Reliability Test of a Car and Structure Improvement Optimization

Abstract. The reasons for the problem of wheel bag fracture in specific models in the process of reliability test were analyzed in the paper, and according to the actual structure and process requirements, corrective measures were put forward, and the reliability was once again demonstrated and verified.

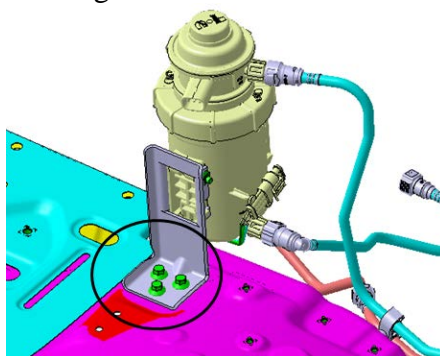
A new development model was involved in the reliability test on the test field, and the accumulated mileage reached 10070 kilometers (3982 kilometers of strengthened road, see table 1 for the mileage of every road segment). The installation stent of the oil-water separator in the front cabin cracks, and the degree of cracking is serious. The specific cracking position is shown in figure 1, and the cracking situation is shown in figure 2.

Fig.1 Cracking position of wheel bag (front cabin)

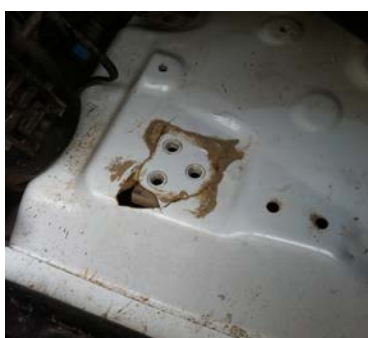
Fig.2 Cracking situation of wheel bag

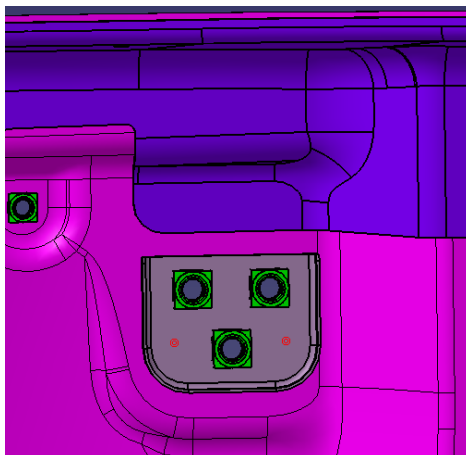
Fig.3 Wheel bag and wheel bag nut mounting plate

Name	Material	Thickness (mm)	Yield limit (MPa)
Wheel bag and wheel bag nut mounting plate	DC04	1.0	165
Mounting plate of oil-water separator stent	510L	3.0	355

Looking from the structure of the oil-water separator stent, a large cantilever is formed; regardless of the vehicle in the idling condition or in other bad conditions, large stress and stress deformation may be produced on the wheel bag and wheel bag nut mounting plate; with regard to the structure alone, this kind of structure has certain defects, and fails to meet the requirements of long-term vibration, with extremely high requirements for the materials. In addition, the installation surface of the oil-water separator stent is small, which will also have a bad effect on the wheel bag.

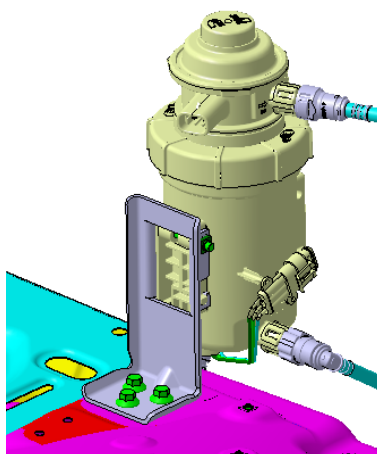
Fig.4 Mounting plate of oil-water separator stent

From a perspective of the oil-water separator stent and wheel bag material, the difference between the two is large, and whether the matching is reasonable is also a key point of this study.

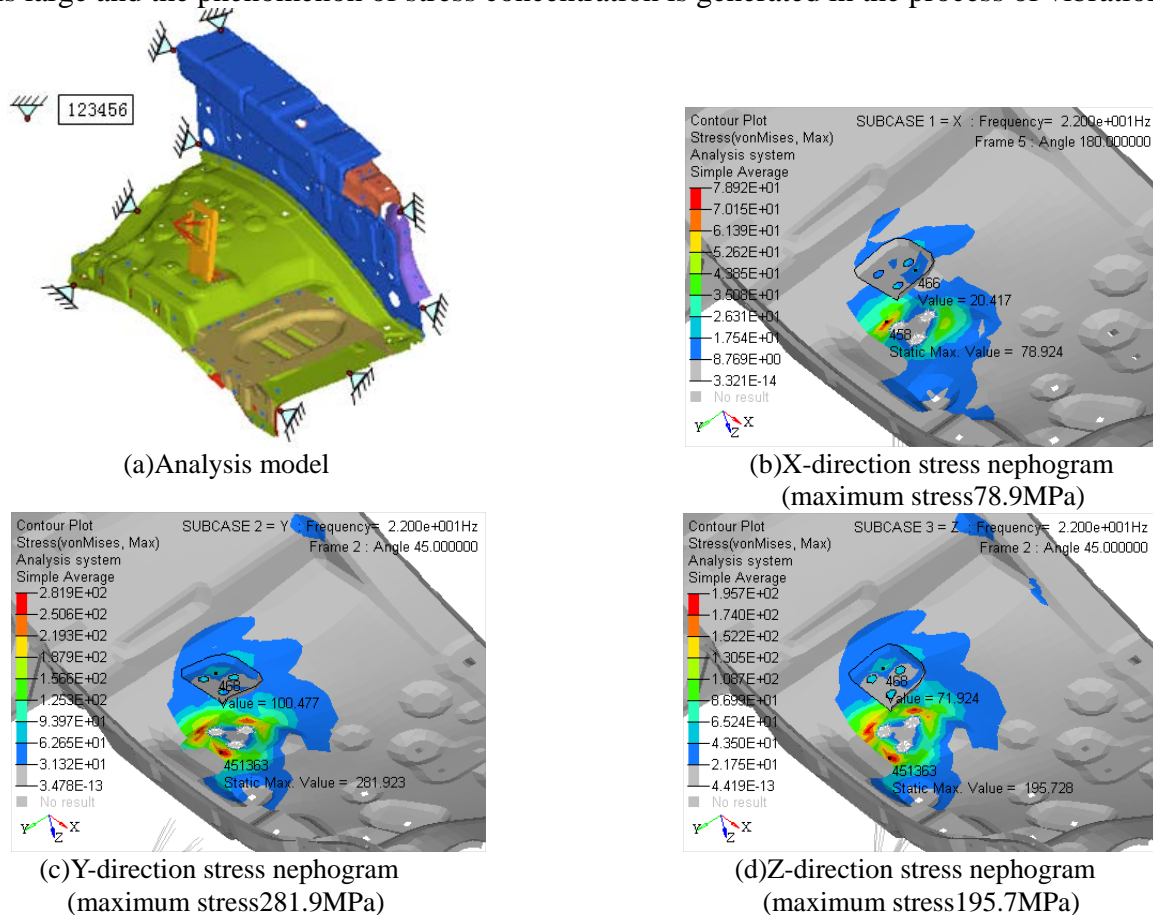
Fig. 5 The finite element analysis

It can be concluded from the analysis in figure 5: the finite element analysis results are basically consistent with the reliability test, and the maximum stress here in the Y and Z direction is beyond the yield limit (165MPa) of the material (DC04).

To sum up, the cracking reasons for the wheel bag in the reliability test are subject 3 aspects as follows:

- (1) The yield limit of the materials selected for the wheel bag and wheel bag nut mounting plate is too small, only 165MPa, which can not meet the requirement of use;
- (2) The structure of the wheel bag nut mounting plate is unreasonable, which only plays the role of installation, but has not played any role in strengthening the wheel bag;
- (3) The mounting surface of the oil-water separator stent is small, and the impact on the wheel bag is large and the phenomenon of stress concentration is generated in the process of vibration.

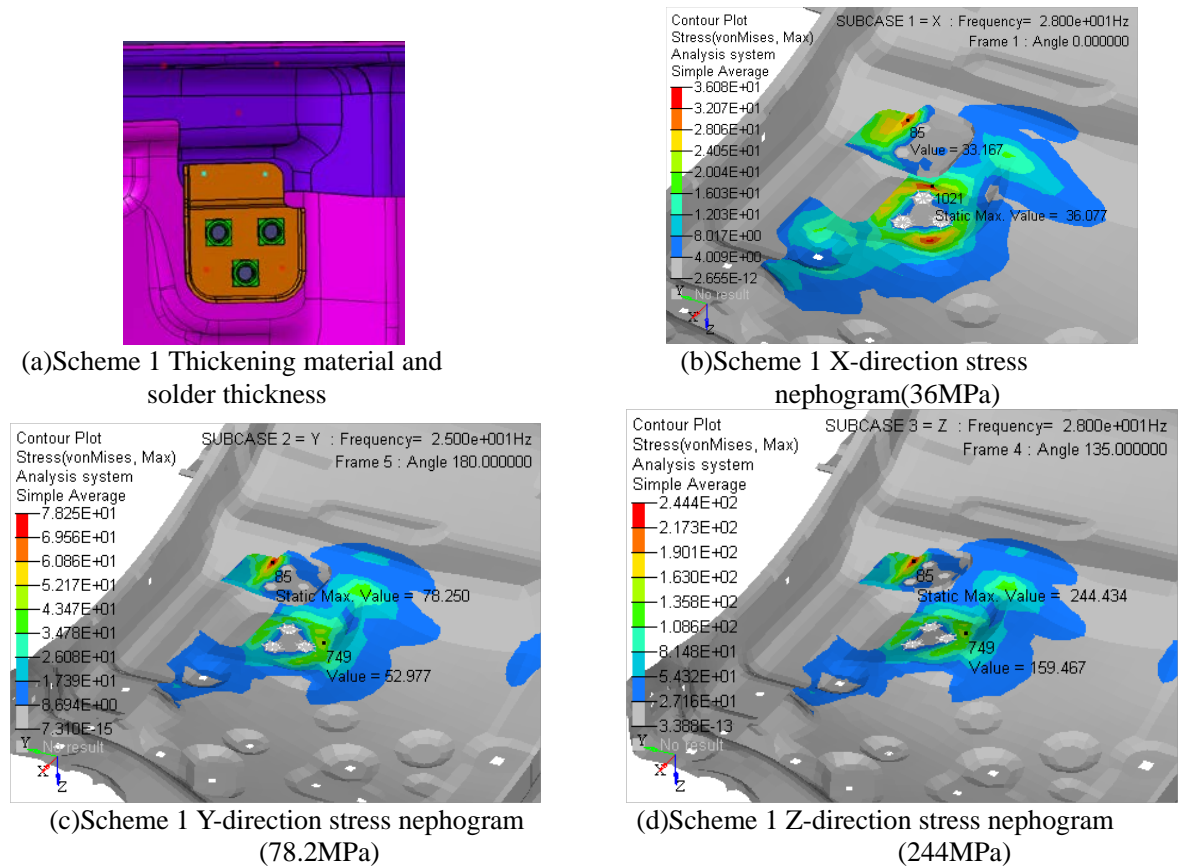
Fig. 6 Scheme 1

It can be seen from the above stress nephograms that the nut mounting plates of the wheel bags in the schemes 1, 2 are beyond the yield limits of the selected materials, and the maximum stress of the wheel bag in the scheme 3 (the wheel bag nut mounting plate is overall increased) is only less than the largest yield limit of the selected material (165MPa), so samples are chosen from the scheme 3 for a new reliability test.

Scheme 1. It can be concluded from the stress nephogram of the original scheme that the strength of the wheel bag nut mounting plate is not enough, so the material thickness of the wheel bag nut mounting plate was increased, that is, the material thickness was increased from 1mm to 1.8mm. The analysis results of scheme 1 are shown in figure 6 using the method of finite element analysis.

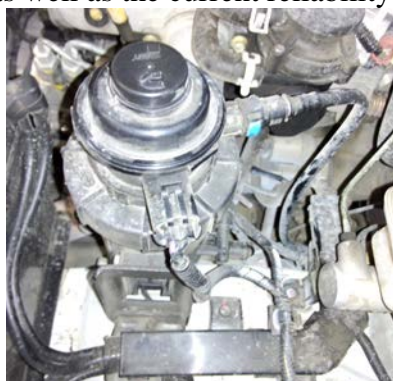
Fig.9 Front mounting position in the verification scheme

In order to test the improvement effect, the quality tracking was carried out every day in the following general road surface test, and no cracks here were found, indicating that the improved design is effective.

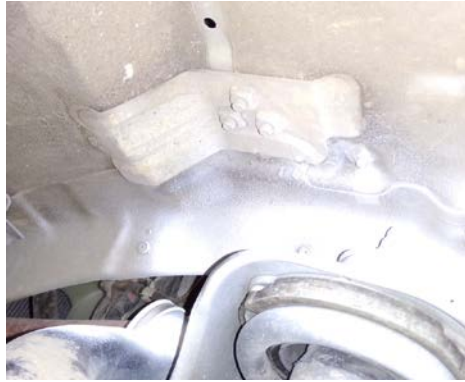
Fig.10 Rear mounting position in the verification scheme
