Treatment Plans of Settlement Deformation at Expressway Tunnel Portal Area

Abstract: This paper presents the cause analysis, treatment plans and treatment results of a settlement deformation accident at tunnel portal area of left line T1 tunnel in Algeria North-South Expressway. The engineering practice demonstrated the feasibility, timeliness, and safety of the treatment plans. The successful handling of the accident provided an important reference for the formulation of the settlement deformation treatment plans in the tunnel portal areas.

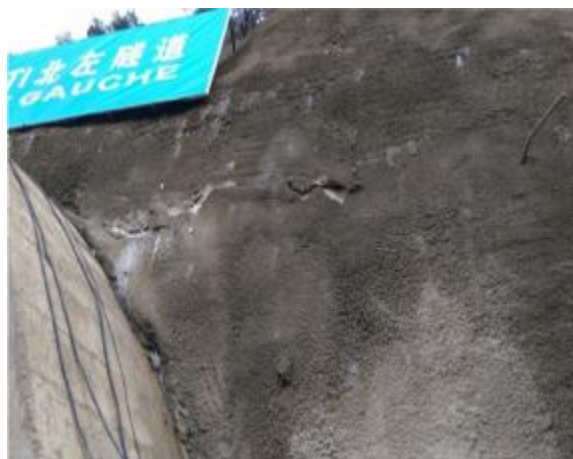
From December 2014, it began a continuous five months rainy season in Algeria. The slope soil was soft and rainwater infiltrated along the surface fissure, which made the slope soil highly saturated. The mechanical properties of the rock and soil became worse, thus it resulted in the instability and cracking of slope rock (figure 1). Also, there was a surge of water spring in the LK5+780 mileage of the left tunnel, and excavation of the tunnel was always accompanied by the water flow (figure 2). Because of the long-term erosion of the groundwater, the bottom rock about 12m surrounding the tunnel portal was muddy, and the bearing capacity was weakened significantly (figure 3). The high degree of saturation of internal water content of rock also caused the stabilizing ability of surrounding rock to be greatly reduced. Therefore, the excavation of the lower step would eventually lead to the cracking of the front slope and the settlement deformation of the supporting part in the tunnel (figure 4).

Fig.1 Cracking of front slope at tunnel portal area

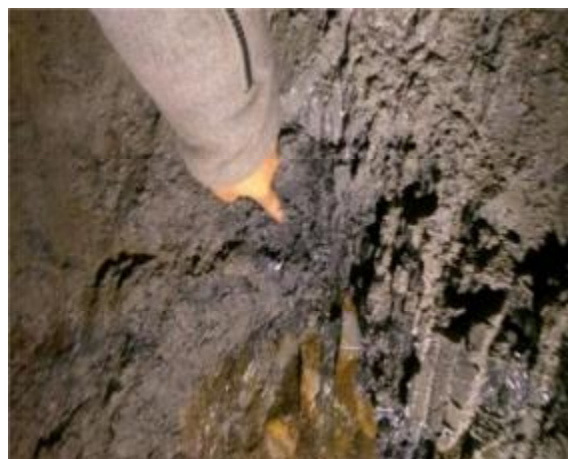
Fig.2 A surge of water spring in the LK5+780 mileage

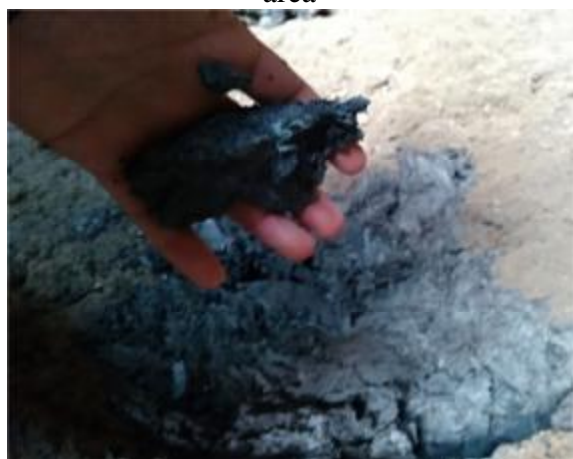
Fig.3 Rock mud in the bottom of the tunnel

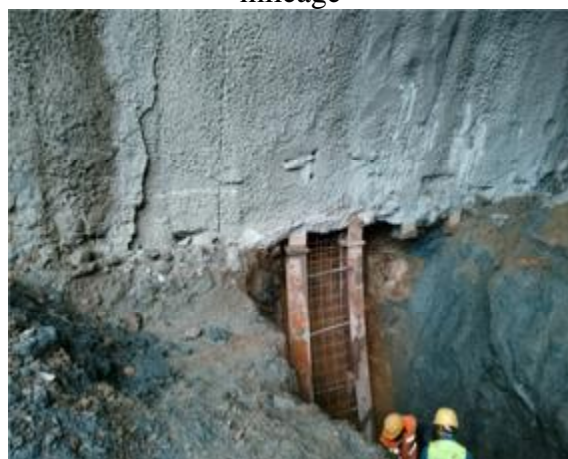
Fig.4 Cracking of initial supporting face inside the tunnel

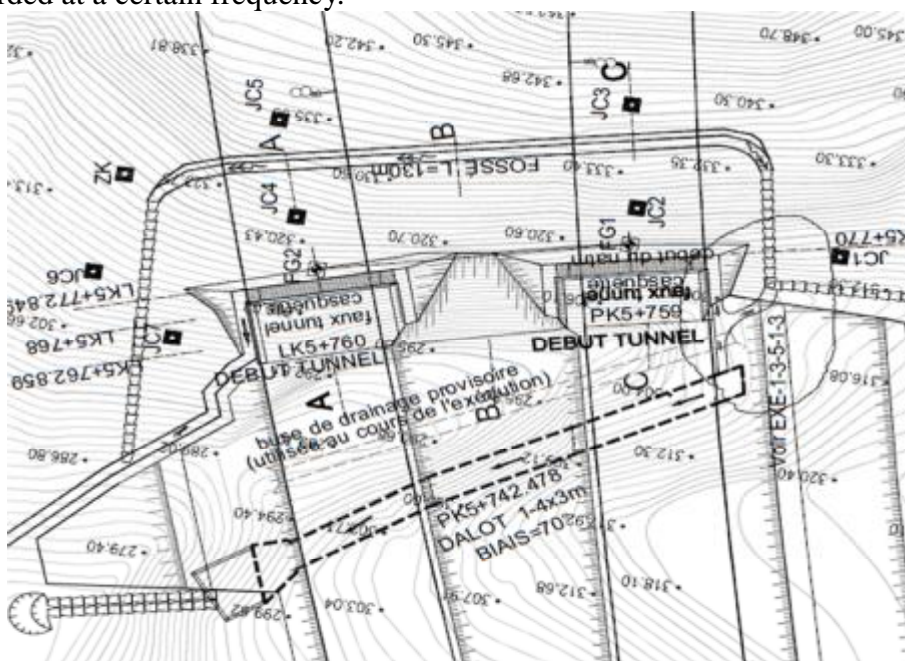
The surface and deep-hole observation piles were set to monitor the settlement deformations in the tunnel portal section (figure 11). The observation points were arranged in appropriate locations inside the tunnel to monitor the deformations in different directions. The deformation data was regularly recorded at a certain frequency.

Through the analysis of the deformation data, the surface deformations outside the tunnel portal were mainly vertical settlements with the maximum vertical displacement of 131 mm and the maximum horizontal slip (toward the outside direction) of 62 mm. The deformations inside the tunnel were mainly vertical settlement with the maximum vertical displacement of 180 mm and the maximum horizontal convergence of 51 mm.

From the observation data, the maximum deformation occurred in January 22, 2015, and the maximum deformation rate occurred in January 22 to January 25, 2015. After January 25, the deformation curves of observed points inside and outside the tunnel tended to be stable, and the data changes returned to normal. In this case, it could be concluded that the measures taken for the settlement deformation of the portal of T1 left tunnel during January 22 to January 25 period were economical and effective, which had successfully prevented the further development of the settlement deformation.
