## Construction survey objects agro industrial complex with system approach

Here is an example of the building a survey department for the production of flour (s.Syuziyum, Kuznetsk area of the Penza region), held in 2014 (in the framework of the examination of industrial safety of buildings and structures), experts and non-destructive testing in "Storage and processing of vegetable raw materials."

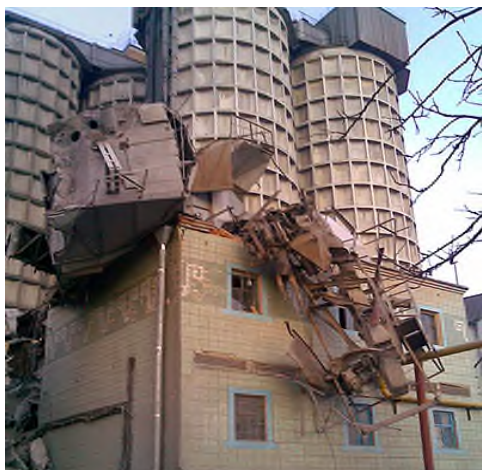
- The collapse of the silo idle breeding complex (s.Rogintsy Romny district of Sumy region, Ukraine, 2005);
- The collapse of the elevator (Guizhou Province, China; (2009);
- The collapse of the silo (Fig. 1), a height of 42 meters bread Bendery (Moldova, 2012);
- The collapse of the wall of the elevator Trinity bakery (2012.);
- The explosion in stock fertilizers (g.Vest, Texas, USA, 2013);
- The collapse of the elevator (Fig. 2) Ekaterinburg flour mill (2014).

Fig. 1 Collapse of 42-meter silo tower "Bendery bread products".

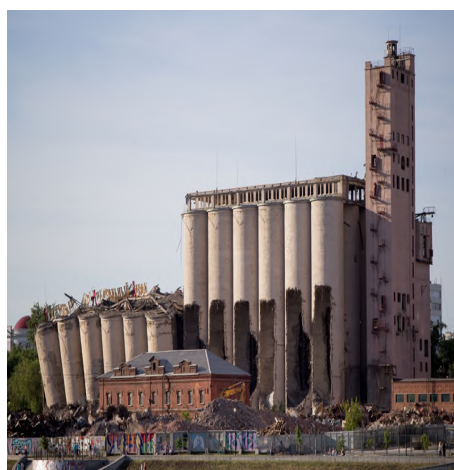
Fig. 2 Collapse of elevator Ekaterinburg flour mill.

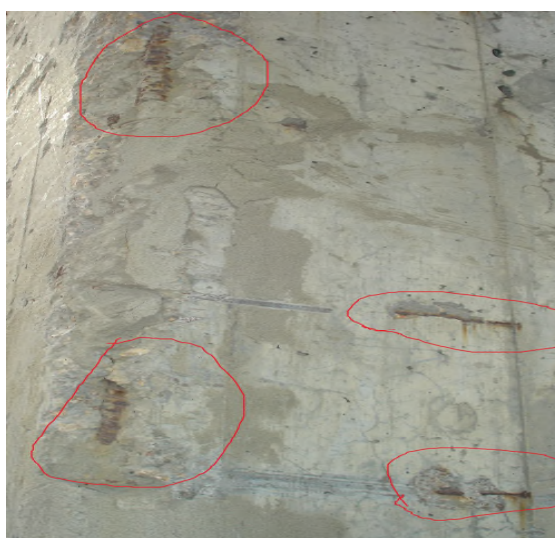
- Lack of the design and operational documentation;
- Cracks in the walls with an opening width of less than 5 mm;
- Exposure of the working reinforcement columns (Fig. 3);
- Weathering joints cover plates (Fig. 4);
- Destruction of the blind area;

Despite the fact that the overall wear and tear does not exceed 25% (classification corresponds to the "usable" category), individual defects (for example, exposure of the working reinforcement, Fig. 3, a crack, Fig. 4) can cause accidents up to the collapse, as the individual structures, and the whole building.

Fig. 3 Bare working armature building columns.

- Overhaul of the external walls and cover plates;
- Injected into the cracks;
- Restore the protective layer of concrete to enable the work of reinforcing bars;
- Restore the blind area of the building;
- Restore the missing design and operational documentation.

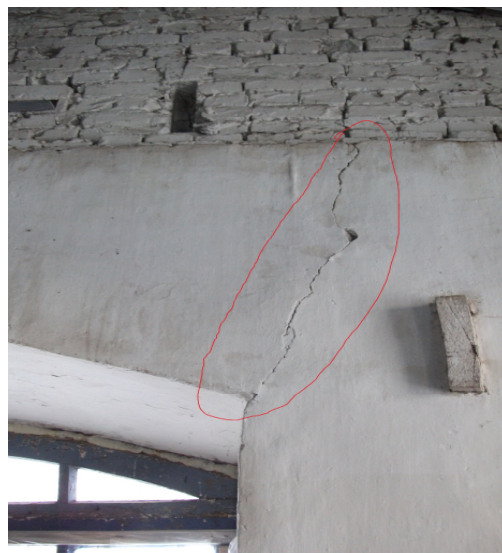
Fig. 4 Vertical crack (opening width greater than 5 mm).
