Experiments of Floatable UAV for Wave Dissipating Block Inspection

Abstract

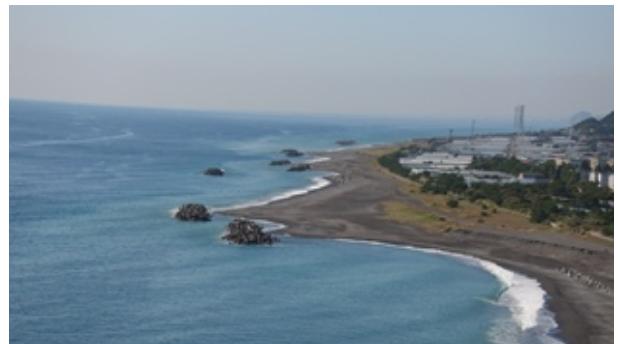
As shown in Fig.1, while the MIHO Island in Shizuoka prefecture is designated as a World Heritage Site, rapid and massive beach erosion of the island is one of the critical issues^{3,4}. It is said that UNESCO is warning if the wave dissipating blocks will not be removed, they will cancel the WHS designation because the blocks damage the beauty of the landscape of the coastline of the island. However, the wave dissipating blocks are essential to keep shore sand from being washed away by waves or currents. There is a very important road Route 150 that faces the shore and the most important role of these blocks is protecting the road from caving or depression due to road foundation washing away.

Fig.1 Coastal shore erosion and wave dissipating blocks

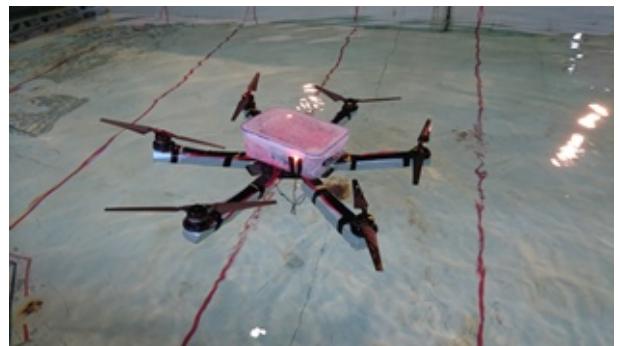
To realize the UAV monitoring system, we firstly need to examine how to make it watertight and floatable. The electrical components that are vulnerable to water are GPS module, wireless communication system, motor drivers, batteries and motors for propellers. We packed those systems inside a watertight container as shown in Fig.2.

The watertight container is made of polypropylene. We chose polypropylene because it's light and no radio wave is shielded. The lid has a silicon rubber sealer and can be attached tightly to the box itself.

Fig.2 Electrical component in a watertight container

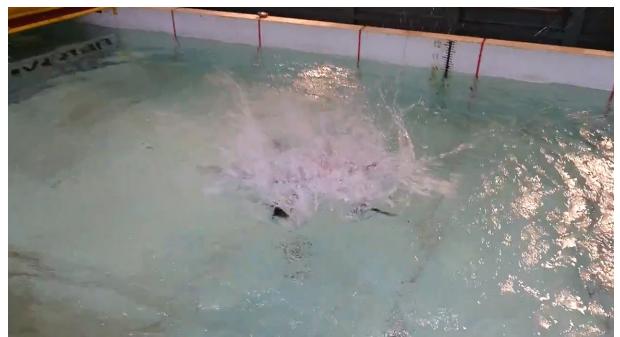
Fig.3 Diving of the UAV drone into the water

From Fig. 3 to Fig. 5 show an experiment of re-takeoff of the UAV after diving into the water. As the float of each arm has enough buoyancy, once the UAV dives into the water, it can come back to float on the water surface immediately. Through these experiences we confirmed the UAV to be able to use on the water surface.

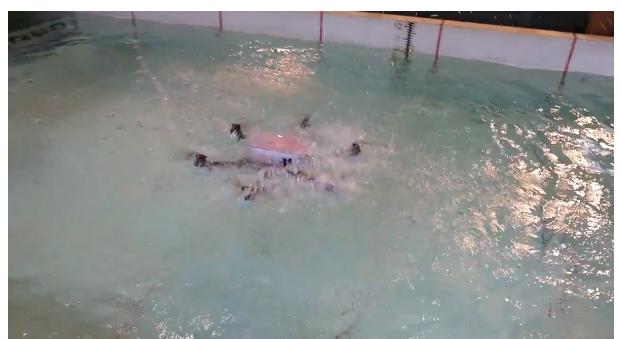
Fig.4 The UAV sunk in the tank

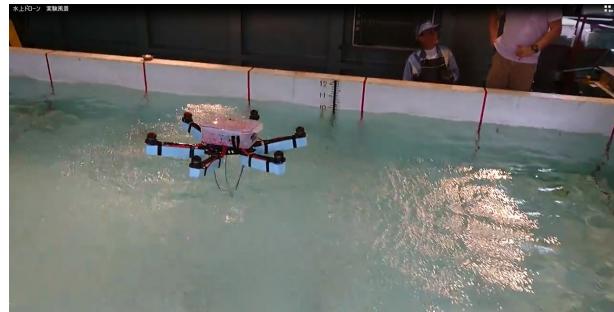
Fig.5 The UAV re-takeoff from the water

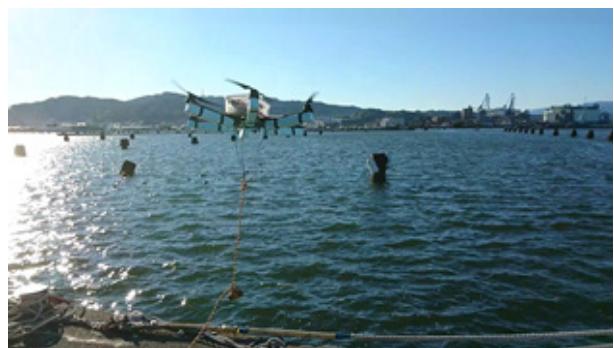
As the motors for the propeller are brushless motors and if we wash those motors with fresh water soon after we use them, they can be used even if we put the UAV into seawater as shown in Fig.6 and Fig.7.

Fig.6 UAV watertight experiment in the sea

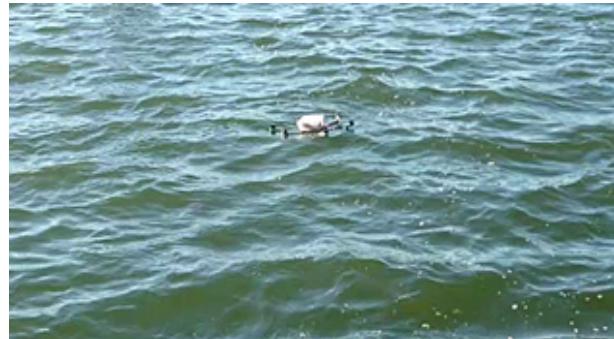
Fig.7 UAV floating experiment on the sea surface

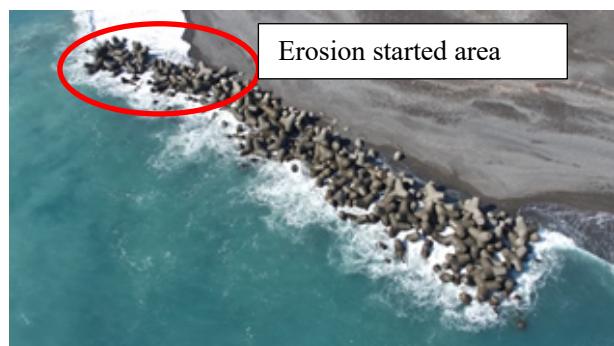
Fig.8 shows one area of those blocks from the height of around 100m. From this picture, we can see the blocks captured some sand that is put by using many dumper trucks to fill the eroded shore to recover. However, it also shows at the edge of the lined blocks, there seems another erosion started as shown in the upper left of Fig.8. We can see this situation from a wider range picture. Figure 9 shows that shore erosion proceeds in between two block areas. As we can see from the picture, the shore line vanished clearly between the two block areas. From the different colors of the water, we can see the sand flow in the sea. From the lower part of the Fig.9, we can notice a kind of vortex flow which surrounds the edge of blocks where

Fig.8 Sand captured by the blocks

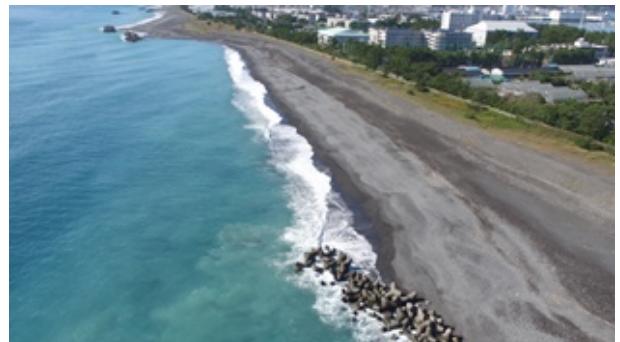
water color is rather green than blue compared to the left side of the picture. This implies a mountain of blocks can keep some sand around its area, however, the effect of accumulation is quite limited. For more than 20 years, hundreds of dumper trucks transported sand to fill the shore and put tons of sand into water, the shore line has not recovered yet. From the pictures taken this time, we confirmed our feeling that sand put into water never recover shoreline, instead, waves wash away sand. This picture indicates if we monitor the same point for a long term and trace changes of the landscape, we can estimate the amount of washed away sand as well as find more effective arrangements of the blocks to capture sand put by the dumper trucks every day.

Fig.9 Erosion proceeds between block areas

As we see in the Fig.9, we cannot say the blocks worked well but massive sand had been lost. We tried to estimate the amount from the picture taken by our UAV shown in Fig.13.

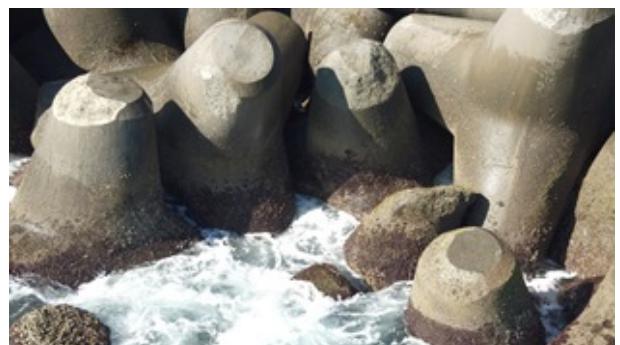
Figure 10 shows the closer look of the blocks where the island of blocks are sagged. From the picture, we can find the sagging downward of the blocks. Those blocks are not old but newly put into the shore. The reason why this area is sagged downward is not clear, however, it is possible that several blocks underwater are collapsed. To find the reason, we inspected the blocks further by taking many pictures.

Fig.10 Downward sagging area of the blocks

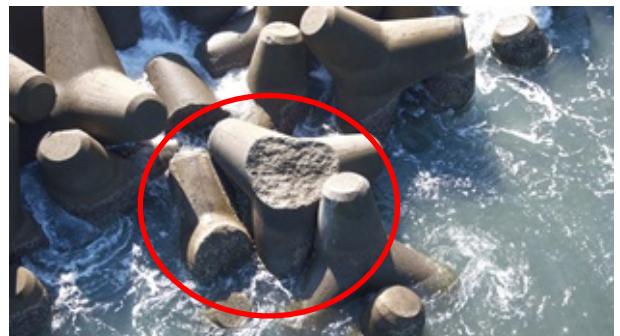
As shown in Fig.11, we found a broken block that looks newly put judging from its surface condition that there are few seaweeds on the surface of the block. The blocks are designed to collapse slowly absorbing the wave force to prevent sand from being washed away. However, as we can find several broken blocks like these, where the collapsing speed of a block looks too fast, and the reason of sagging downward shown in the Fig.10 seems due to this kind of collapse. We need to investigate further to find the exact reason of this kind of collapse of a block.

Fig.11 Broken blocks which are relatively new

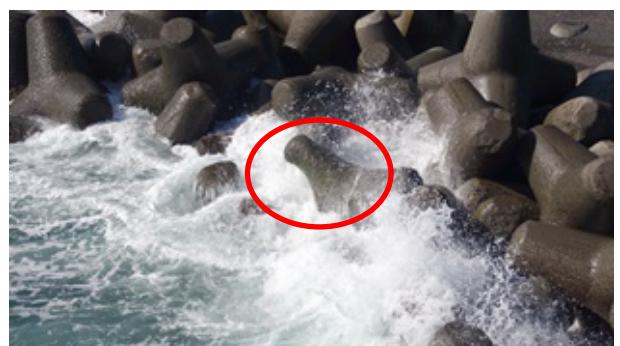
Furthermore, we found the evidence of wave abrasion of the block as shown in Fig.12. This is because the water around the mountain of blocks contain sand as we can see in Fig.9. From Fig.12, we guess sand mixed water abrades the block faster than we expected compared to normal sea water.

Fig.12 Wave sand abraded block

make the UAV watertight and floatable. Thanks to this advantage we newly found the possibility that sand mixed water abrades the block faster than it is designed, comparing between the picture taken from far (Fig.9) and near (Fig.12).

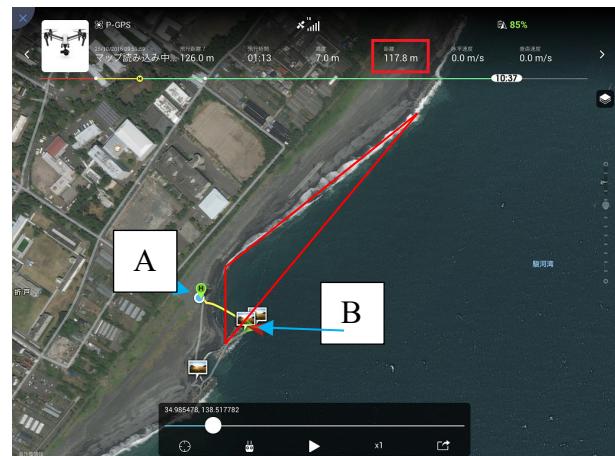
The distance from the point A to B is 117.8m. Using this distance, we can estimate the each side of the red triangle as 133.5m, 471.2m, 549.7m respectively. So we can estimate the area as 27322.9 m^2 . The average water depth can be estimated as 3m, so we estimated the lost sand amount around 81968.8 m^3 . If we use the specific weight of sand as 2.0, then this amount equals to 163,938 tf. This means almost 16,000 10-ton trucks. Although we have to investigate more precisely how much amount of sand is losing every year, especially by measuring the water depth profile further, we have just learnt to be able to start this kind of estimation using our UAV.

Fig.13 Lost sand estimation from the image
