# Structural Evaluation of Railway Warren Steel Truss Bridge with Span Length of 42 Meter According to SNI 2833:2016 and Earthquake Hazard Map 2017

**Abstract**—Railway bridge with the warren type truss structure in the Sumatera region is an infrastructure has existed since the Dutch colonial era. Bridge is used as a mode transportation for natural resources of coal. The construction of railway bridge must always be monitored and evaluated for the feasibility of the structure, especially for earthquake load. This is due to change the latest of earthquake hazard maps and regulations regarding earthquake load. The research used SNI 2833:2016 regulations, about bridge planning for earthquake load and 2017 earthquake hazard maps, by modelling the 42 meter warren type of truss structure using SAP2000 V.21 software. The results of the research indicate that, the largest of mode shape value occurs UZ point with the 6 mode number of 0,82536 displacement unit and a period value of 0,075276 second. The largest of period (T) value occurs in 1 mode number of 0,37002 second. The maximum displacement occurs U3 point at the joint 25 of 36,437377 mm opposites the axis. The value of displacement i

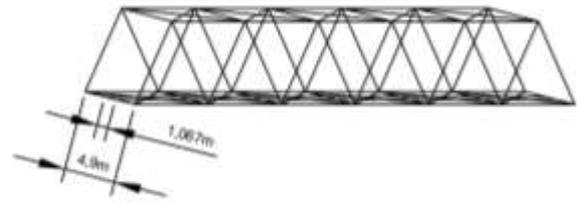
Fig. 1. 2D dimension bridge from side view

In this study, the bridge that became the object of analysis in this study was a railroad bridge in the operational area of Lampung region, Sumatera Island. The following is the technical data from the structural bridge dimension. Also, the illustrations of two and three dimensional bridge dimension are shown in **Error! Reference source not found.** and **Error! Reference source not found.**.

The material used in this study is steel which the material and dimension is based on ASTM A36 and has a yield stress of 36 ksi ( $f_y = 250$  MPa,  $f_u = 400$  MPa) with Young's modulus of steel ( $E_s$ ) of  $2.1 \times 10^6$  kg / cm<sup>2</sup>. The modeling is performed using SAP2000 v21 which the license is provided in Computation Laboratory, Department of Civil Engineering, UMY Indonesia. These modellings follow the existing bridge design criteria, with a span of 42 meters and a bridge width of 4.9 meters. The procedures of this study are elaborated below.

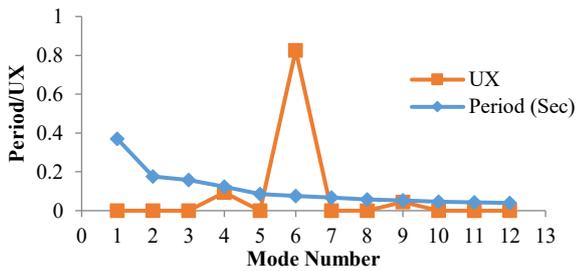
Fig. 3. Period and mode shapes displacement in X direction

The value of the maximum shapes mode whose dominant movement towards UX occurs in mode number 6 is 0.82536 displacement units with a period value of 0.075276 seconds. For the dominant movement towards UY occurs in mode number 1 which is 0.432378 displacement units with a period value of 0.370023 seconds and for the dominant movement in the direction of UZ occurs in mode number 4 which is 0.7308 units of displacement with a value of 0.124213 seconds. The biggest vibration period produced on the bridge structure has a period value (T) of 0.37002 seconds in mode 1. These values can be seen in Fig. 3 to Fig. 5.

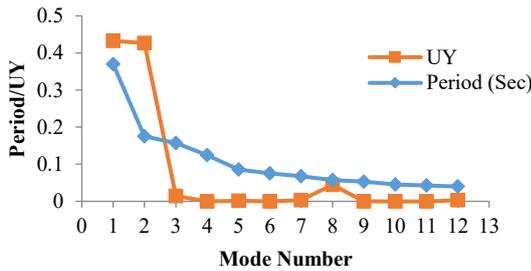
Fig. 4. Period and mode shapes displacement in Y direction

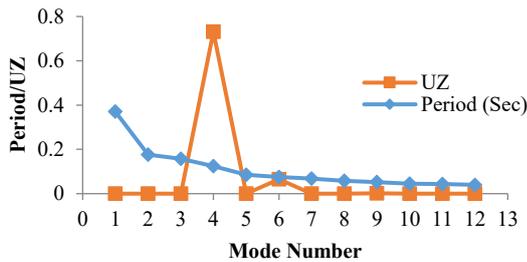
Fig. 5. Period and mode shapes displacement in Z direction

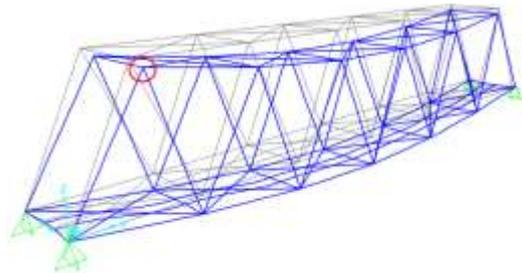
Fig. 9. Period and mode shapes displacement in Z direction

The maximum displacement value in the direction of U1 occurred at joint 51 (Fig. 9) with a value of 11.222773 mm, in the direction of U2 occurred at joint 54 (Fig. 10) with a value of -0.615116 mm and in the direction U3 occurred at joint 25 (Fig. 11) with a value of -36,437377 mm. The sign min (-) shows the direction of displacement opposite to the direction of the axes U2 and U3. In Fig. 12, Fig. 13 and Fig. 14 show a graph of the displacement values in each direction, namely U1, U2 and U3.

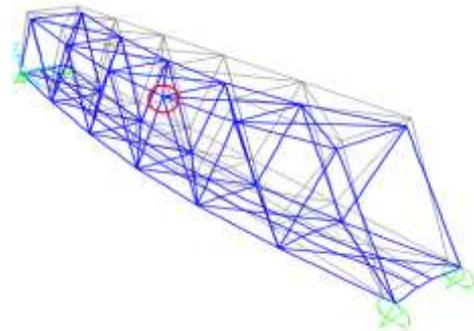
Fig. 10. Period and mode shapes displacement in Z direction

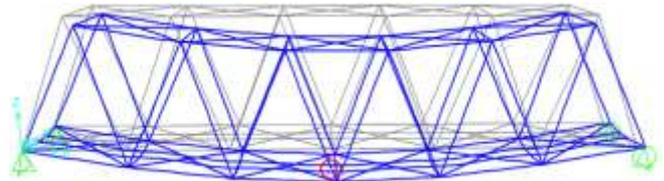
Fig. 11. Period and mode shapes displacement in Z direction

The displacement results that occur at U3 at the joint 25 have a value of 36.437377 mm opposite U3 smaller than the permit deflection value, which is equal to 52.5 mm. So, the structure is declared safe against deflection that occurs.

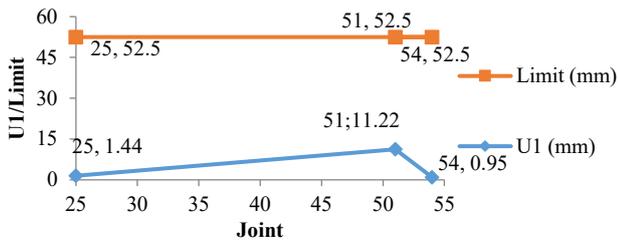
Fig. 12. displacement in X direction

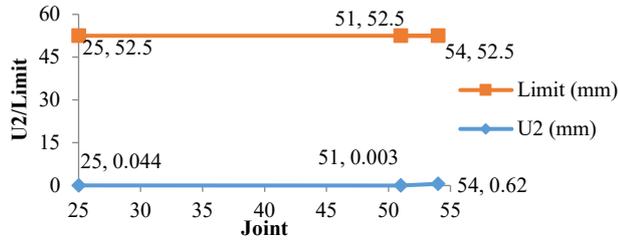
Fig. 13. displacement in Y direction

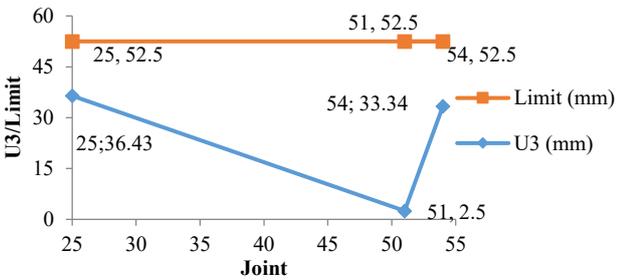
Fig. 14. displacement in Z direction

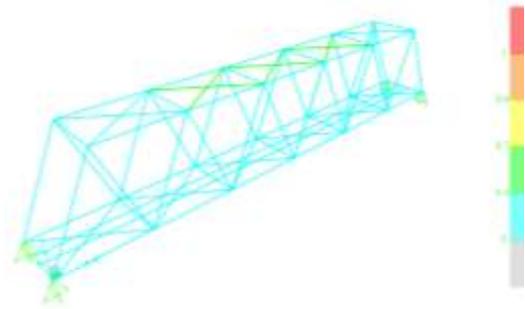
Fig. 15. Safe condition

The Run Analysis and check structure results in conditions 1-9, steel frames are safe for loads found in conditions 1-9 when running (Fig. 15). In conditions 10 and 11, the train load / moving load is added and carried out, both have the same capacity ratio value. The results show that there are 13 steel frames that have failed capacity or unsafe conditions (Fig. 16). The failed frame is the upper wind bond and 3 transverse girder.

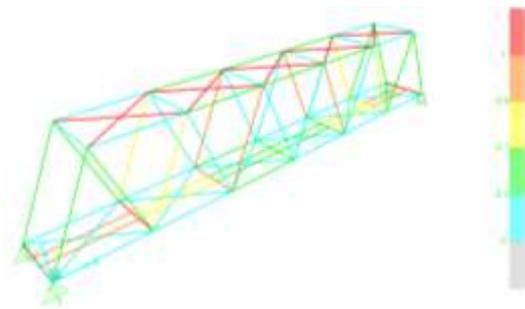
Fig. 16. Ultimate condition

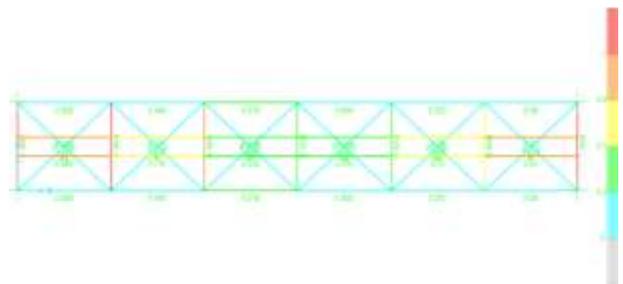
Fig. 17. overstressed frames viewed from longitudinal view

There are 3 frames that were overstressed on the transverse girder in the form of IWF1100.400.16.28 steel profiles. The ratio frame graph can be seen in Fig. 20 and the rod / frame position which is overstressed as seen in Fig. 17 to 19.

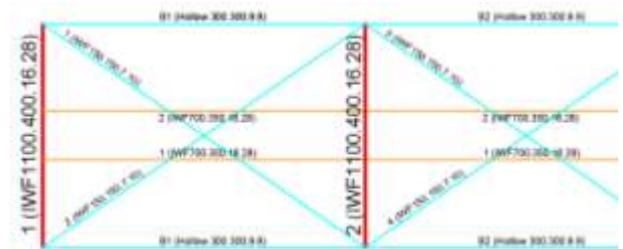
Fig. 18. overstressed frame number 1 and 2 (IWF1100.400.16.28)

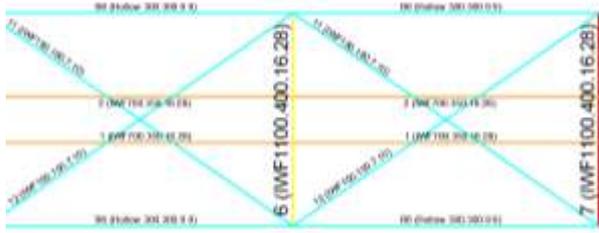
Fig. 19. Overstressed frame number 7 (IWF1100.400.16.28)

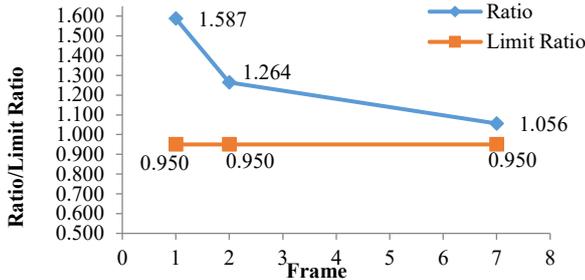
Fig. 20. Ratio and limit ratio for frame number 1, 2, and 7 (IWF1100.400.16.28)

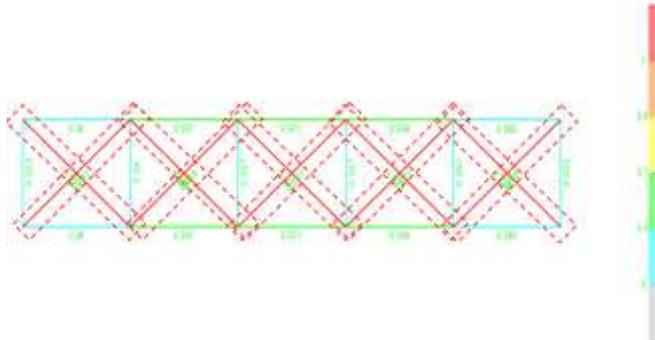
Fig. 21. overstressed happen in wind bracing

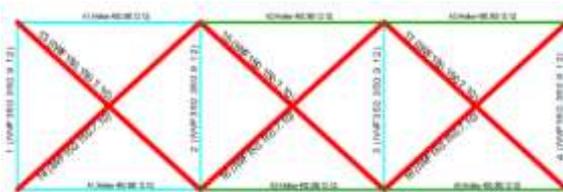
Fig. 22. Detailed of overstressed frame number 13-18 (IWF150.150.7.10)

The results of the magnitude of the resistance in the frame that was overstressed. Each frame has a voltage capacity capacity to be able to withstand the stress that occurs in the frame. the frame that experiences the greatest stress occurs in the press rod, namely frame 17 and 18 (IWF150.150.7.10) with a Pu value of 25,324 tons with a compressive capacity of 12,612 tons. Thus, the frame is declared insecure against the amount of compressive stress that occurs.

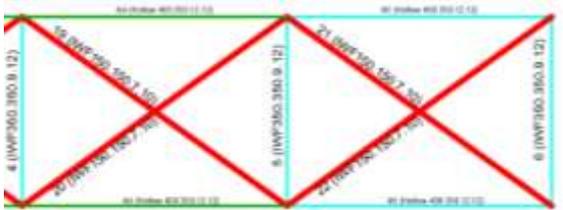
Fig. 23. Detailed of overstressed frame number 19-22 (IWF150.150.7.10)

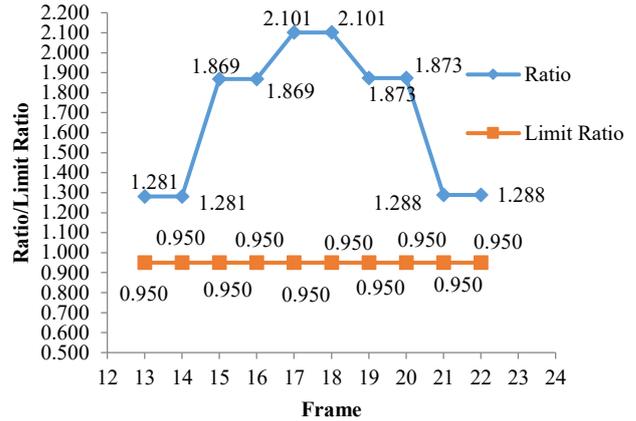
Fig. 24. Ratio and limit ratio for frame number 13-22 (IWF150.150.7.10)
