Repurpose Historical Building for Hotel Use Case Study: Harbour Rocks Hotel, Sydney

Keywords: *adaptive reuse, historical building, hotel, culture, tourism*

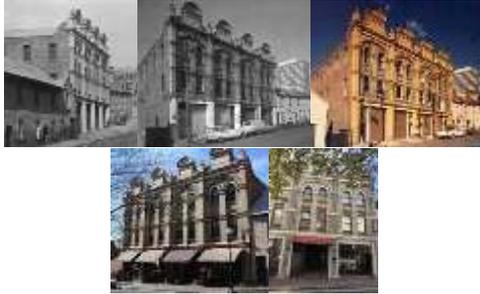
Figure 1: Harbour Rocks Hotel, Sydney buildings on 1900, 1970, 1980, 2009 dan 2019. [8]

There is a significant colour change in between 1980 and 2009. Traditional paint schemes are still being used to recall the historic scape of the area.

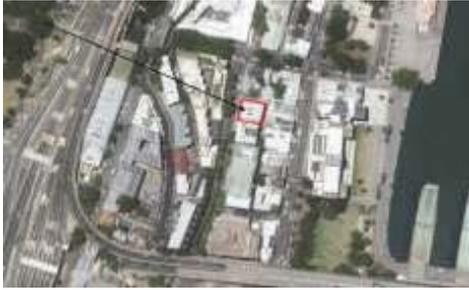
Figure 3: Aerial View

Street, The Rocks, Sydney, NSW, Australia. The location is prime as it served as conservation area, historical setting and one of the main tourist attractions in Sydney

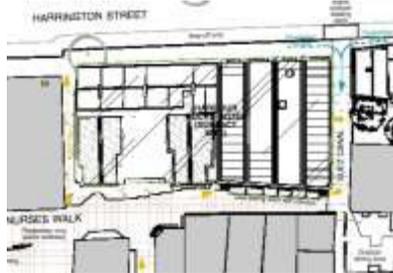
Figure 4: Roof Plan (Welsh+Major, 2017)

Roof is to be retained as much as possible. Additions of two skylights were introduced to be located on top of access (staircase) and airwell at the lobby (see Figure 3) which was allowed by the guidelines

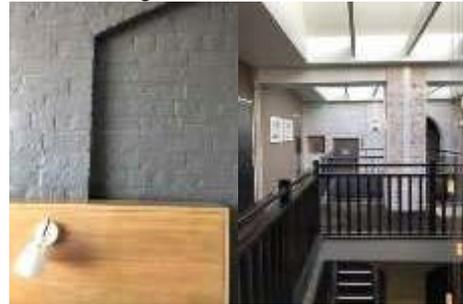
Figure 6: Wall finishes

Existing wall is rendered as fair-faced brick wall, the wall is restored and repainted for rooms. The wall at the corridor is retained as it is with restoration and no paint.

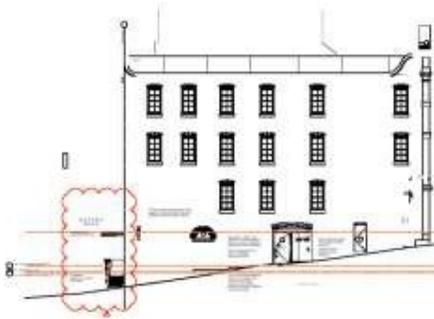
Figure 8: Side Elevation [8]

The other elevations still adopt and follow the existing treatment, such as no alteration to existing windows and ornaments.

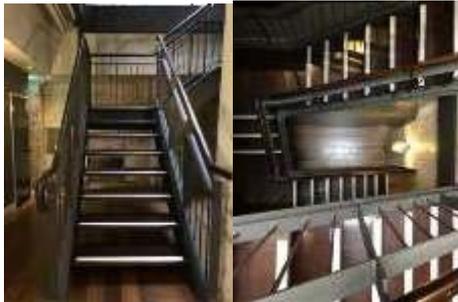
Figure 9: Staircase

To adjust to the new function, new vertical access was introduced to cater for the necessity of a hotel and fire safety purpose. There is no lift at this hotel as there was a space and structural constraint.

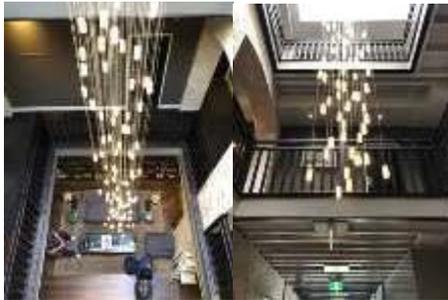
Figure 10: Airwell

Based on the guidelines, airwell location and size is to be retained. There are 2 airwells in this building, 1 for the vertical access and at the lobby. The airwell open directly to sky to lend the interest of spatial experience. A lightweight translucent material roof covering is used

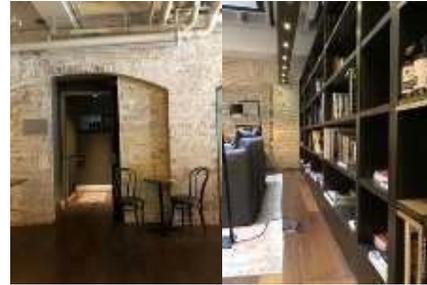
Figure 11: Timber flooring at 1st storey

Overall the floor structure was retained. First storey finished still using the original timber flooring with some new portion at the facility area. The subsequent floor was modified to cater for new bathrooms, therefore concrete was introduced as it was allowed by the guideline. The upper storey corridor was covered in carpet but still retaining the wood structure.

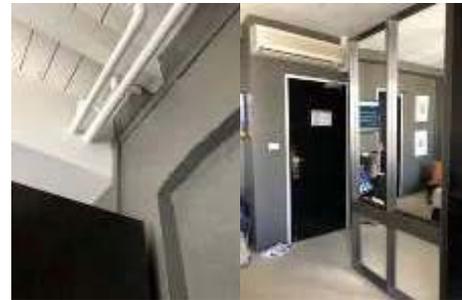
Figure 13: Sprinkler pipe

Most of the building using out bow system where all the conduits, piping is exposed. Due to the strength of the building hacking the building id not preferred and is considered has followed the conservation guidelines.

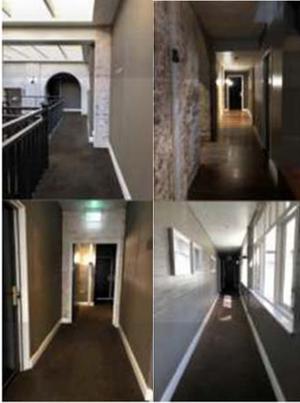
Figure 14: Corridor

The spatial layout does have a big impact to the hotel in heritage building. The existing floor plan was divided into rooms and facilities. The size, the contours of the space, will be considered as character defining and it depends on from what is the previous function of the building itself. Due to the hotel programme, rooms are located along the perimeter of the building with corridor and an airwell located at the centre of the building.

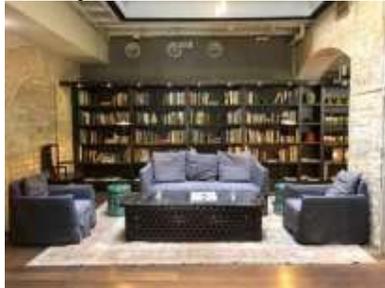
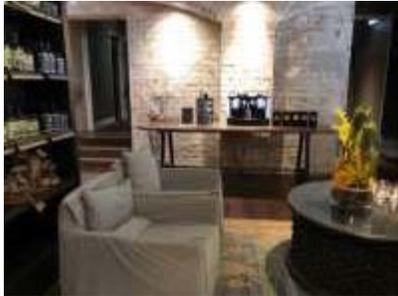
Figure 15: Lobby

The lobby, that should be inviting, was altered in order to fit the purpose of a hotel lobby. A small reception in conjunction with hotel bar due to space constraint. All the element of the architectural elements at the lobby retain as it is with additional false ceiling to conceal mechanical and electrical support, like air conditioning without breaking the whole historical ambience.

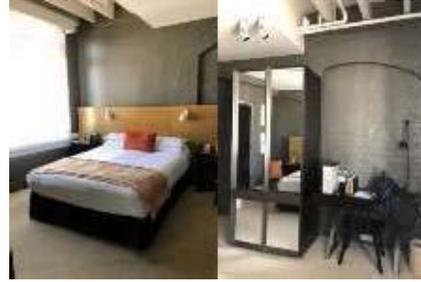
Figure 16: Room

The rooms were fit in with the existing structure with additional brick wall to demarcate each individual room. This hotel, resulting an odd-shape rooms and a non- standard size, building into a hotel, like faced the down side of turning historical. But having a various shape and type of rooms often appeals to visitors who value experience with each visit.

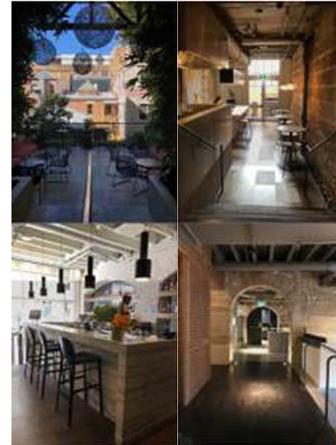
Figure 17: Facilities

The facilities provided is to be determined based on the stability of the building itself and case by case basis, such as restaurants, bar and gym. The historical feel is still imposed on those facilities.

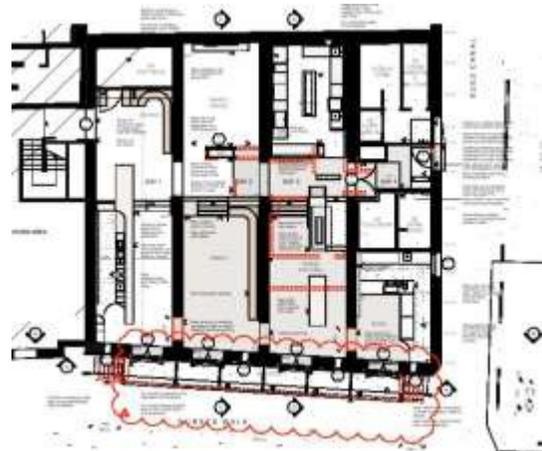
Figure 18: Facility (restaurant plan) [8]

The restaurant is the latest edition of the hotel, which having a veranda, kitchen, seating area and bar and retail. The design of the restaurant and its amenities still following the guideline of conservation by retaining most of the space and architectural ornament.

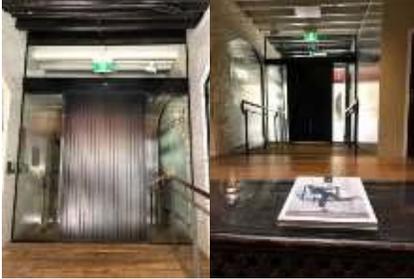
Figure 19: Ramp at the entrance

Even though it is a heritage building, the necessity of barrier free access is still required due to the function of the building is for public use. Ramp was provided at the entrance to cater for wheelchair user and rooms at 1st storey is available for them as well. Tactile tiles, a textured ground surface, were provided to assist visually impaired visitor.

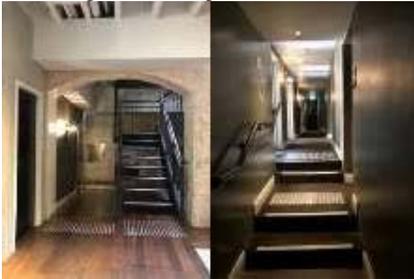
Figure 20: Tactile Tiles
