# Failure Analysis on Reheater Tube Boiler Furnace Base on Tensile and Impact Test

Failure on reheater tube was rupture. Scale latched on the outer surface and progressively thinning thickness with a minimum thickness of tube rupture at the nearest corner. An analysis of this research is to find the cause fracture mechanism and prevent similar failure. The mechanical analysis used tensile and impact test on failure and replacement tubes. Quantitative data analysis used descriptive methods. Characteristic of tube SUS347HTP with tensile strength standard 550N/mm<sup>2</sup>. The yield strength obtained on replacement tube, temperature 30<sup>0</sup> (399.55Mpa), 160<sup>0</sup> (234.09 Mpa), 290<sup>0</sup>C (198.13Mpa), 420<sup>0</sup>C (136.26 MPa), 500<sup>0</sup>C (102.10Mpa), 550<sup>0</sup>C (80.75 Mpa), 580<sup>0</sup>C (67.94Mpa), and 600<sup>0</sup>C (59.40MPa) and on failure tube, temperature 30<sup>0</sup>C (244.45MPa), 160<sup>0</sup>C (206.93MPa), 290<sup>0</sup>C (158.70 MPa), 420<sup>0</sup>C (118.14Mpa), 500<sup>0</sup>C (91.9MPa), 550<sup>0</sup>C (75.5MPa), 580<sup>0</sup>C (65.66MPa), 600<sup>0</sup>C (59.10MPa). Tensile test aimed that pressure of failure tube de

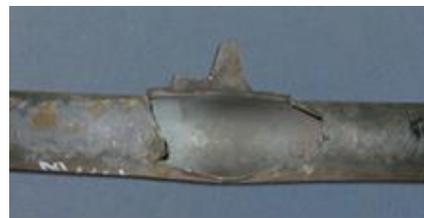
Figure 1. Material tube no 47.

Material tube: SUS347 HTP tube no 47

length: 1260mm

The failure can be explained as follows break with a tear in the direction of fluid flow. The broken area is located at the bottom with a horizontal position when the tube is in the reheater circuit, where in that part is the path of the combustion process and the path in the water jet cleaning process. The ruptured tube is located at the bottom with the position parallel to the fluid flow.

Failure tube in the reheater tube outlet circuit is in the form of a rupture in the direction of parallel to the fluid flow and thickness changes. On the outer surface there is crust attached. The crust that attaches to the part is very hard and sticks to the material so it is called hard slag. The outer protective layer of the tube has also disappeared. On the inner surface the protective layer is still visible even though there are some peeling parts (there are spots on the surface). Visually the form of failure is shown in Fig. 1. The visual appearance of a failing tube is very different from the replacement tube. On the outer surface area still looks smooth and uniform thickness when viewed from a side view. This shows that in plain view the failure tube has changed in terms of dimensions.

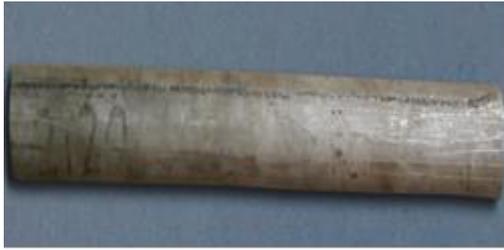
Figure 2. Material of replacement tube.

replacement tube length: 620mm
