Evaluation of the Impact of Side Scouring of the Cipeles River on the Reliability of the Cipeles Bridge on the Cisumdawu Toll Road STA 9 + 050 - STA 9 + 350 West Java

ABSTRACT

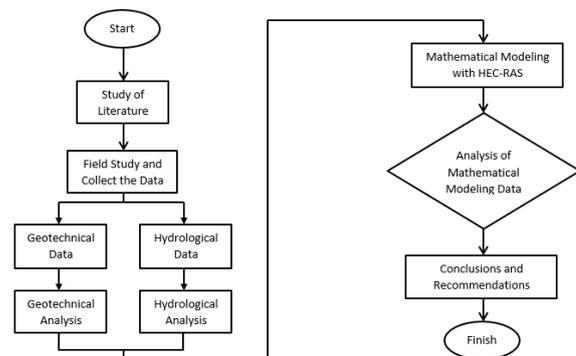
Figure 2. Research flow chart

The research flow chart can be seen in Figure 2.

The Research Methodology step will be described as follows: The Researcher search the literature study for theoretical references that are relevant with the topic being researched by the researcher. The references of literature study can be research from journals, books, research report article, theses, and websites on the internet. The purpose of literature study is to identify problem as well as become a theoretical basis for conduct research.

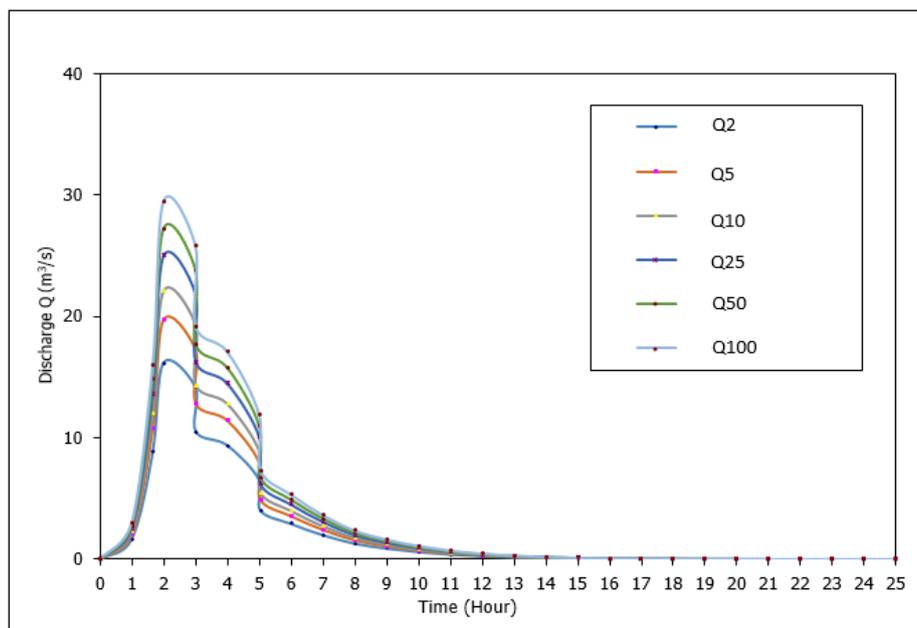
Figure 3. Nakayasu HSS method of flood discharge chart for each period

From the hydrological analysis that has been carried out, which consists of rainfall, watersheds, and etc., using the Nakayasu method, the hydrograph diagram of rain can be obtained, as shown in Figure 3.

Figure 3 above shows the rain intensity data between 1 to 3. where this has an impact on the discharge that will flow in the Cipeles River. In the first few hours, the diagram shows an increase in discharge increasing until it reaches a peak at 2 hours; after reaching the peak, the rainfall begins to decrease.

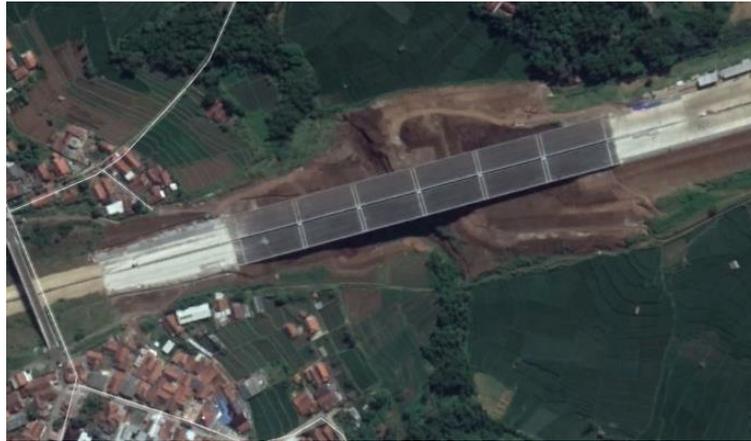
Figure 4. Research location map with google earth

From the figure 4, we can see the shape of the research location taken from Google Earth. From Google Earth, the coordinates of the location of the research. The coordinates that have been obtained from Google Earth are then imported into the global mapper software to get the contours of the research location. Furthermore, the map obtained from google earth and the location contours obtained from the global mapper software are integrated into Civil 3D software. The results of this merger can be seen in Figure 5.

In this research, to determine the location and place of research, researchers used Google Earth software. From Google Earth, we get the coordinates and areas of the research location. After obtaining the coordinates, the data is imported into Civil 3D software, which will produce a contour map of the location along with a cross-section of the river. An overview of the location map, along with a cross-section of the river, can be seen in Figures 4 and 5.

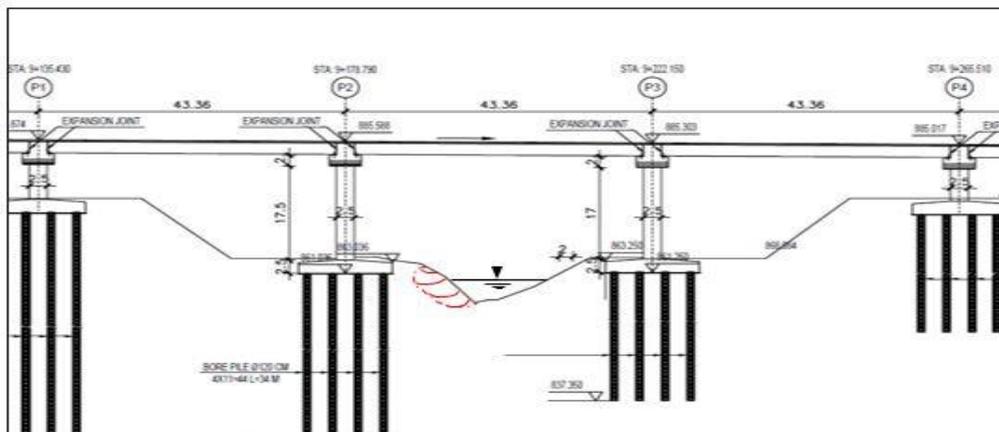
Figure 6. A side plan of the scour that occurred

From the results of mapping carried out using Civil 3D software, a river flow was obtained, which would later be used as input to the HEC-RAS software. After the data has been collected, a river simulation is performed using the HEC-RAS software, which will produce a scouring pattern that occurs in the Cipeles River. The following picture is an illustration of the scour that occurs in the Cipeles River.

From figures 6 and 7, we can see that the scouring that occurs in the Cipeles River occurs due to the behavior of river morphology. At the time of the simulation using HEC-RAS software, scouring occurs around the lower structure of the bridge; this can cause a decrease in the bearing capacity of the underlying bridge structures.

The scour that occurs in the Cipeles River is categorized as side scour. the magnitude of the side scour that occurs in the Cipeles River is approximately 1-2 meters. the scouring that occurs can endanger the lower structure of pillar number 2. Therefore, it is necessary to strengthen the river walls of the Cipeles River.
