# Properties of Archaeological Pottery Tile Excavated from Sanyangzhuang Site Henan, China

**ABSTRACT:** Sanyangzhuang settlement sites is a ancient villages, which are flooded by the Yellow River in early Western Han Dynasty. A large number of pottery tiles as a part of ancient villages excavated from Sanyangzhuang sites has great value in the study of early Chinese village building. In order to preserved those well, we analyzed the properties of pottery tile by XRD (X-ray diffraction), ESEM (Environment scanning electron microscope) and Electronics omnipotent material trial instrument for the component, structure and mechanical. The results shown that the pottery tile's main ingredients is silicide with loose structure, low mechanical strength and high salt content, which is main reasons for pottery tile weather.

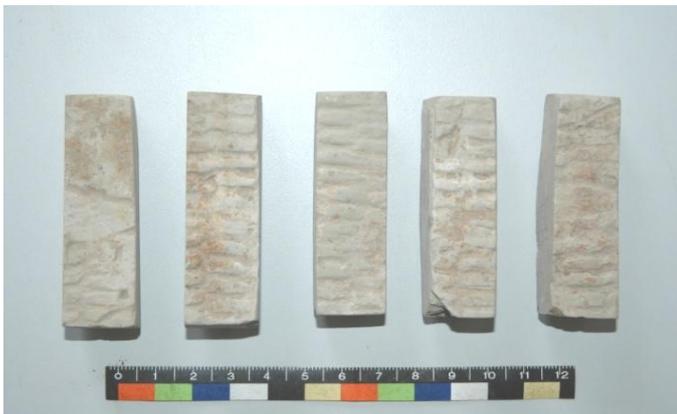
The terracotta sample from the sites show graphite color that indicates it should be prepared under a reducing atmosphere at high temperature sintering. We take the maximum value in thickness, according to the test requirements have the samples cut into 6cm\*3cm\*2cm in long width high respectively. Then put them into oven, drying in 103 °C to constant weight for use.

Fig. 2 sample for characterizing

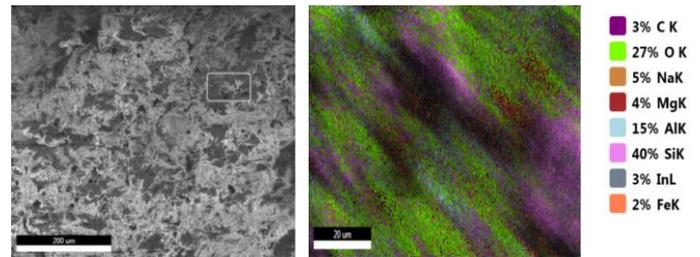
As shown in Table1and Fig3, there were higher content of soluble salt in unearthed terracotta, most anion are SO<sub>4</sub><sup>2-</sup>, and most of cation are Ca<sup>2+</sup>.

Fig.3 map of element

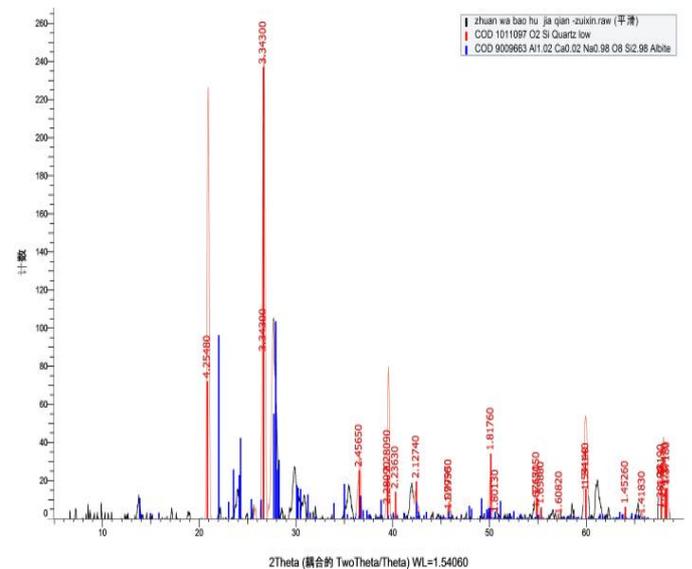
Terracotta artifacts were made of clay minerals by high temperature sintering. Which usually composed of quartz, feldspar, calcite, mica minerals and a small amount of organic detritus[6-10]. As shown in Figure 4, the main species of terracotta unearthed from SanYangzhuang settlement site are quartz, minor phase albite and anorthite.

Fig.4 XRD of Terracotta

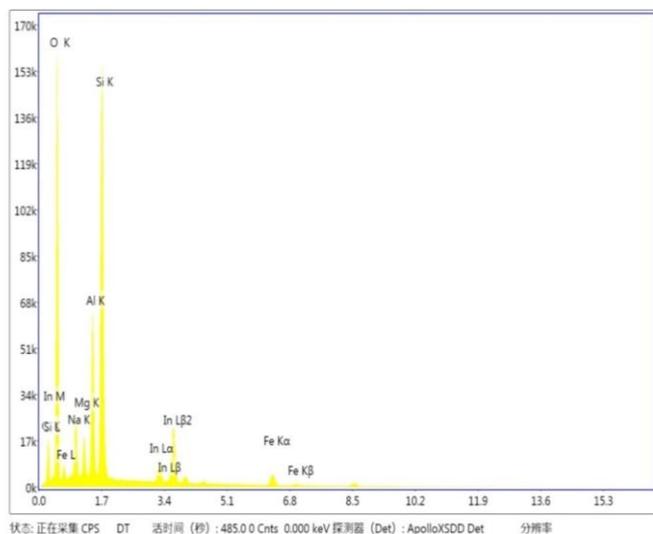
As shown in Fig5, according to the map of EDS, it mostly made up of Si ,O and some metal ion, such as : Na<sup>+</sup>, K<sup>+</sup>, Ca<sup>2+</sup>, Al<sup>3+</sup>, Mg<sup>2+</sup>, Fe<sup>2+</sup> and so on. The content of each element are listed.

Fig.5 EQUA element

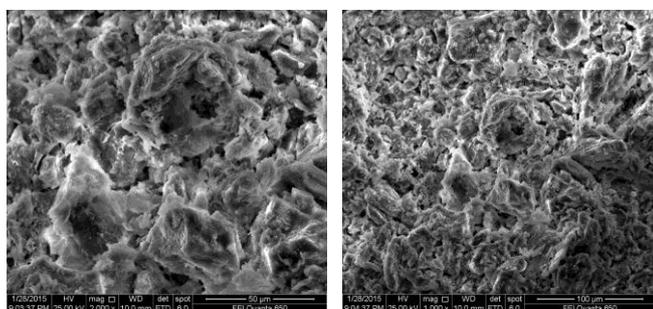
As shown in Fig 6, the SEM of Terracotta indicates the tile body structure is loose and porous structure, and the pore size and distribution is heterogenous due to manufacturing defects might result in the pore structure; on the other hand, During the firing adobe process, clay with different mineral, size different shrinkage of organic matter and pore fluid will result in uneven distribution. This structure make ceramic relics susceptible to be etched by soluble salt in groundwater in long-term buried underground environment.

Fig. 6 SEM of Terracotta

The main component of terracotta unearthed from SanYangZhuang Han Dynasty sites is silicide with loose porous structure and low mechanical. The soluble salt content is higher. After terra cotta unearthed, the soluble salt invaded into cultural relics will cause "dissolving crystalline" cycle phenomenon, when the environmental temperature and humidity changes. The volume change of the soluble salt in this process will result in the terracotta surface crisp powder and other diseases. Therefore, factors have directly effect on the diseases of unearthed terracotta have been proved as follow: osteoporosis, erosion of soluble salt cultural ontology structure and low mechanical strength and so on.
