Study of Failure Analysis of Power Transistors

Abstract. This paper present a process of failure analysis which, to some extent, can demonstrate a variety of failure process in regard to power transistors. General failure analysis process will be introduced at the beginning of this article. The test objects are power transistors which were found to be the fundamental cause towards failure of control system. Specifics of test procedure will be disclosed as below in the text. The procedure of failure analysis was conducted through comparison. Through integrating examination, inspection result and deduction, outcome illustrates that the interaction of congenital defects and ambient activation in use contribute to failure. Ultimately, given the inferences that inherent defects existed before employment, and that adverse ambience aggravate the damage of components, we will propose conclusion and opinions on production. The possibility that failure analysis makes power transistors more reliability will sustain our endeavor.

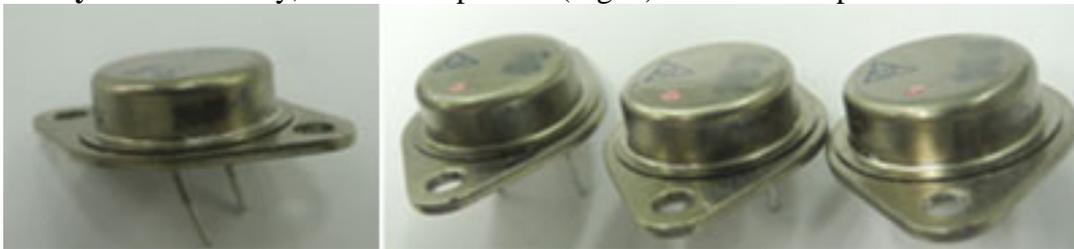
Fig. 1 Appearances of failure (L) and comparisons(R)

It turns out that the failure almost show no difference from comparisons through the examination of optical microscope. However, electrical performance test (Tab. 1) at ordinary temperature proves that electrical properties of the failure are completely disordered. It's obvious that the failure is bad performed because parameters of BVCEO (opposite breakdown voltage between collector and emitter) and HFE (a criterion for Static current amplification factor) are disordered.

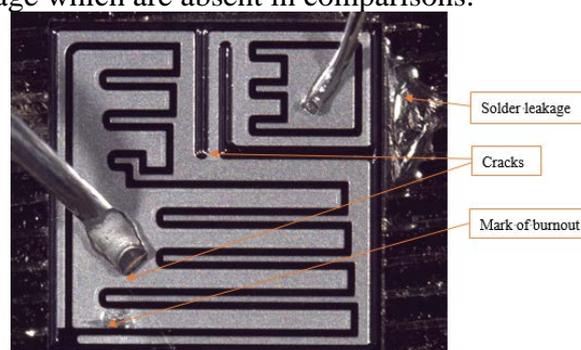
In order to investigate disordered properties, internal inspection(Fig. 2) were implemented and it disclosed several weaknesses and flaws. There are two distinct cracks penetrating chip and a mark of burnout and solder leakage which are absent in comparisons.

Fig. 2 Internal inspection

Mark of burnout: it results from localised overcurrent damage. In some respect, fatal cracks localise the mark of burnout. However, the most fundamental reason due to burnout could be welding hole inside the chip;

Solder leakage: solder below a side of the chip overflows which is consistent to principles for rejection of GJB-128A——Test methods for semiconductor discrete devices.[5]

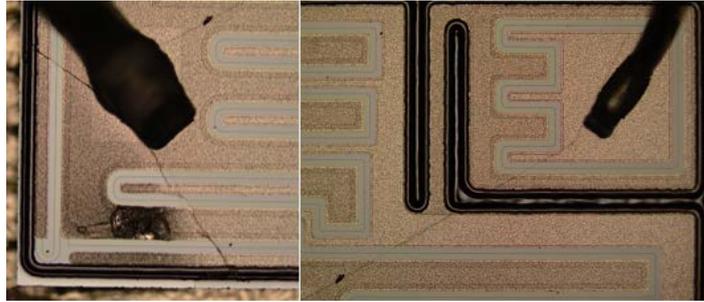
Two distinct cracks penetrating chip(Fig. 3): to some extent, they are the most intuitionistic state we learned which could directly lead to failure;

Fig. 3 Cracks in detail

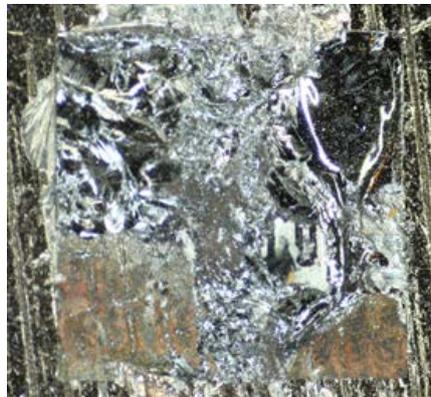
Examination of optical microscope led to another clue. Concretely, we checked the quality of welder layer after chips were removed. Large tan interface were found from solder layer of all chips except comparison 1#. The region of tan interface of comparison 3#(Fig. 4) exceeds 60 percent of welding area of chip. In addition, the region of tan interface of both the failure(Fig. 5) and comparison 2#(Fig. 6) approximately occupy 20 percent. We should take this possibility into consideration that it comes out failure of batch.

Fig. 4 Tan interface on solder layer of the failure

Analysis and Summary The fact we cannot deny is airtightness of components was compromised before they came into service because both failure and comparisons were found with tan interface which was oxidized. Because result of ingredients analysis displayed the existence of

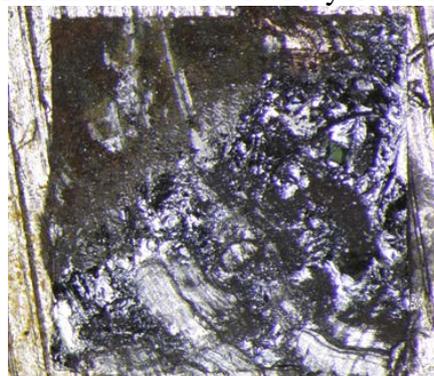
Fig. 5 Tan interface on solder layer of comparison 2#

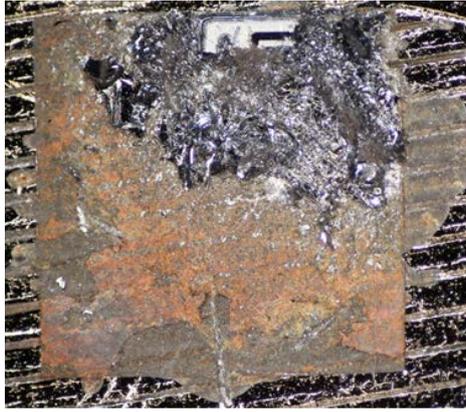
Fig. 6 Tan interface on solder layer of comparison 3#

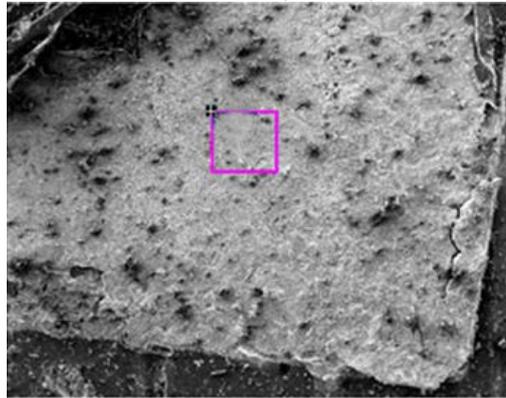
In order to clarify the ingredient of tan interface, examination of electron microscope was conducted in this section. According to the instruction of manufacturer, ingredients of solder layer are mainly compound metal of Pb-In-Ag of which content of Pb dominate 92.5 percent. However, detection result revealed that elements of carbon and, especially numerous content of oxygen existed. Region of examination and situation of ingredients analysis are shown in Fig 7 and Fig 8. Concrete numerical value of element are as follows(Tab. 2).

Fig. 7 Examination of electronic microscope

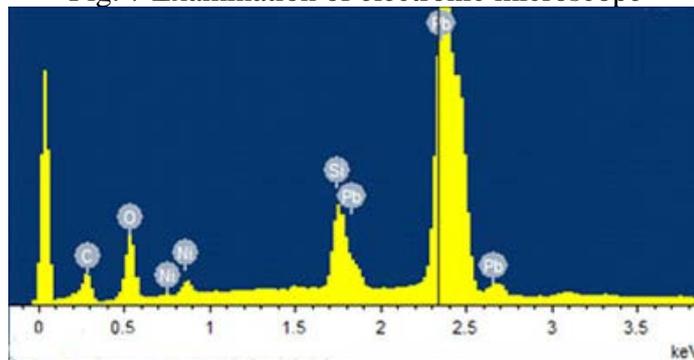
Fig. 8 Ingredients analysis of pink region

There are several doubts about data shown in Tab 2. Where were C, Si and Ni from? And where did In and Ag (ingredients of solder layer) go? Actually, the surface we test and analyzed is between chip and solder layer. This's why chips were removed before we checked the quality of welder layer. Where were C, Si and Ni from? They came from chip. C, Si and Ni are common materials for chip. Material bonding because of high temperature working condition left trace of such elements, especially C and Si. Ingredients analysis was conducted by electronic energy spectrum analysis instrument. This instrument of UV-light acting the role of the excitation sources only act on the sample surface, and obtain the distribution of information of photoelectron energy finally. It is the reason why In and Ag were not displayed in the outcome. Electronic energy spectrum analysis instrument only analyzed the surface. Spectroscopy of Ag and In are similar, not to mention the situation that their element content is extremely rare. These with the addition of the fact that solder layer surface attached residual material of chip contribute to the disappearance of Ag and In. removing the surface, we'll find their existence.
