Seepage Cut-off Wall Detection of Reservoir Based on Groundvue Series of Ground Penetrating Radar

Keywords: Ground Penetrating Radar, Groundvue series, Nanmenxia Reservoir, seepage cut-off wall, detection

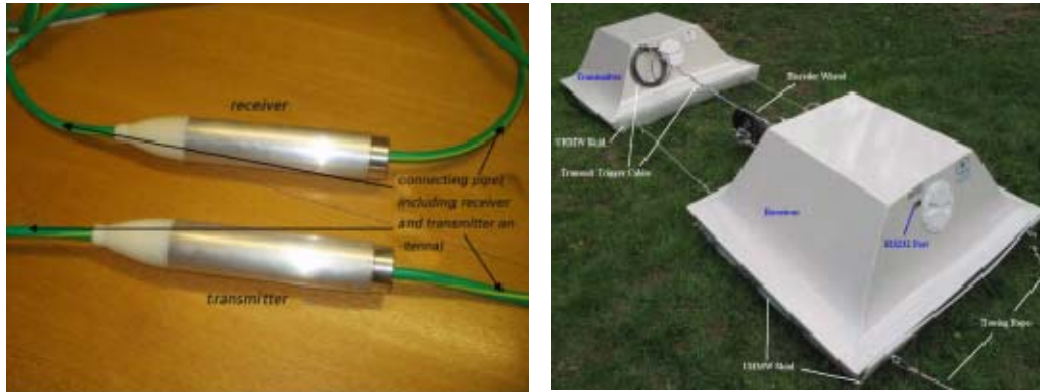
Figure 1 GV series of ground penetrating radar antenna

Geological radar antenna according to the classification in different ways can be classified into different types of antennas. From the nature of the work, it can be classified into transmit and receive antennas; from the shield or not shield, it can be classified into shielded and unshielded antenna ,as shown in figure 1.

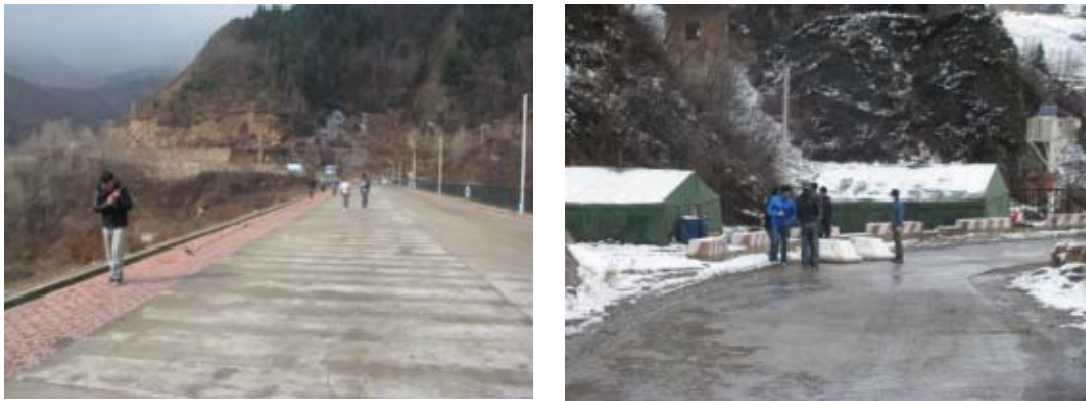
Figure 2 GV6, GV2 measured at the crest of the dam

Dam fore slope survey lines were detected from grouting platform to the top of slope. Its direction perpendicular to the dam's trend. Because there are many stone on dam slope, it was not conducive to larger size and weight GV2's probe (smaller effect on the light GV6), so the measuring space was arranged to 3.5 m. The total of survey lines is 26. Test method is shown in figure 2.

The main survey line is arranged in the top and fore slope of the dam. The main detecting route include: three equidistant longitudinal survey lines along the highway direction on the dam crest, two longitudinal survey lines on the dam fore slope grouting platform, they were GV2 and GV6 detection;

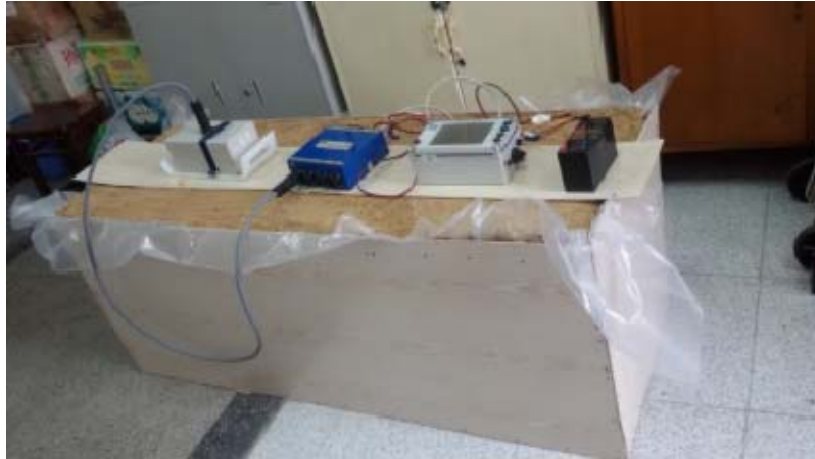
Figure 3 GV ground penetrating radar indoor test platform

For a reasonable analysis of Nanmenxia reservoir's images measured by GV ground penetrating radar, Hohai University established a simulation platform based on 1GHz of GV3 ground penetrating radar antenna in the laboratory, to understand the characteristics of the target model image measured by GV ground penetrating radar. As shown in Figure 3.

As the indoor test platform of GV3-1G antenna is able to effectively simulate and test the radar image characteristics of underground target objects, its results help to improve the detection interpretation efficiency of Groundvue geological radar.

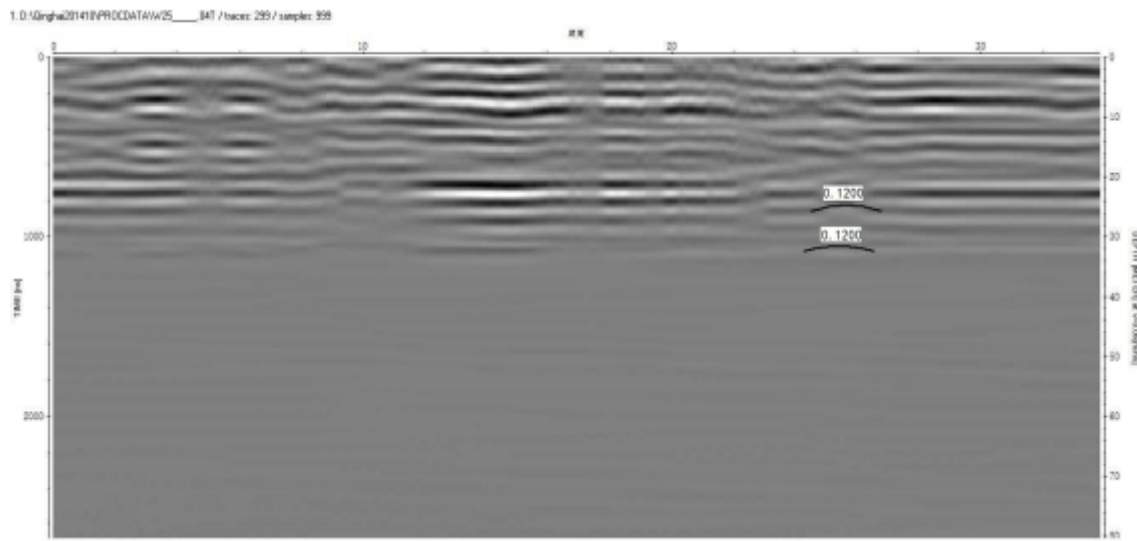
Figure 4 GV6 grayscale image of 0 + 034 section in dam foreslope vertical to the dam axis

Used GV6 GPR to test in dam fore slope. The direction of survey line is perpendicular to the dam trend and from the bottom of the slope to the dam crest. The measuring grayscale image of the 0 + 034 section see image 4. From the image, we found there are some reactions of GPR electromagnetic waves in dam fore slope, whose position is 26m away from the dam crest and at a depth of 26m and 32m. So we suspected it is the location of concrete cut-off wall. The location is parallel with the strike of the dam, near the grouting platform toward to the dam crest, 3m away from the existing grout platform. This may be an important reason of previous poor grouting effect.

In order to confirm the above speculation, we view the radar images of other positions that are parallel with that survey line. We found most of the GPR images that are parallel with the 0 + 034 section appear suspected GPR reactions almost at the same position. In Figure 5 we can see the GPR arc of 0 + 208 section, whose position is in the dam fore slope 24m away from the dam crest, at a depth of 24m and 32m.

From the relative positions of the two reflex arcs in Figure 4, the shallower reflex arc is often closer to the left than the deeper reflex arc. This is not difficult to explain. Because the measurement is carried out from bottom to top, and there are a 20 degrees slope toe between the measurement path and the horizontal. With respect to the vertical concrete cut-off wall there is an angle of 70 degrees. When the measuring route is displayed in the image in the horizontal direction, the cut-off wall in the image naturally shows a tilt angle of 20 degrees relative to the vertical direction. Form a "tilt wall" phenomenon.
