An Experiment on the Seismic Behavior of Reinforced Masonry Buildings with Transverse Bearing Wall

Keywords: Masonry structure; Aseismic strengthening; Pseudo-dynamic test; Quasi-static test

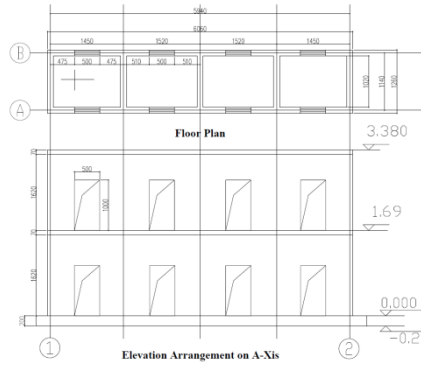
Fig.1 Masonry structure model

The model was an ordinary masonry structure with no seismic fortification measures, which is shown in Fig.1. According to the specification^[2], the plane size of the structure was 6060mm×1260mm, open-plan was 1450mm and depth was 1140mm, each floor height was 1690mm. The model was built on the reinforced concrete baseplate which connected with ground by high strength bolts.

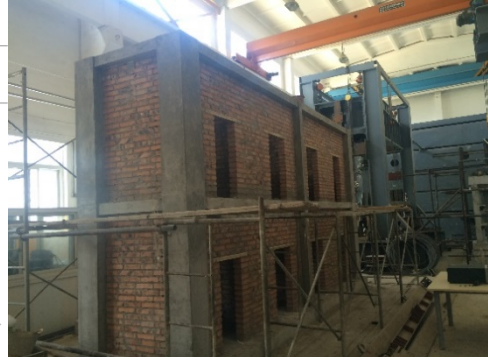
Fig.2 Reinforced masonry model

The section size of the beam was 120mm×100mm, set 4φ6 rebar. According to the specification^[3]^[4], L type section was used in reinforced concrete column in the corner of wall, dimensions of long and short side was 300mm and 120mm, longitudinal steels in ring-beam were 4φ6 and 12φ6 in column which were laid in two rows. No less than 0.9m steel ties were settled at bottom, mid and top of each story to tie columns and walls. The size of pin key was 100mm×100mm, connected with beam, column and wall, set 4φ6 rebar and stirrup 2φ6, 100mm depth in the wall. C25 concrete used in column, beam and baseplate. Mu10 fired common brick which size was 240mm×115mm×53mm and M7.5 cement mortar were used to build the model. The thickness of concrete precast slab was 70mm, and wall was 120mm. Reinforced masonry model is shown in Fig.2.

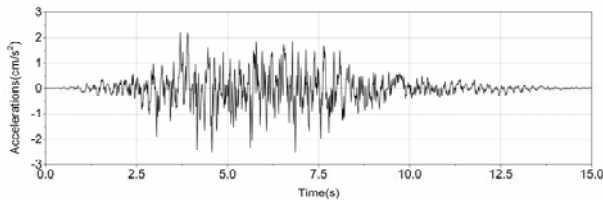
Fig.3. 6 degree rare earthquake wave

Working Condition and Seismic wave. Seismic wave shown in Fig.3 and Fig.4 was artificially synthesized according to working condition of the test (site classification is II, seismic design group is group I). Parameter used to synthetic seismic wave are shown in Table.1.

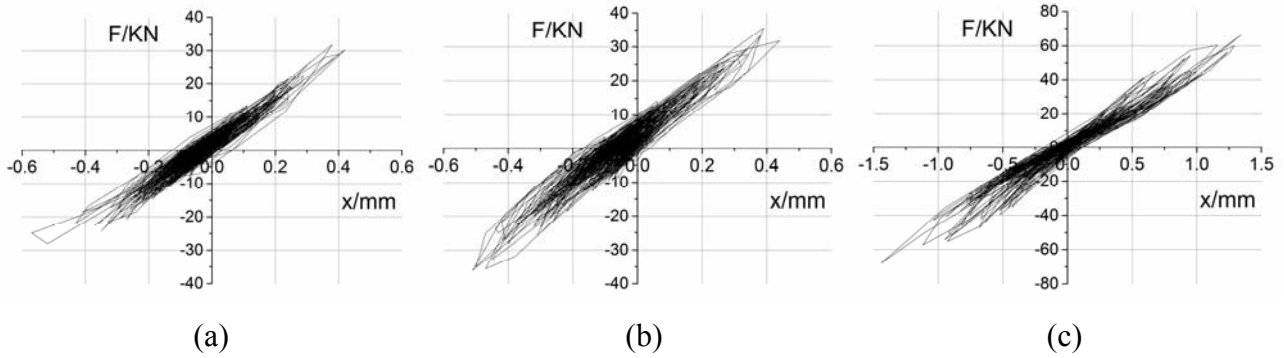
Seismic Response. The maximum value of displacement, velocity, and restoring force under the earthquake action of the model are shown in Table 2. The hysteretic curve of the structure can reflect the damage degree of the structure^[5] which is shown in Fig.5. The reinforcement ring beam and structural column improved the structural integrity and stiffness. The curve shown in linear relationship, plastic deformation is small and the structure is still in elastic stage.

Fig.5. restoring force-displacement curve:(a) 6 degree rare earthquake of pre reinforcement (b) 6 degree rare earthquake of after reinforcement(c) 7 degree rare earthquake of after reinforcement

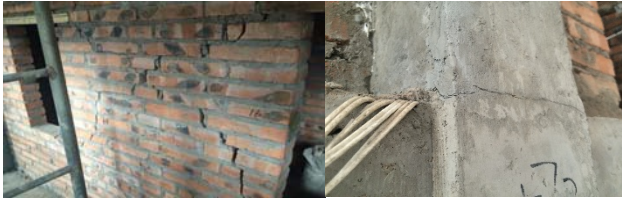
Track Development.One layer of wall cracked first along with the dropped off of mortar in the process of loading. The two layers of wall, beam, column joints also appeared cracks with the increase of load, crack extension along 45 degrees at four corners of windows and doors and formed cross cracks gradually, which is shown in Fig.6. Crack distribution is shown in Fig.7. After the ultimate load, the displacement increased and load began to decrease. The cracks appeared almost through the wall then the structure reached to the limit state.

Fig.6. Crack in wall, joint of beam and column

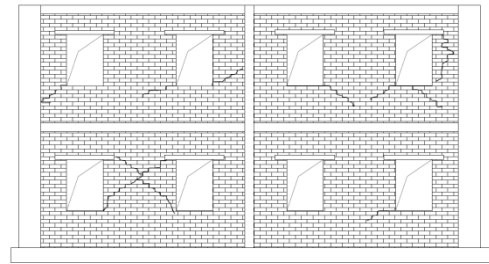
Fig.7. Crack patterns in the wall

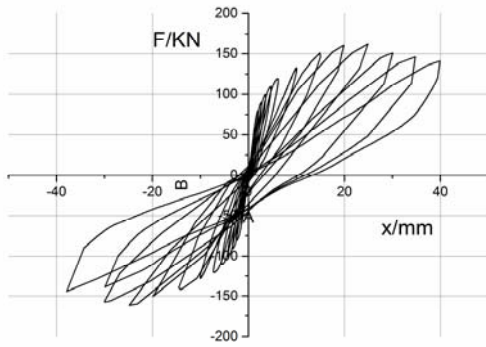
Fig.8 Hysteretic curve

Hysteretic Curve.Hysteretic curve of the structure is shown in Fig.8. We can see that at the beginning of loading, the restoring force-displacement curves of the structure shown in linear relationship, almost no residual deformation, and the structure was in the elastic stage. Then the curve was nonlinear, the slope decreases and relatively full with the load increased. The ultimate load is 161KN and the test was terminated when the displacement was close to 40mm.

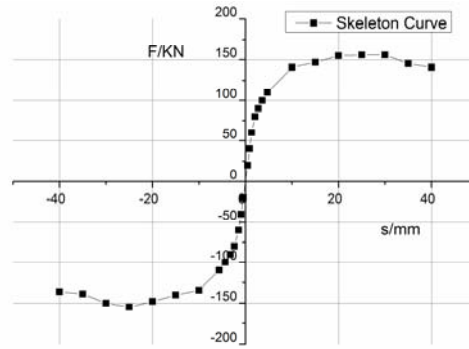
Fig.9 Skeleton curve

Skeleton Curve.The skeleton curve ^[6](which is shown in Fig.9)of the model can reflect the characteristics of the restoring force, displacement and the ductility of the structure directly. Crack on the wall was large, the wall loss carrying capacity when the structure close to limit state. But because of the beam, constructional column, the structure still maintain good integrity, not collapsed.

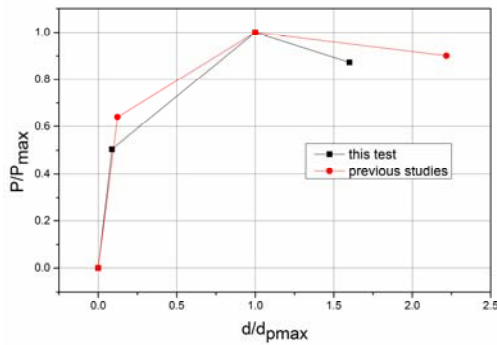
Hereon, compare the experiment status with previous studies^[7]. The model structure in the previous studies was a two layers and single bay full-scale masonry structure which only set L type constructional column in the four corners, and that made the ring beams and constructional columns relatively large. The plane size was 2400mm×3600mm and the section size of the structural column was 240mm×240mm. The skeleton curves are normalized^[8] by using non dimensional form, which is shown in Fig.10 and the eigenvalue is shown in Table.3. Structure's stiffness and restoring force of this test dropped uniformly with the increase of displacement when reached the ultimate load. But it decreased slowly in previous studies due to the large ring beam and structural column.

Fig.10. Normalized skeleton curves

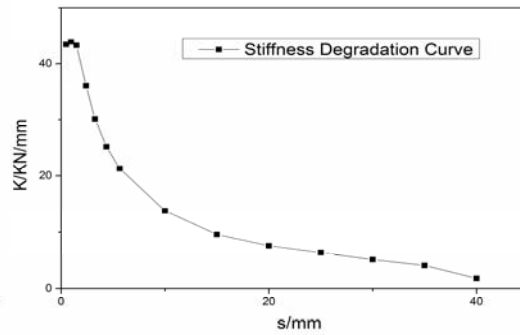
Fig.11. Stiffness degradation curve

Stiffness Degradation. Stiffness degradation curve of the structure is shown in Fig.11. The stiffness of the structure was 43.5KN/mm at the beginning of the experiment and 1.8 KN/mm in the end. The stiffness of the structure was obviously reduced with the development of the crack. With the development of the crack, concrete beam and column replaced the walls, bearing capacity and stiffness degrade slowly at that time.
