# *Performance of polyurethane grouting to handle heavy seepage in tunnels*

N Rana and R Nair

Heavy Civil Infrastructure, L&T Construction  
Chennai, India  
ns-rana@Intecc.com

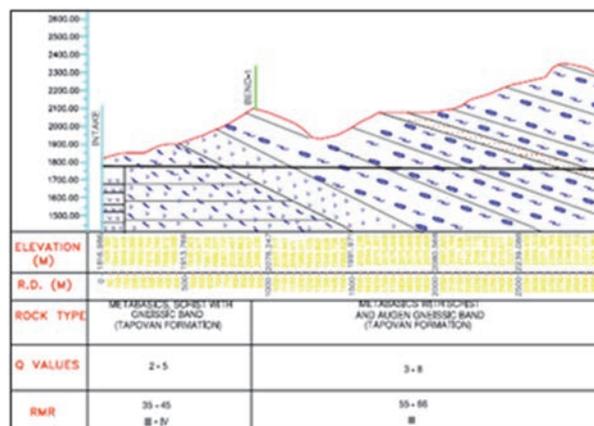
Fig. 1. Longitudinal section along head race tunnel (during initial site investigation)

major low angle fault zone along the Himalayan lies about 3 km south of power house location. The rock cover and rock type over the tunnel are shown in Fig. 1, which varies from ± 300m up to chainage 1475m. Beyond which it varies gradually to ± 1200m up to chainage 10500m. From chainage 10500m, it gradually decreases down to ± 200m near to surge shaft.

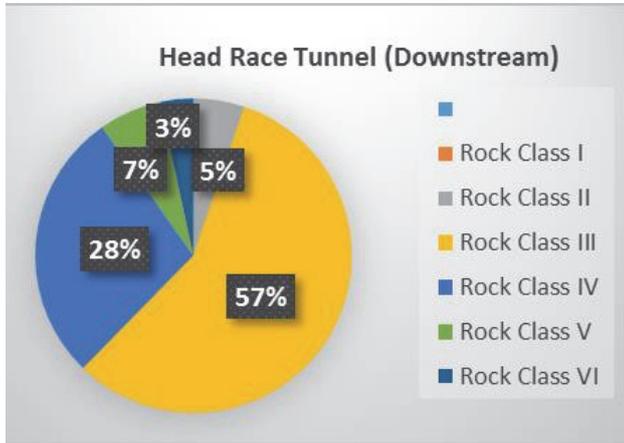
Fig. 2. Rock mass classification of head race tunnel (Ch. 0.0 to 1553 m)

In the entire length of head race tunnel excavation of project was 57% rockmass encountered falls under class III (Fair), 28% under class IV (Poor), 7% under class V (Very Poor) 3% under class VI (Extremely poor) rock category as shown in the Fig. 2.

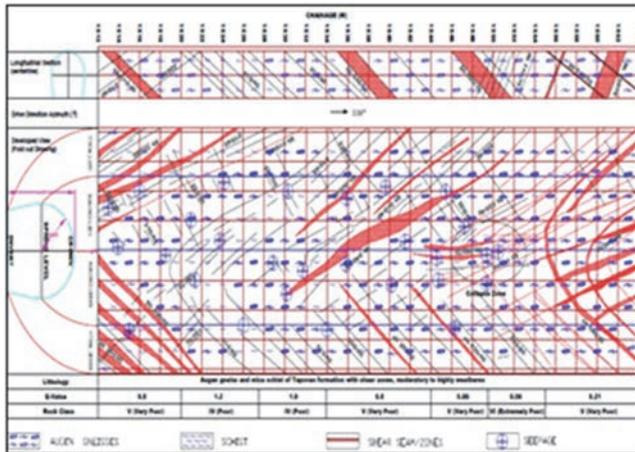
Fig. 3. Three dimensional tunnel log of the head race tunnel

contact, zone or bands of disintegrated or crushed rock and clay. The tunnel orientation N338o and the main joint orientation of the face was J1/Foliation joint 40/N020o, J2 40/N220o. J3 70/N120o and Jr 70/No50o and its falling in the rock class V (Very Poor). Three-dimensional tunnel log of the HRT is shown in the Fig. 3 and joint properties are tabulated in Table I.

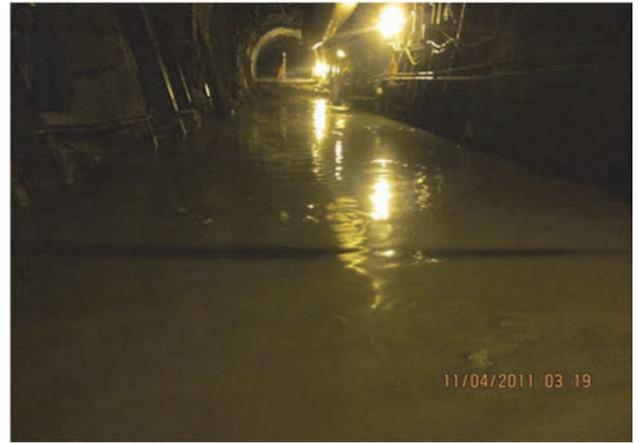
Fig. 4. Waterlogged in the head race tunnel due to heavy water ingress

water was encountered from the crown portion of the face, it covered a region of 75 m area away from the face. After few hours' ground water stabilized and flow continued at a rate of 1500 to 1800 Kl/day. Due to this heavy slush, 4-5 lattice girder near to face has completely damaged and formed a huge cavity above the crown level at face. The entire construction work has hampered along with severe damage to machineries and pre- installed rock support as shown in Fig. 4 to 6. Treatment of this failure zone was identified as the critical task.

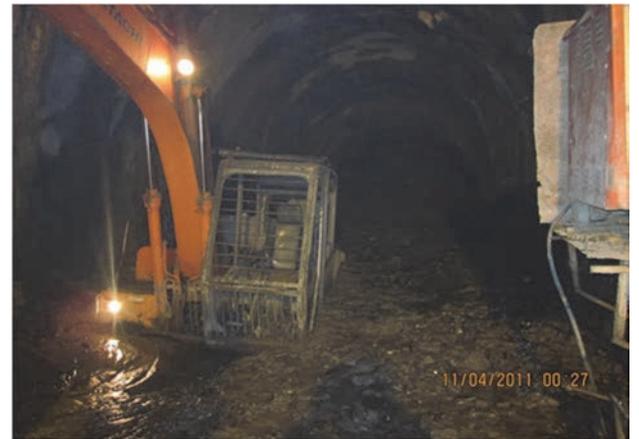
Fig. 5. Machineries and equipments stuck in the slushes

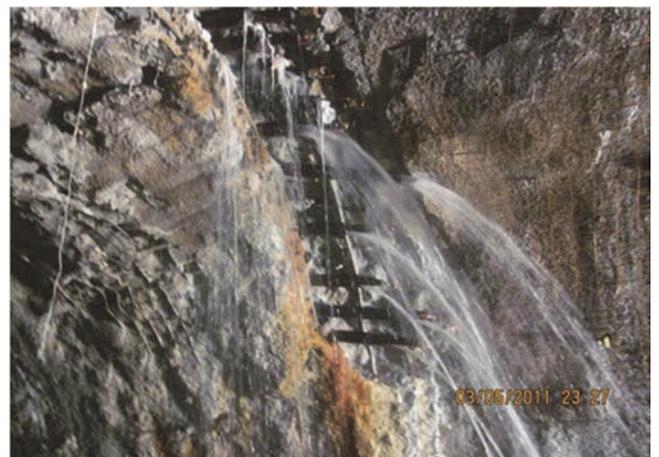
Fig. 6. Seepage water diverted from the tunnel face by using probing holes

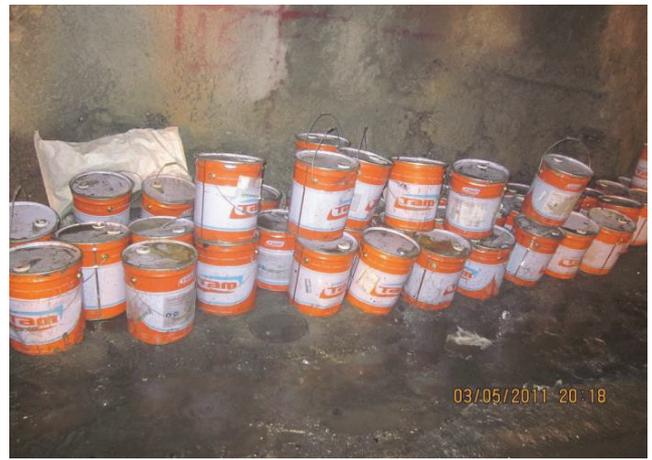
Fig. 7. Polyurethane grout materials

In this case study, TamPur 125 is used as polyurethane is employed for grouting. TamPur 125 is based on a polyol component (part A) and a polymeric MDI (part B). When mixed, hydrophobic polyurethane foam formed which is tough, rigid and resistant to a wide range of chemicals. The compound reacts rapidly to "cut off" large water leaks [1]. Polyurethane, polyol and isocyanate reacts forming a high strength adhesive material. The main property of polyurethane is its versatility, it can be found in different formulations having different properties either in liquid or in hardened phase, such as viscosity, thixotropic, foaming reaction (depending on the water being present) and mechanical strength. The properties of polyurethane compound are presented in Table II. The polyurethane chemical grout swells up to 20 times its size when it comes into contact with water and seals the rock mass. The grout has good compressive strength of 80MPa once it hardens, thus providing sufficient strength to loosen material in the joints Table III provides reaction time of polyurethane compounds at different temperatures. The key benefits of polyurethane grout are:

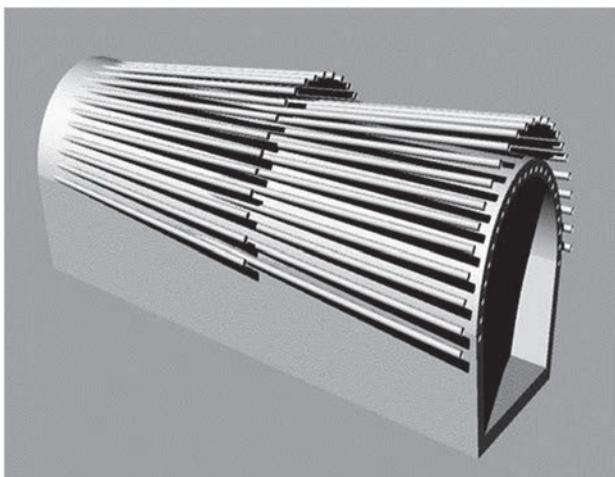
Fig. 8. Polyurethane grouting scheme

drilling time was 10 min/m. The pipe lengths of 3.0 m were coupled after inserting of previous pipe segments and simultaneously the pipes were pushed during drilling. In order to inject polyurethane grout, these pipes were perforated in different spacing on the basis of the probe hole and previous drilled holes. Geologists continuously observed and recorded the drilling behaviors, penetration rate and seepage behaviour to investigate the exact shear zone location for grouting purpose. Thus, pipe roofing was used to create an umbrella like structure around the roof and above spring level to control displacement of rock masses (Fig. 8).

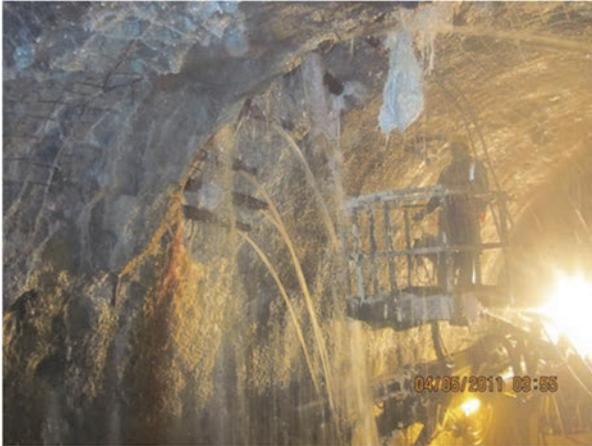
Fig. 9. Diverted water seepage from the tunnel face by drill holes

Fig. 9 to 14 shown the heavy seepage and rock failure in the tunnel before polyurethane grouting and the process involved during grouting, diverting seepage water by grout holes and the tunnel after completion of polyurethane grouting.

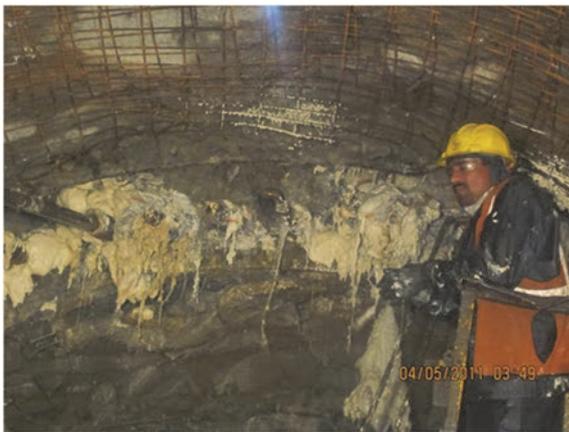
Fig. 10. Pipe roofing arrangements for polyurethane grout

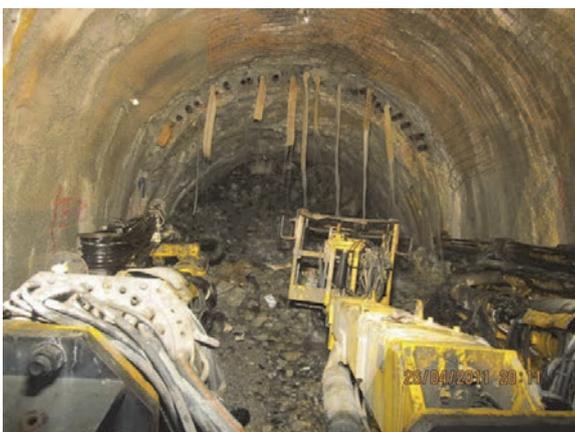
Fig. 11. Packer fixing for polyurethane grout

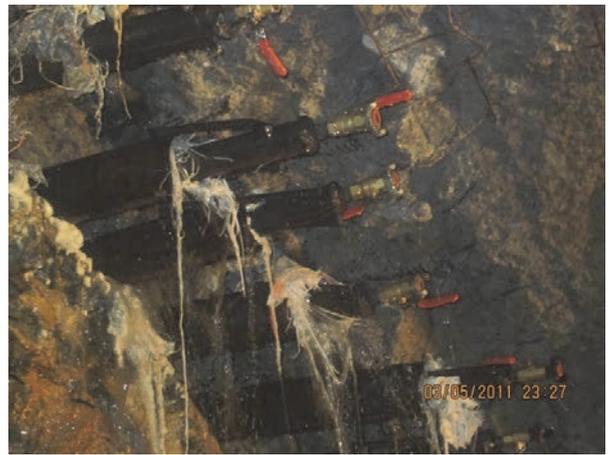
Fig. 12. Polyurethane grouting process

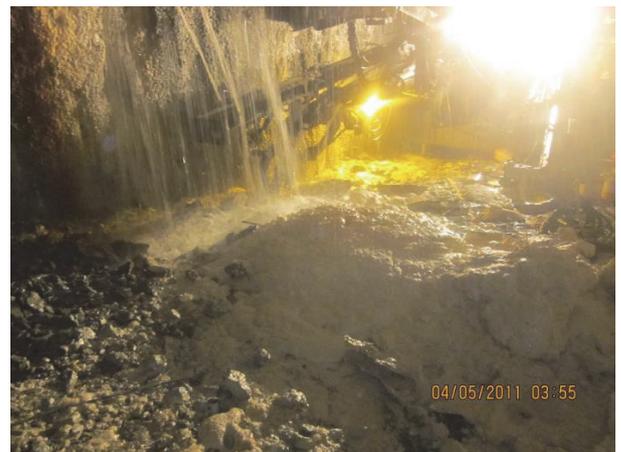
Fig. 13. Tunnel before polyurethane grout

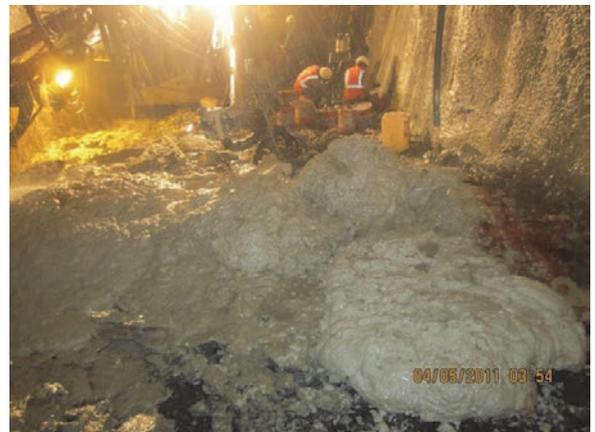
Fig. 14. Tunnel after polyurethane grout
