# *Tunnelling hazard in the diversion tunnel of Sengulam Augmentation Scheme, Idukki district, Kerala*

KR Praveen, CS Vishnu and C Thanavelu

Geological Survey of India,  
Thiruvananthapuram, India  
geopraveen@gmail.com

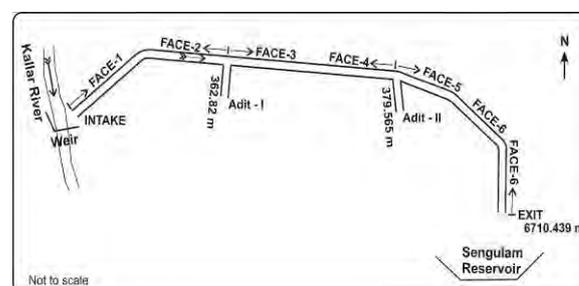
Fig. 2. Schematic diagram of diversion tunnel of SAS

Sengulam Augmentation Scheme (SAS) envisages transfer of water from Western Kallar River Basin to the existing Sengulam Reservoir by constructing a 10 m high concrete gravity weir and a 6.8 km long, 3.50 m diameter free flow diversion tunnel. The weir site is located 15 m upstream of the bridge over Kallar River on NH-49 (Fig. 1). Commencing in the year 2010, the project is under advanced stage of construction. Driving of the tunnel is being done by drilling and blasting method with six faces, one each from inlet and exit and two each from two adits (Fig. 2). The tunnel has been driven for about 4090 m. The authors were associated with the 3D geological logging of about 530 m reach of the tunnel and collected data for characterisation of the rock mass media.

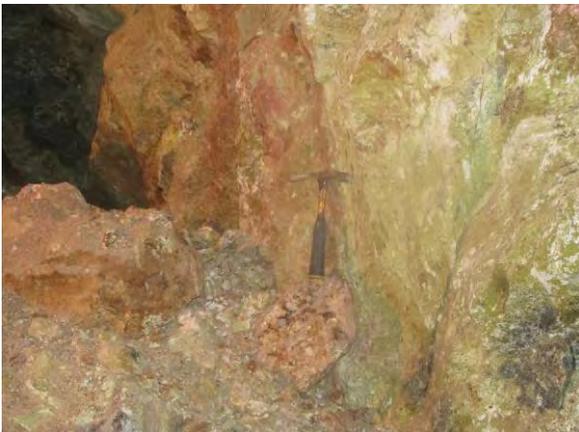
Fig. 3. Weathered olivine bearing alkali syenite and pinkish pegmatite with sharp contact

Olivine bearing alkali syenite (larvikitic) and pegmatite are found to occur as a multiple intrusion as observed in the weathered zone in Face - 4 (Fig. 3) of the diversion tunnel. These intrusive veins and bodies are in general trending in NW - SE direction parallel to Ottappalam – Kuttampuzha fault and disposed askew to the tunnel alignment. Pink and yellowish green minerals are dominantly present with conspicuous pockets and veins of epidote in the intrusive rocks particularly that are deeply weathered. The predominant discontinuities present in the rock mass include foliation, five prominent and persistent joint sets and four sets of shears.

The rock mass is thoroughly weathered in the reach from Ch.4004 m to 4095 m. The weathering is to the extent that the rock has become clayey sand even at about 135 m below the ground level (Fig. 3). The weathered rock material is very fine to coarse grained, soft, friable and dominated either with yellowish green or pinkish colours. The rock is subjected to shearing evidenced by presence of relict angular fragments and fractures in the epidote rich matrix.

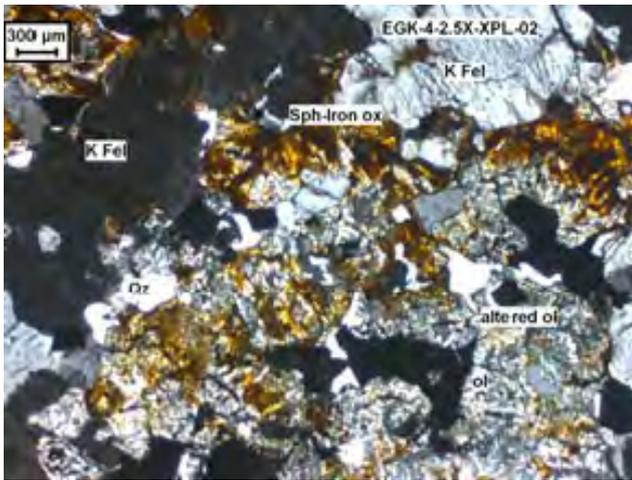
Fig. 4 : Photomicrograph of weathered olivine bearing alkali syenite

Kaolinised and sericitized K-feldspars, epidote, zoisite and altered fayalite are occurring as framework minerals in the breccia. The matrix of the breccia is fine, variegated with yellow, green, yellowish brown and also comprises aggregates of epidote, altered product of K-feldspars viz. sericite and kaolin. Opaques mainly of iron oxides, sphene and allanite are the other minor minerals identified in the matrix (Fig. 4). The yellowish epidote in matrix is found to altering to brownish material probably oxy-allanite.

Based on the petrographic studies, it is inferred that the original rock could have been fayalite bearing alkali syenite (larvikitic). The protolith is subjected to shearing resulting to brecciation and influx of hydrothermal solutions rich in epidote, sphene and iron oxide. Presence of epidote occurring as vein could also indicate simultaneous metasomatism. Shearing facilitated infiltration and migration of water and the least resistant mineral assemblages of intrusive rocks caused extension of weathering to deeper level.

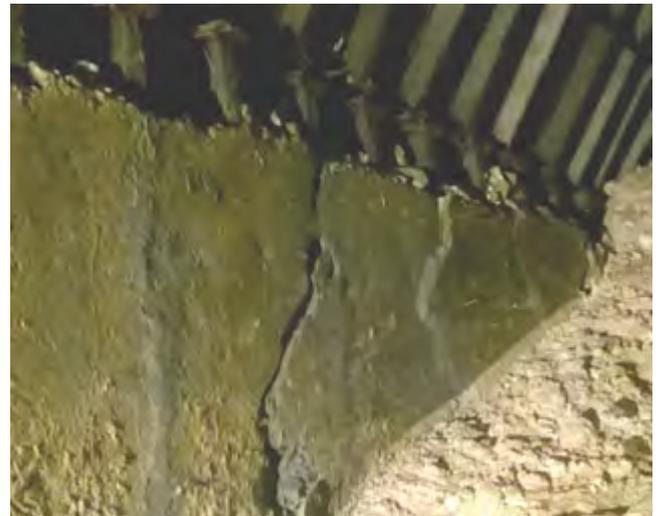
Caving type of failure has occurred from Ch. 4004 m to 4095 m (91 m) in Face 4. The extent of caving varies from about 1.5 m to 3 m beyond the designed profile. Presence of completely weathered zone is assessed to be the cause for the failures. Bending of steel ribs and development of cracks in concrete lining with shifting or converging towards the opening are observed particularly on the right wall of the tunnel between chainage 4002 m and 4006 m.

Squeezing of the weathered material due to high stress could be the reason for development of cracks and the associated movement (Fig. 5). Flowing type of failure is met at about chainage 4002 m (Fig. 6). Completely weathered, stressed rock mass saturated with percolated and accumulated

Fig. 5. Depicts bending of steel ribs and development of cracks in concrete lining in Face 4.

The reaches with caving type of failures in Face 4 is recommended to be supported with steel ribs spaced at 0.5 m with suitably spaced props touching the excavated profile, provision of concrete sleeper between steel ribs, rubble packing and grouting. Blocking concrete embedding the steel ribs is recommended instead of back packing and grouting. As recommended, tunnelling was furthered by simultaneous support till met with squeezing and flowing hazard. Provision of steel rib support has also been recommended for the reaches of heavy over breaks with continuing loose fall that has been driven through sheared rock mass. Classified the rock mass of the other reaches and worked out support system as per updated ‘Q’ system [4]. The reach wise details on ‘Q’ value and support system recommended are given in the Table I.

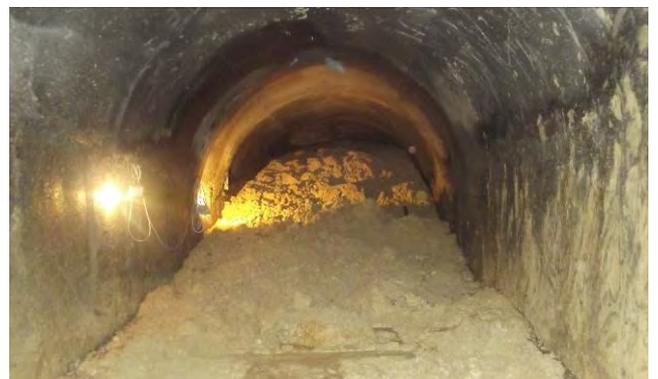
water from the surface is assessed to be the cause for the flowing failure.

Fig. 6. Flowing condition met in Face 4

In order to negotiate the reaches with squeezing and flowing conditions, it is suggested to carry out measures such as draining of flown muck by inserting horizontal perforated pipes, grouting of the flown muck, excavation of the flown muck up to the original face, pre-grouting, provision of pipe roofing or fore poling in the crown and horizontal drain pipes on the driving face. Further driving of the tunnel may be resumed by adopting heading and benching or multiple drifting methods with simultaneous rib support and concrete lining suitably.

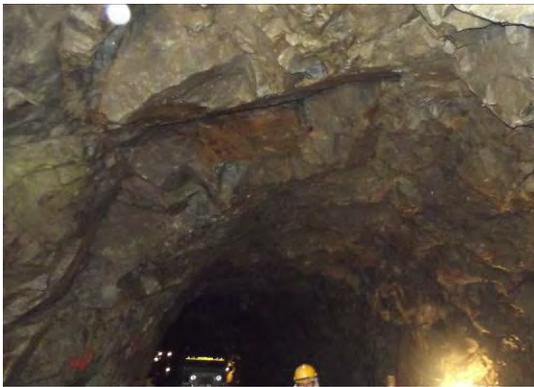
Failures by over breaks up to 3.5 m have also been occurred due to dislodgement of rock wedge at the intersection of weak, sheared / weathered zones and shear joints or only shear joints mainly in the reach from 5150.4 m to 5260.4 m in Face 6 (Fig. 7, 8, 9). The failed rock mass comprised mainly rhomboidal and cuboidal blocks of varying sizes limited by smooth, strained and weathered planes. Loosening of blocks could have been initiated by shear movement along two filled joints due to reduction in inter block friction aided by the presence of water charged gouge fillings. The causative features are parallel to the Periyar and Mattupetty shear zones, both disposed at about 30° askew to the tunnel alignment. The third low dipping smooth planar joints are acted as limiting plane.

Fig. 7. Over break due to failure of wedges in Face – 6

SI. No.	Chainages (m)	Q value	Nature of Rock Mass	Support Measures
1	4767.3 – 5150.4	5.3	Blocky	No Support
2	5150.4 – 5159.4	2	Blocky with minor / moderate over break at the intersection of slickensided and smooth planar joints.	Systematic rock bolting and plain shotcreting of about 10 cm.
3	5159.4 – 5216.4	0.13 to 0.25	Seamy and sheared with heavy to very heavy over break due to intersection of sheared and weathered zones with shear joints.	Rock bolting and Rebar Reinforced Shotcreting of about 30 cm.
4	5216.4 – 5256.4	8	Blocky	No Support
5	5256.4 – 5260.4	0.5	Fractured / sheared	Rock bolting and mesh reinforced shotcreting of about 10 cm.

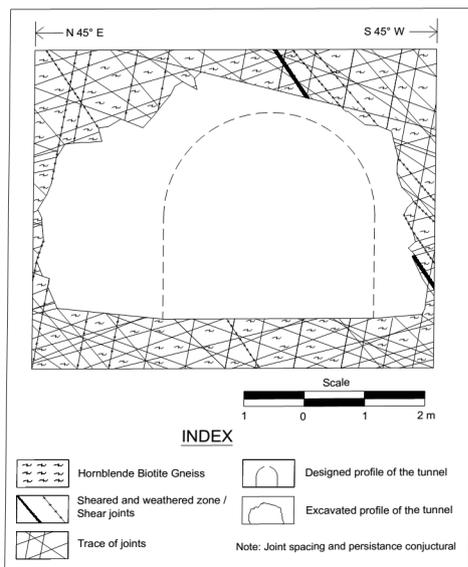
Fig. 8. Geological cross section of wedge failure at Ch. 5150.84 m in Face-6

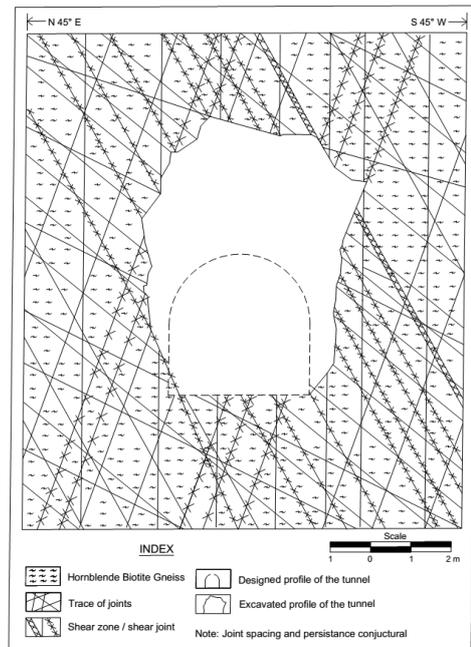
Fig. 9. Geological cross section of the failed reach at Ch. 5211.44 m in Face-6
