Replacement of Health Monitoring System and Health Evaluation for Jinan Yellow River Cable-stayed Bridge

Abstract. In order to understand the behavior of Jinan Yellow River Bridge more accurately and evaluate the bridge health, we change the sensors of the health monitoring system so that the data collected are more detailed and comprehensive. The monitoring data are analyzed synthetically. And then, based on this, the health condition of the Jinan Yellow River cable-stayed Bridge was evaluated.

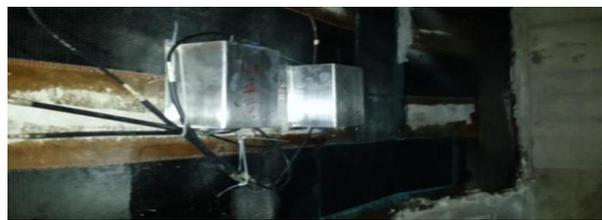
Fig.8 The vibration sensor after replacement

To avoid vibration sensor from accidental damage, the vibration sensor needs adding an external housing protection, that must be marked with the direction of sensor test to check and replace in late period, as shown in Figure 7 and 8.

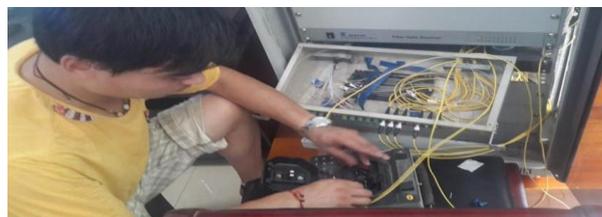
Fig.9 Connect the optical fiber in the box

When the strain and vibration sensors are installed, we start to connect and arranged the bus. We need to locate each fiber corresponds to the channel in the collective line box of monitoring room, and then through the jumpers connect the fiber's jack to the demodulator's socket accordingly, as shown in Figure 9. Finally, debug the data conversion software of demodulation instrument on the computer that is connected to the demodulator, and display real-time strain and acceleration values monitored on the computer screen, as shown in Figure 10 and 11. Then store the data in the corresponding database for analysis and processing.

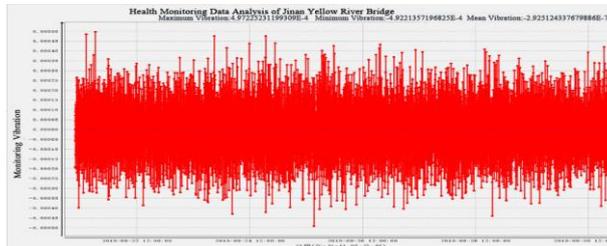
Fig. 12 The longitudinal acceleration in the mid-span

Fig.13 The vertical acceleration of western side in the box girder

Fig.14 The vertical eastern side in the box girder

Fig.15 The transverse acceleration in box girder lateral

From Figure 12 to 15, we can see if the noise (the acceleration increases abruptly in the figure) is ignored , the maximum of longitudinal acceleration does not exceed 0.0003g (g is the gravitational

acceleration 9.8m/s^2 , the same below). Longitudinal stiffness of the bridge is still very large, able to meet the needs of normal use. The western side's maximum acceleration of western box girder does not exceed 0.0005g and eastern side's does not exceed 0.01g . The eastern and western sides of box beam are quite different in the acceleration, indicating box girder damaged and concrete used in the bridge changed to some degree after a long period of operation, causing torsional stiffness decreased. The maximum of horizontal acceleration is at most 0.00002g , declaring that the bridge tower and bearing work in good condition. Overall, due to the longer time of use, there have been some changes in the bridge structure and the overall stiffness has declined, but it's still in normal use. And the bridge still needs to strengthen the periodic maintenance.
