## Construction Process and Common Problems of Isolated Bearing

**Abstract.** This paper mainly studies the characteristics of the construction technology of laminated rubber damping bearing and sliding isolated bearing, the common problems and solutions in the construction process, which provides reference for the construction of the relevant isolation bearing in the future.

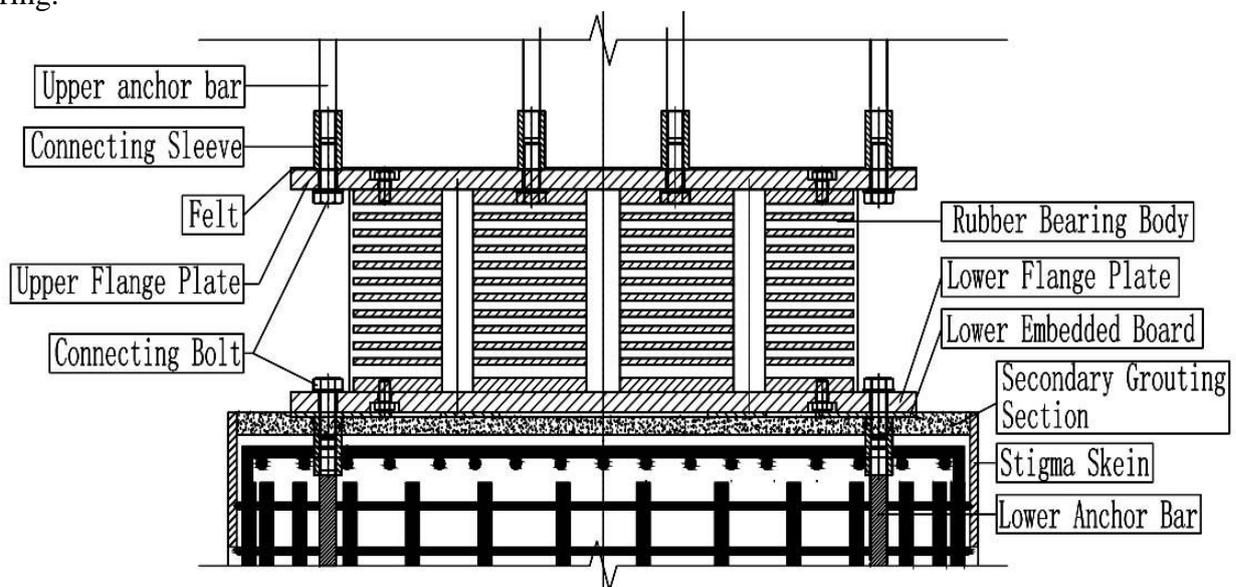
Fig. 1. Construction of laminated rubber damping bearing

At present, in order to connect bearing body with lower buttress and upper buttress, upper and lower embedded parts, upper and lower anchorage steel, bolts and sleeves are necessary in the actual construction process. The specific construction drawings are as follows: Fig. 1 shows the construction of laminated rubber damping bearing and Fig. 2 shows the common construction process of isolation bearing.

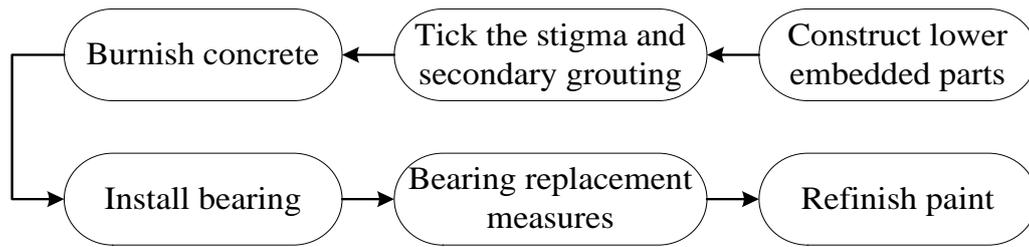
Fig. 2. Common Construction Process of Isolation Bearing

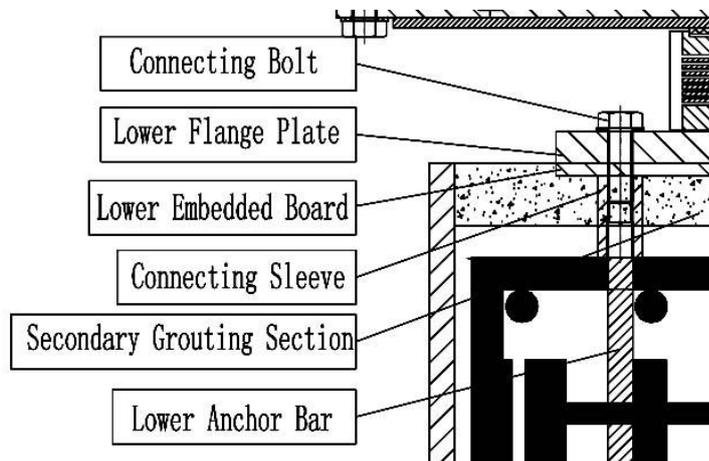
Fig. 3. The installation of the sleeve

**The Sleeve is not in Full Contact with the Embedded Board.** The installation of the sleeve and the embedded board during the installation of the isolation bearing is a prerequisite for the installation of the bearing. Fig. 3 shows the installation of the sleeve. The relationship between the connecting sleeve and the embedded plate is vertical. By doing this, we can ensure that the sleeve is tightly fitted with the embedded board so as to be uniformly stressed by the connection of the bolt with the lower anchor bar, the lower embedded board and the bearing.

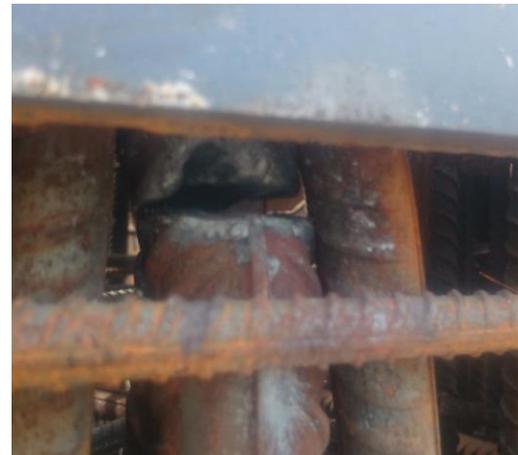
Fig. 4. The main reinforcement is cut

**Problems of Cutting Column Gluten.** The steel bar in the part of the column pier is too dense in some projects, and there is column gluten, column pier gluten, sheet-beam and beam bar which are crisscrossed together. The upper and lower anchor bars of the bearing may conflict with the bars of the column during the installation. Due to management problems, the phenomenon that the steel bar or even the main reinforcement of the beam-column is cut will appear in the part of the project. Fig. 4 shows that the main reinforcement is cut. If the reinforcement is too dense, the main reinforcement lap can be replaced by straight thread connection which helps avoid the disadvantage of too much main reinforcement [2].

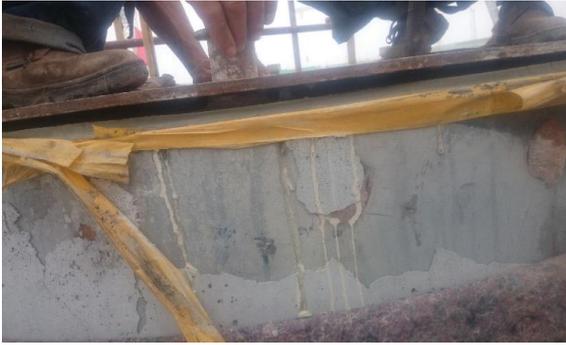
Fig. 5. The hollowing problem of the embedded board

**Reliability of Stigma Secondary Grouting.** In order to strengthen the stigma, the stigma will be given secondary grouting in some projects. Due to the thickness of the grouting is limited, the grouting material has been filled with the embedded board resulting from non-dense vibrating and the embedded board is hollowing after the concrete is solidified in the process of secondary grouting. Fig. 5 shows the hollowing problem of the embedded board. There are two main reasons for this phenomenon. The first one is that the stigma skein is too low that the grouting material is higher than the template and spills over it. The second one is non-dense vibrating. To solve this problem, the grouting material which slightly expands can be used and the stigma secondary grouting material must be fully vibrated.

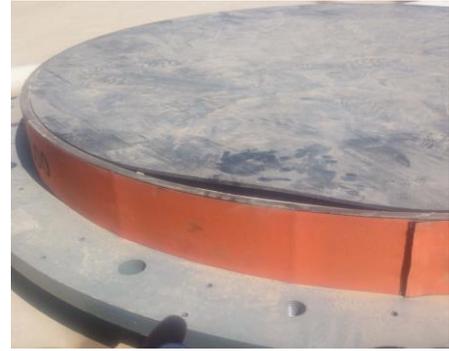
Fig. 6. The PTFE isolation bearing exposed to the sun is degummed and with bulge

Isolation bearings are treated with improper storage after entering into the site and being accepted. Fig. 6 shows the phenomenon that the PTFE isolation bearing exposed to the sun is degummed and with bulge. Fig. 7 shows that storage location and other issues lead to the corrosion of the bearing in the preparation process of the construction materials. Fig. 8 shows that PTFE is contaminated in preparation for the installation process of the isolation bearing. And Fig. 9 shows that the sliding isolated bearing is inverted in the preparation process of the construction.

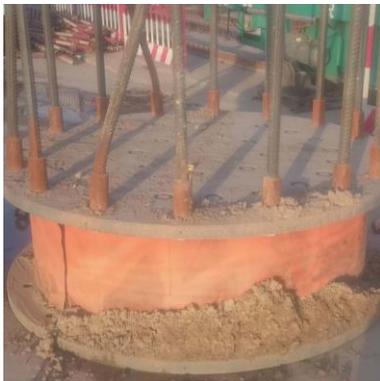
Fig. 7. Storage location and other issues lead to the corrosion of the bearing

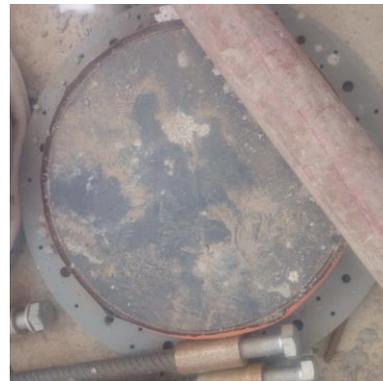
Fig. 8. PTFE is contaminated

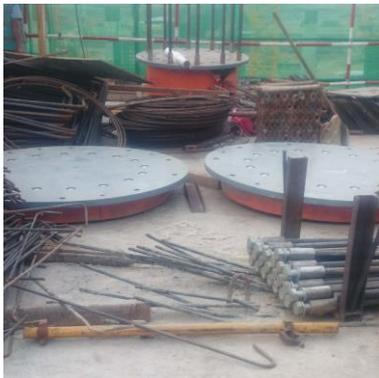
Fig. 9. The sliding isolated bearing is inverted

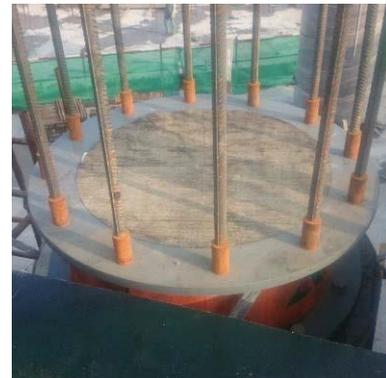
Fig. 10. The size of the felt is too small

and the felt shall be cut and perforated according to the sleeve position and the same size as the flange plate. The felt should be laid flat. The situation that there is not a felt matched with a flange plate, the size of the felt is less than that of the flange plate of the bearing, or the felt has broken holes should be avoided. Fig. 10 shows that the size of the felt is too small.

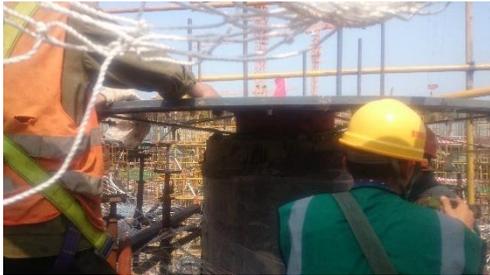
Fig.11. The placement of the sliding isolation bearing

**Installation of Mirror Board of the Sliding Bearing.** In order to make full use of the space of the isolation layer, it is a common practice to set up an isolation layer under the roof of the basement whose sliding isolated bearing is composed of mirror board and PTFE bearing body and the area of the mirror board is much larger than that of the bearing body. Therefore, placing the mirror board of the bearing on the bearing body to ensure the use of the lower space is a usual practice. Fig.11 shows that the placement of the sliding isolation bearing.

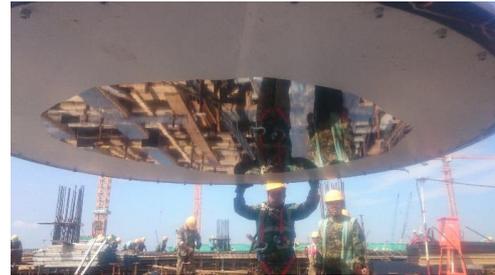
Fig. 12. Uncover the upper flange plate of the protective film during installation

**Installation of Upper Cover of the Sliding Isolation Bearing.** We are expected to use prefabricated hoisting holes in the process of the lifting process of the upper cover of the sliding isolation bearing and there must be 4 or more hanging points which ensures that the mirror board remains horizontal in the lifting and is protected from any bumps. Uncover the protective film on the mirror board under the upper cover. The size of the protective film uncovered is the same as the diameter of the bearing body, and the rest is removed after the pouring of the upper buttress is finished which avoids contaminating the mirror board in the pouring process of the upper structure. Fig. 12 shows the process of uncover the upper flange plate of the protective film during installation.

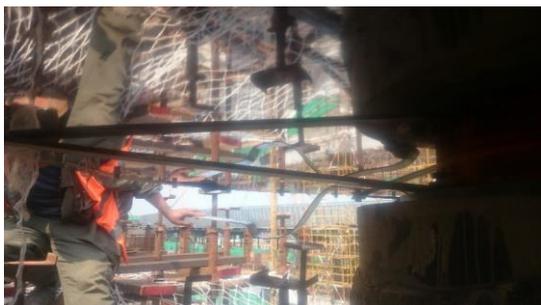
Fig. 13. The connection bars

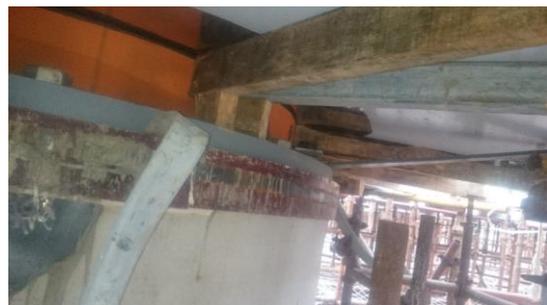
Fig. 14. The upper cover of the sliding isolation supported by the scaffold

**Fixation of Upper Cover of the Sliding Isolation Bearing.** If the flange plate with a mirror plate is on the upper part of the sliding isolation bearing body, it would be called the upper cover of the sliding bearing. The size of the upper cover of the sliding bearing is much larger than that of the isolation bearing body, so the upper cover of the sliding bearing may move or overturn due to the stampede from installers, the installation of the upper buttress template, the grouting, the vibrating, etc., in the pouring process of the upper buttress. Taking what we have discussed above into consideration, there are two specific measures. The first one is to use connection bars to connect the lower and upper flange plates of the sliding isolation bearing. Fig. 13 shows the connection bars. The second one is to use the scaffold around the pillars to support the upper cover of the sliding isolation bearing. But pay attention to add square wood when contacting with the mirror panel of the upper cover to prevent the scaffold from scratching the mirror panel. Fig. 14 shows the upper cover of the sliding isolation supported by the scaffold.
