Application of MVC-DI process to the treatment of the municipal landfill leachate

Abstract. An application of treating the landfill leachate by MVC-DI process is introduced. The leachate evaporation treatment system (MVC) of a landfill decreased by 70% in the treatment capacity, and the effluent quality was not up to the discharge standard. The hot-running test, the cold-stop detection and the analysis of the scale sample have been proposed. After rectification process, the results show the daily treatment capacity is restored to 175 t/d, the effluent quality reaches the design requirement, and the environmental benefits are significant.

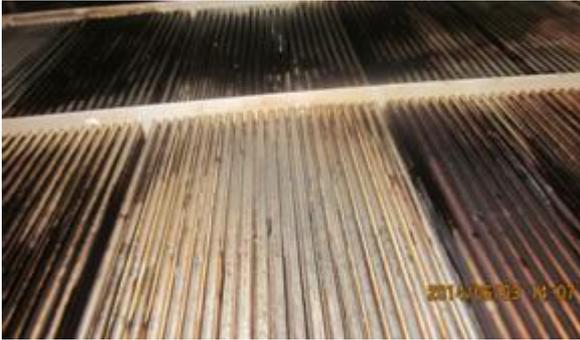
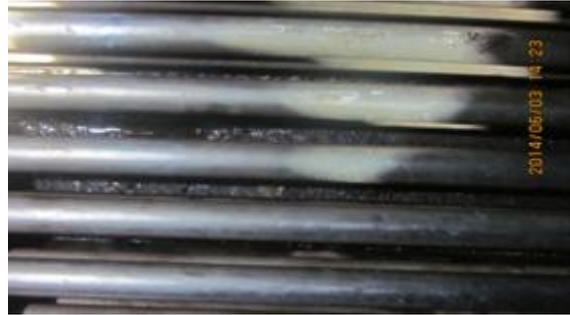
Main detection units	Detection result
Evaporation heat transfer agent	Severe fouling between tube bundles, thick dirt covering mist eliminator, no corrosion inside heat exchange tube (figure 2~6)
Electric heating boiler	The heating resistance element had a little white attachment (figure 7)
Compressor	The steam was leaking and the smell was strong and pungent.
Others	No abnormalities were observed.

Figure 2. Severe fouling between tube bundles

Figure 3. Severe fouling between tube bundles

The heat transfer tubes between the tube and shell heat exchanger is seriously clogged with dirt. The plate heat exchanger inside is fouled seriously; the fluid is not flowing smoothly. The heat transfer of the MVC heat transfer tube is worsened, and the effective water volume of the shell is greatly reduced.

After scaling, the heat transfer in the inside of the tube is greatly reduced with the temperature of the low-temperature liquid outside the tube. The main temperature is low, so that the amount of the original liquid is greatly reduced and the concentration of the discharge system is larger. The evaporation of the original liquid in the evaporative heat transfer agent decreases, the vapor intake of the compressor is insufficient, and the high temperature steam releases low heat.

(1) Firstly, manual mechanical cleaning of dirt on the MVC's heat transfer tube and other parts (e.g. High pressure water gun, etc.). The dirt and sewage cleaned up should be eliminated from the thermal well below the MVC, avoiding sewage and dirt entering the MVC system piping and plate heat exchanger, causing secondary blockage and pollution.

(2) Chemical cleaning. It can be seen from the analysis of scale samples that the main components of dirt are organic materials and minerals, and the suitable and effective chemical cleaning drugs are selected according to the fouling ingredients, cleaning the heat transfer system.

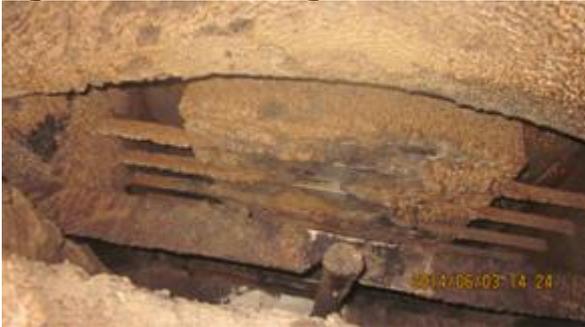
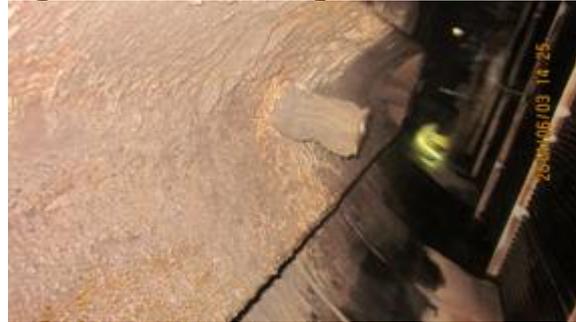
Figure 4. Thick dirt covering mist eliminator

Figure 5. Thick dirt covering mist eliminator

The mist eliminator is covered with thick dirt, which reduces the efficiency of the MVC's soda separation, resulting in reduced heat exchange efficiency.

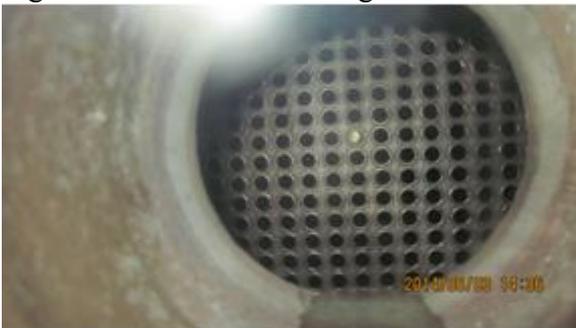
Figure 6. No corrosion inside heat exchange tube

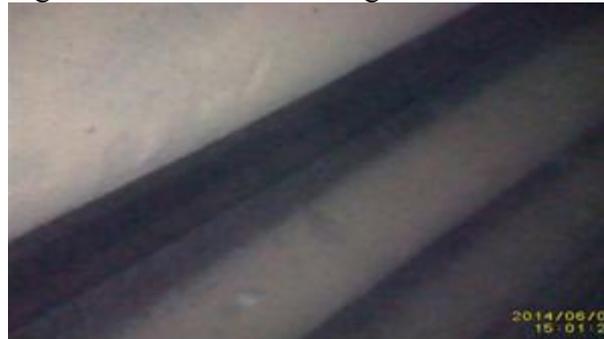
Figure 7. A little white attachment around heating resistance element
