Failure Analysis of Welding Insulation Cylinder

Abstract: In order to analyze the failure cause of welding insulation cylinder, to which explosion had happened, in a filling station, a series of experiments and analysis were taken, including macroscopic analysis, chemical composition analysis, fracture Analysis, metallographic examination and so on. The results showed that irrational structure led to fatigue cracking of fillet weld, connecting the inner-shell and neck pipe, and then pure oxygen continuously leaked into the vacuum interlayer. Friction heat or static electricity generating with the leaking finally caused combustion and explosion of flammable insulation materials in the interlayer. At the end, proposals were put forward.

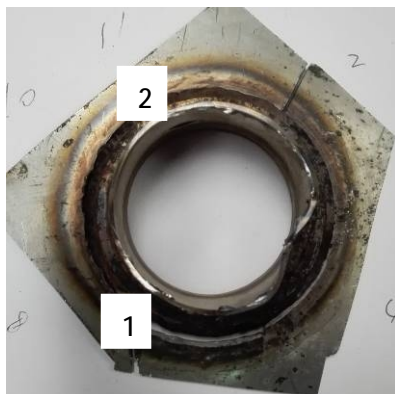
Fig.5 Diagram of sampling
(1-Position "A", 2-Position "B")

Sampling from the fillet weld, connecting the inner-shell's upper head and neck pipe, and its adjacent areas for metallographic examinations^[4], shown in Fig.5. The results were as follows:

(1)The microstructure of base metal in the inner-shell's upper head, reinforcing ring, and neck pipe, was twinning austenite (in Fig.6~Fig.8), without exceptions. While in weld, was austenite of columnar crystals, and there was apparent carbide precipitation in base metal of heat affected zone (in Fig.9~Fig.10).

(2)Fracture was located on the heat affected zone of fillet weld, connecting the inner-shell's upper head and reinforcing ring, near the side of head (in Fig.9~Fig.11), and incomplete fusion existed in the fillet weld (in Fig.12).
