Analysis and Detection of Seepage Path of Nanmenxia Reservoir Using Ground Penetrating Radar

Keywords: Ground Penetrating Radar, Nanmenxia Reservoir, seepage path, detection and analysis

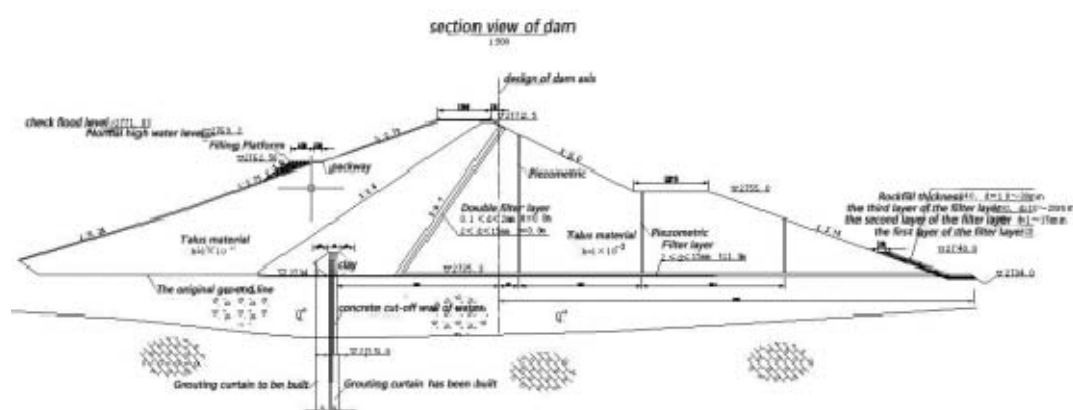
Figure 1 Sectional view of Nanmenxia reservoir dam

Nanmenxi reservoir is a medium-sized project mainly used for irrigation. It was founded in 1974 and put into operation in 1982. Because the reservoir is located in karsts areas, it has complex geological conditions, the structure karsts and fracture of dam base and two dam abutment was very development. Leakage is also serious. Seepage treatment works of Nanmenxia reservoir have already begun as early as 1975 during the dam construction. It has been carried out three stages of curtain grouting, but the effect was not ideal. Sectional view of Nanmenxia reservoir dam was shown in Figure 1.
