# Corrosive Behavior Study of Q235 Steel Coated with Epoxy Composites in Substation Environment

Abstract. In this work, the epoxy composite coating composited by zinc rich epoxy primer and silver epoxy enamel, was sprayed on the surface of Q235 steel. The anticorrosion of as-prepared samples in substation environment with atmospheric exposure for 18 months, and in 5% NaCl aqueous solution for 250 days were evaluated and compared, respectively. Electrochemical impedance spectroscopy (EIS) was employed to analyze the corrosive behavior of epoxy composite coating in 5% NaCl aqueous solution, the weather resistance and salt resistance were also evaluated. Additionally, the structure changes of epoxy composite coating induced by salt immersion and atmospheric exposure were characterized by fourier transform infrared (FT-IR). The results are demonstrated that the epoxy composite coating is corroded to be invalid after immersed into 5% NaCl aqueous solution for 250 days, which the impedance decreases from  $3.967 \times 10^9$  ·cm² to  $9.780 \times 10^2$  ·cm². The mechanism of corrosion is proposed that the corrosive medium gradually penetrate into the composite coating to form micro e

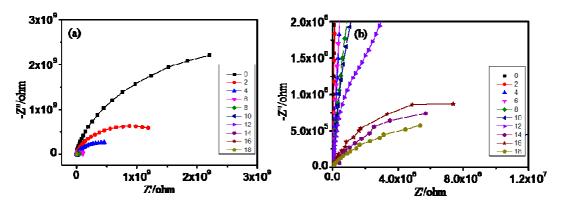
Fig.2 EIS results of Q235 epoxy composite coating in different atmospheric exposure time

The surface picture of epoxy composite coating exposured in nature for 18 months was shown in Fig.1. No pitting, cracks and corrosion marks can be found and the surface is smooth in the coating sample, indicating the good weather resistance of epoxy composite coating. In order to understand the corrosive properties of coating sample deeply, the Fig.2 showed the electrochemical impedance spectroscopy of epoxy composite coating exposured for different time. The equivalent circuit diagram 3a is used to fit with Zview software to obtain Rct and Cdl in Table 1.

The impedance of coatings decreases gradually with the exprosure time prolonged, indicating the corrosion resistance of the coating was gradually decreased. The impedance of coatings is  $2.708 \times 10^6$   $\Omega \cdot \text{cm}^2$ , demonstrating the good protection of coating, which is consistent with the results of Fig.5.

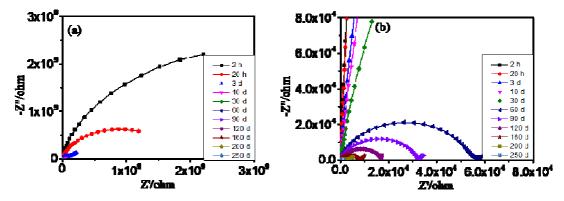
Fig. 5 EIS results of Q235 epoxy composite coating with different immersion time

The EIS results of epoxy composite coating treated in 5% NaCl aqueous solution for different time were revealed in Fig.5. Fig.5b is the local magnification of Fig. 5a. In the primeval immersion, the EIS only shows a time characteristic constant by fitting Z-view software using equivalent circuit diagram 3a. At this time, the resistance of coating is much large, which is isolated from the substrate and corrosive media contact, playing a protective role. A small arc resistance in high frequency region and a large arc resistance in low frequency region appear in Nyquist spectrum and there are two time characteristic constants in EIS after immersing 3 days, illustrating that electrolyte penetrated into the coating with the effects of penetration to reach the surface of the metal substrate. After that, the coating enters into medium and late stages of immersion. The equivalent circuit diagram 6b is used to fit with Zview software to obtain Rct and Cdl in Table 2.
